**HAZARDOUS BUILDING MATERIALS
SURVEY REPORT**

230-232 Sussex Street

Report Number 610.14201.00100/01/HMR

6 February 2015

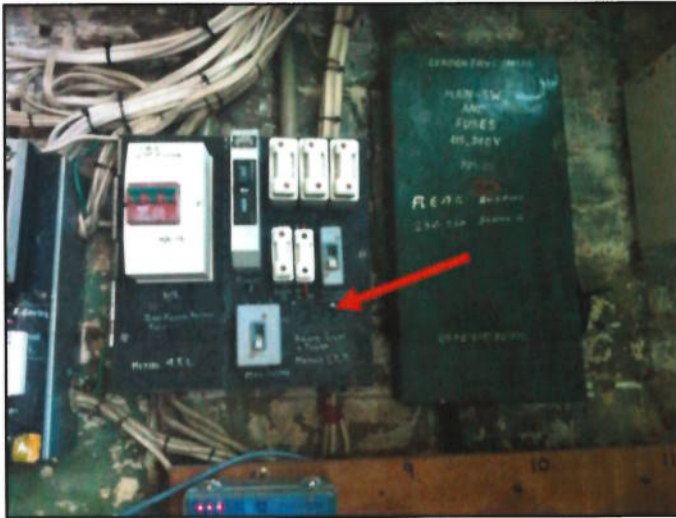
Photograph 1

Ground Floor, Southern Section, Electrical Distribution Cupboard, Western BEBB (asbestos containing).

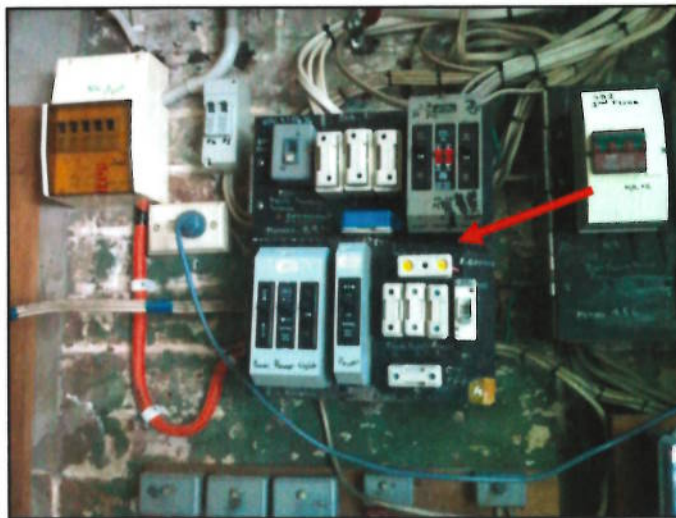
Photograph 2

Ground Floor, Southern Section, Electrical Distribution Cupboard, Eastern BEBB (asbestos containing).

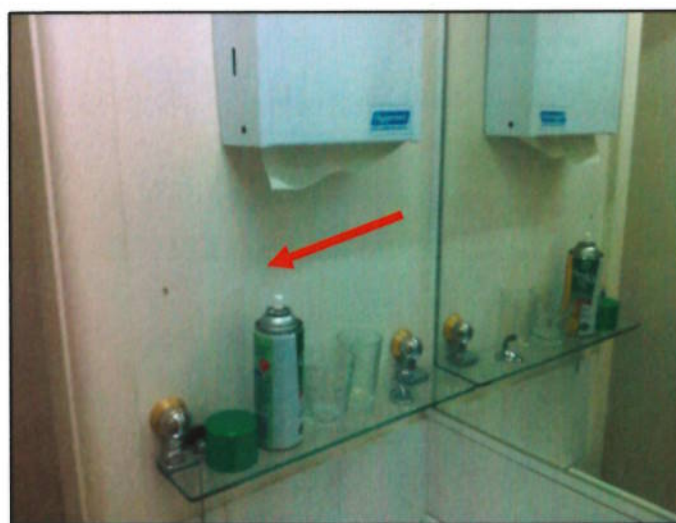
Photograph 3

Ground Floor, Northern Section, North Eastern Toilet Airlock Room, FCS wall sheeting (all walls) (asbestos containing).

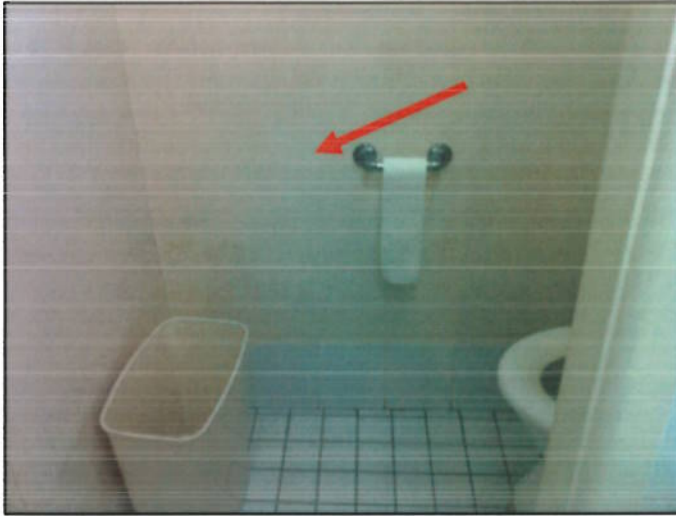
Photograph 4

Ground Floor, Northern Section, North Eastern Toilet, FCS wall sheeting (all walls) (asbestos containing).

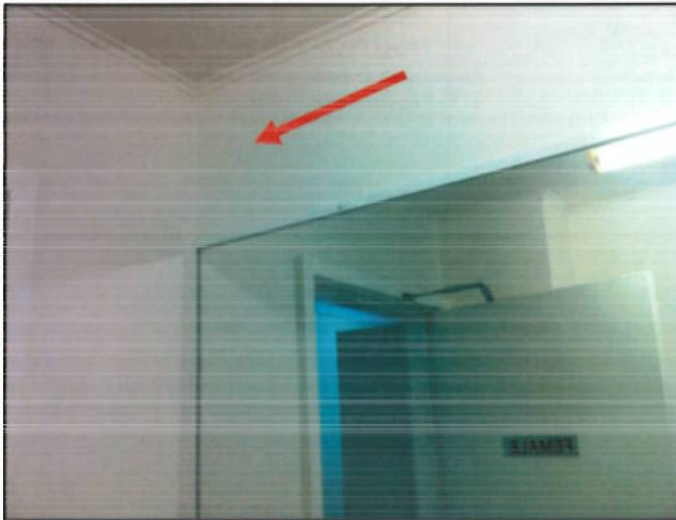
Photograph 5

First Floor, Female Toilet Airlock Room, FCS wall sheeting (all walls) (asbestos containing).

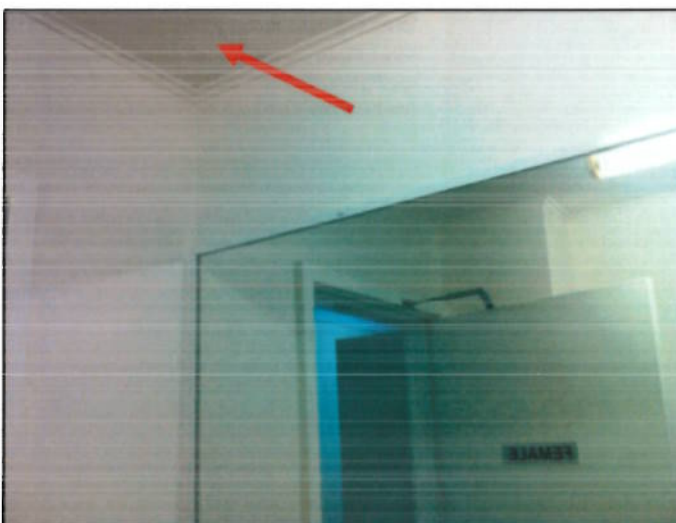
Photograph 6

First Floor, Female Toilet Airlock Room, FCS ceiling sheeting (asbestos containing).

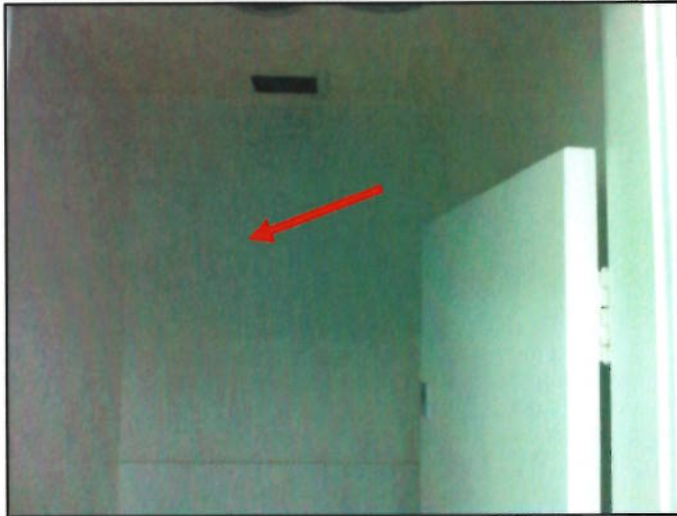
Photograph 7

First Floor, Female Eastern Toilet, FCS wall sheeting (all walls) (asbestos containing).

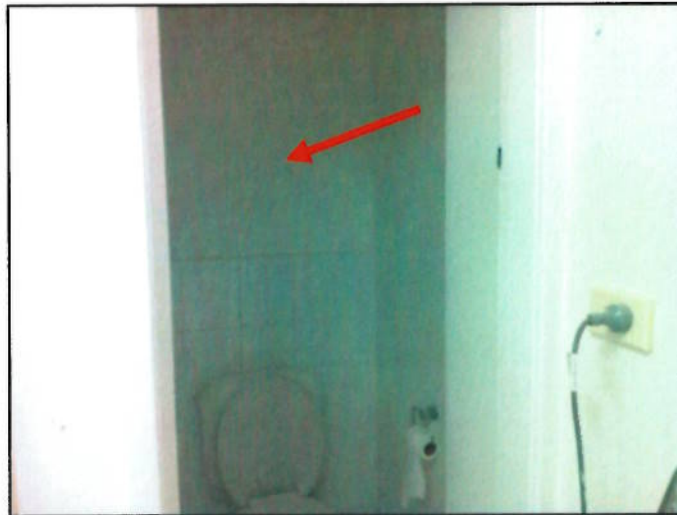
Photograph 8

First Floor, Female Western Toilet, FCS wall sheeting (all walls) (asbestos containing).

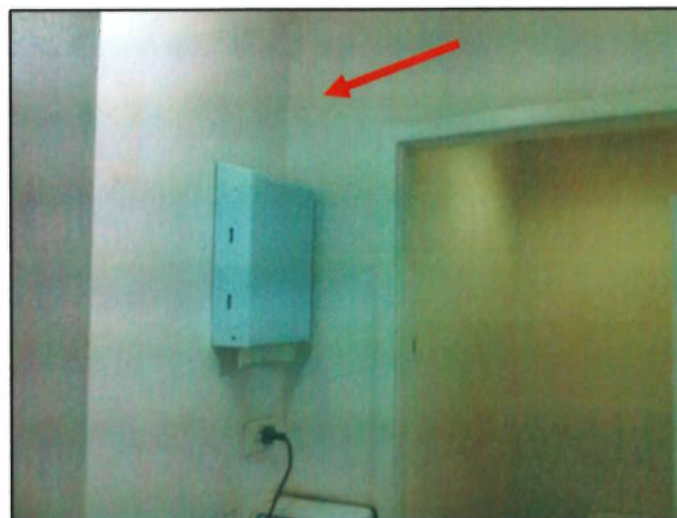
Photograph 9

First Floor, Male Toilet Airlock Room, FCS wall sheeting (all walls) (asbestos containing).

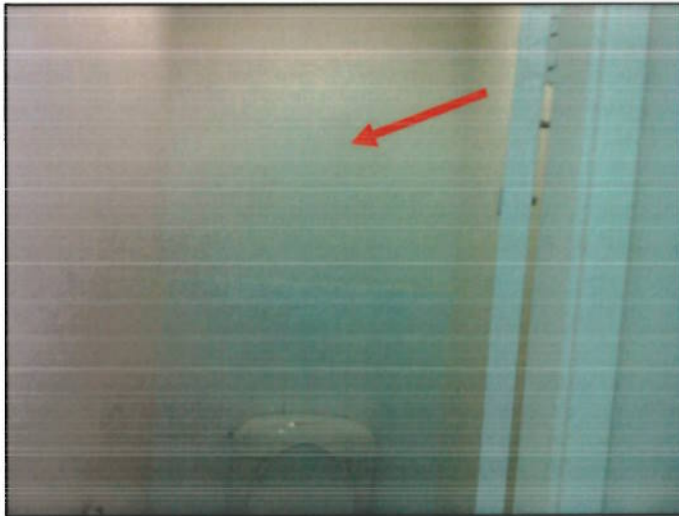
Photograph 10
First Floor, Male Toilet, FCS wall sheeting
(all walls)
(asbestos containing).

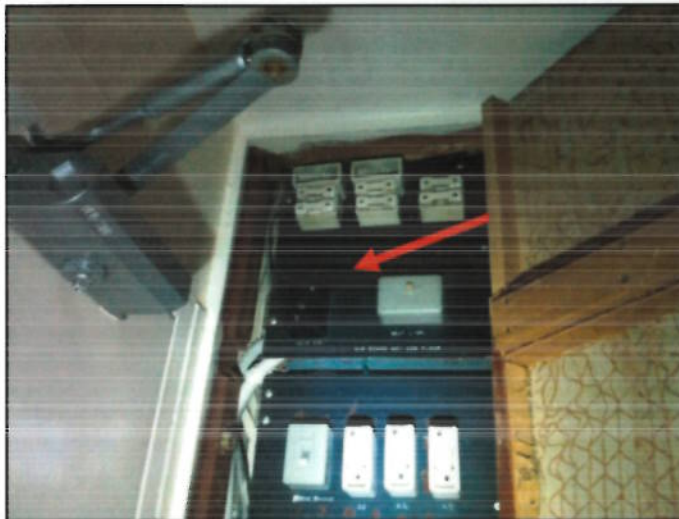
Photograph 11
Second Floor, Western Electrical
Distribution Cupboard, upper BEBB
(asbestos containing).

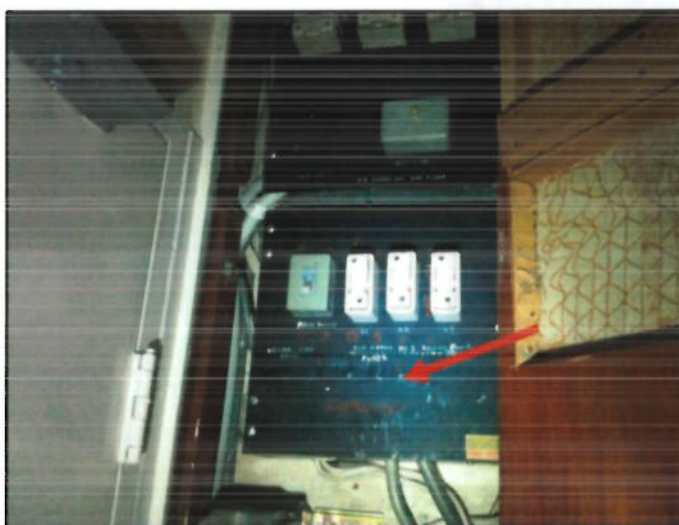
Photograph 12
Second Floor, Western Electrical
Distribution Cupboard, lower BEBB
(asbestos containing).

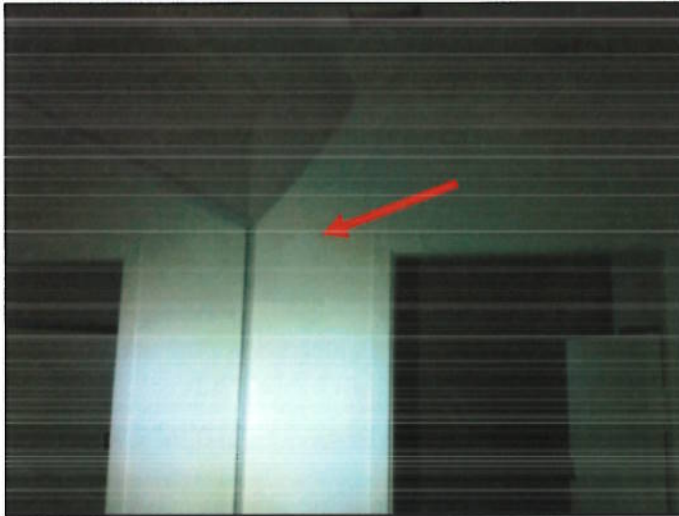
Photograph 16
Second Floor, Female Toilet Airlock Room, FCS wall sheeting (all walls) (asbestos containing).

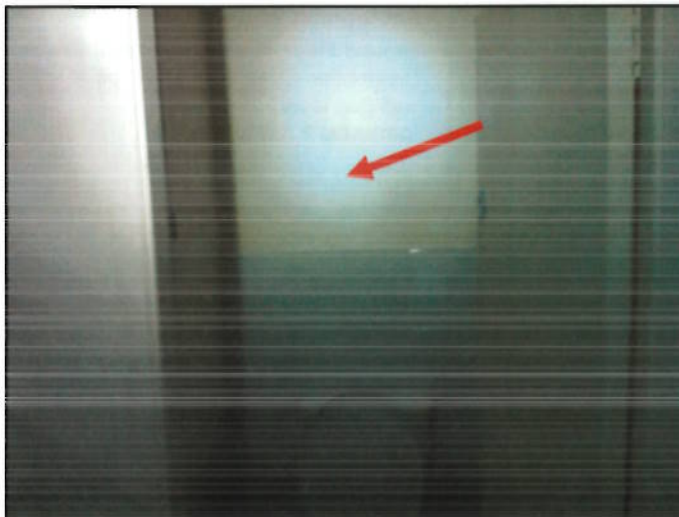
Photograph 17
Second Floor, Female Toilet, FCS wall sheeting (all walls) (asbestos containing).

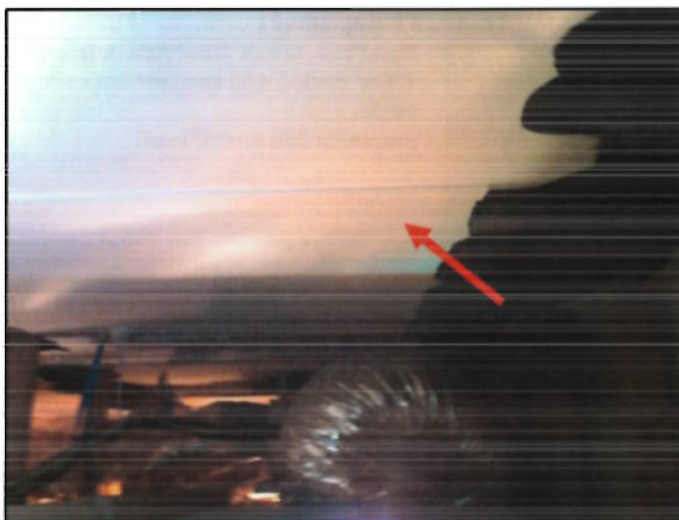
Photograph 18
Ground Floor, FCS ceiling sheeting within ceiling cavity (asbestos containing).

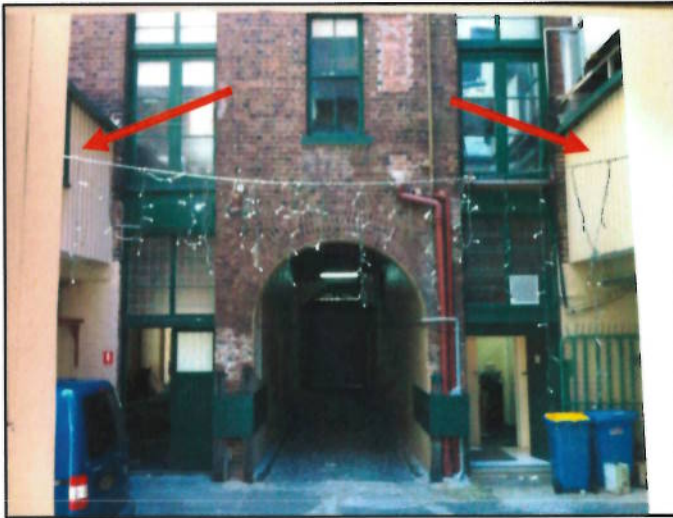
Photograph 19

FCS shadow-lining to Northern and Southern external walls of Enclosed Walkways (asbestos containing).

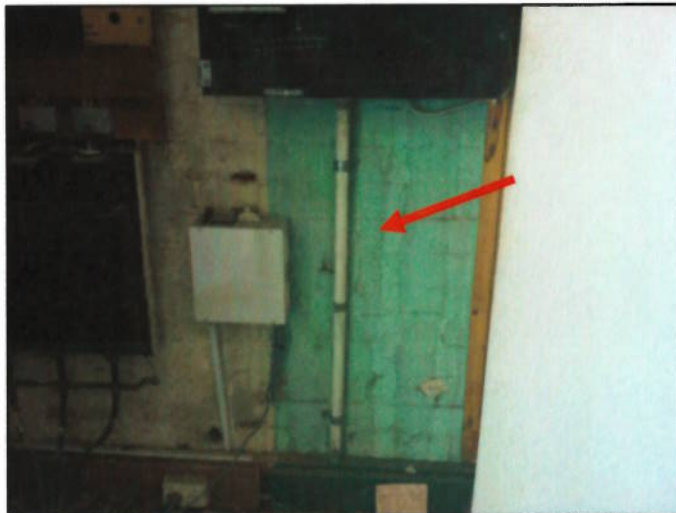
Photograph 20

Ground Floor, Northern Section, Electrical Distribution Cupboard, green paint to brick wall (top layer) (contains > 1% Lead).

As a precautionary health measure and to prevent contamination to surrounding areas, flaking/deteriorated lead containing paint should be treated as soon as practicable. Treatment may include the removal of flaking/deteriorated paint (using the appropriate procedures and precautions) before surfaces are repainted.

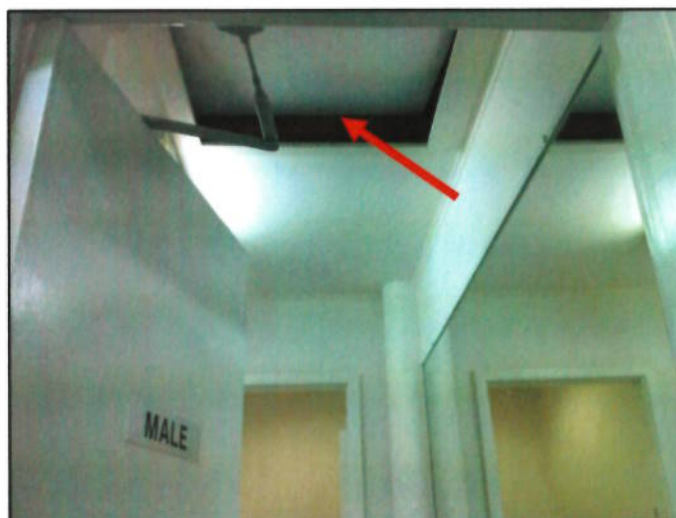
Photograph 21

First Floor, Males Toilet Airlock Room. 10cm² settled dust sample from ceiling cavity (contains 230 mg/m² lead).

- Workers to wear appropriate PPE;
- Ceiling dust to be sprayed with a dilute Polyvinyl Acetate (PVA) emulsion to restrict the ability of the dust to become airborne; and
- Vacuuming the ceiling free of dust before the application of a dilute PVA spray.

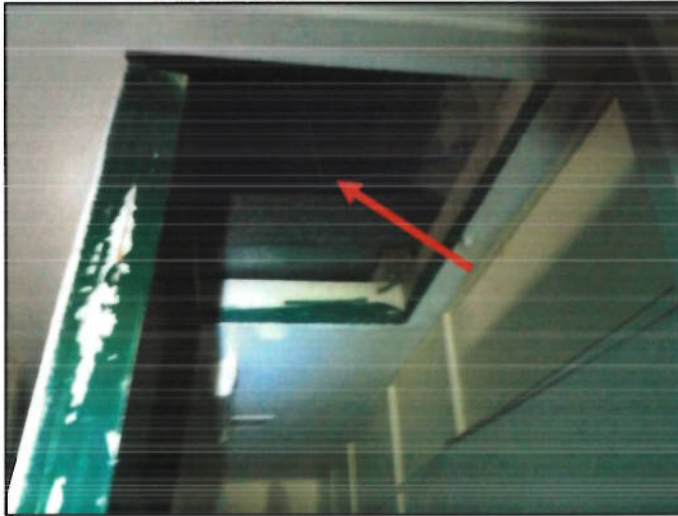
Photograph 22

Second Floor, Hallway adjacent Female Toilet. 10cm² settled dust sample from ceiling cavity (contains 970 mg/m² lead).
