Phase 1 Contamination Due Diligence

Lend Lease Circular Quay

Client: Lend Lease Development Pty Ltd

16-Oct-2015

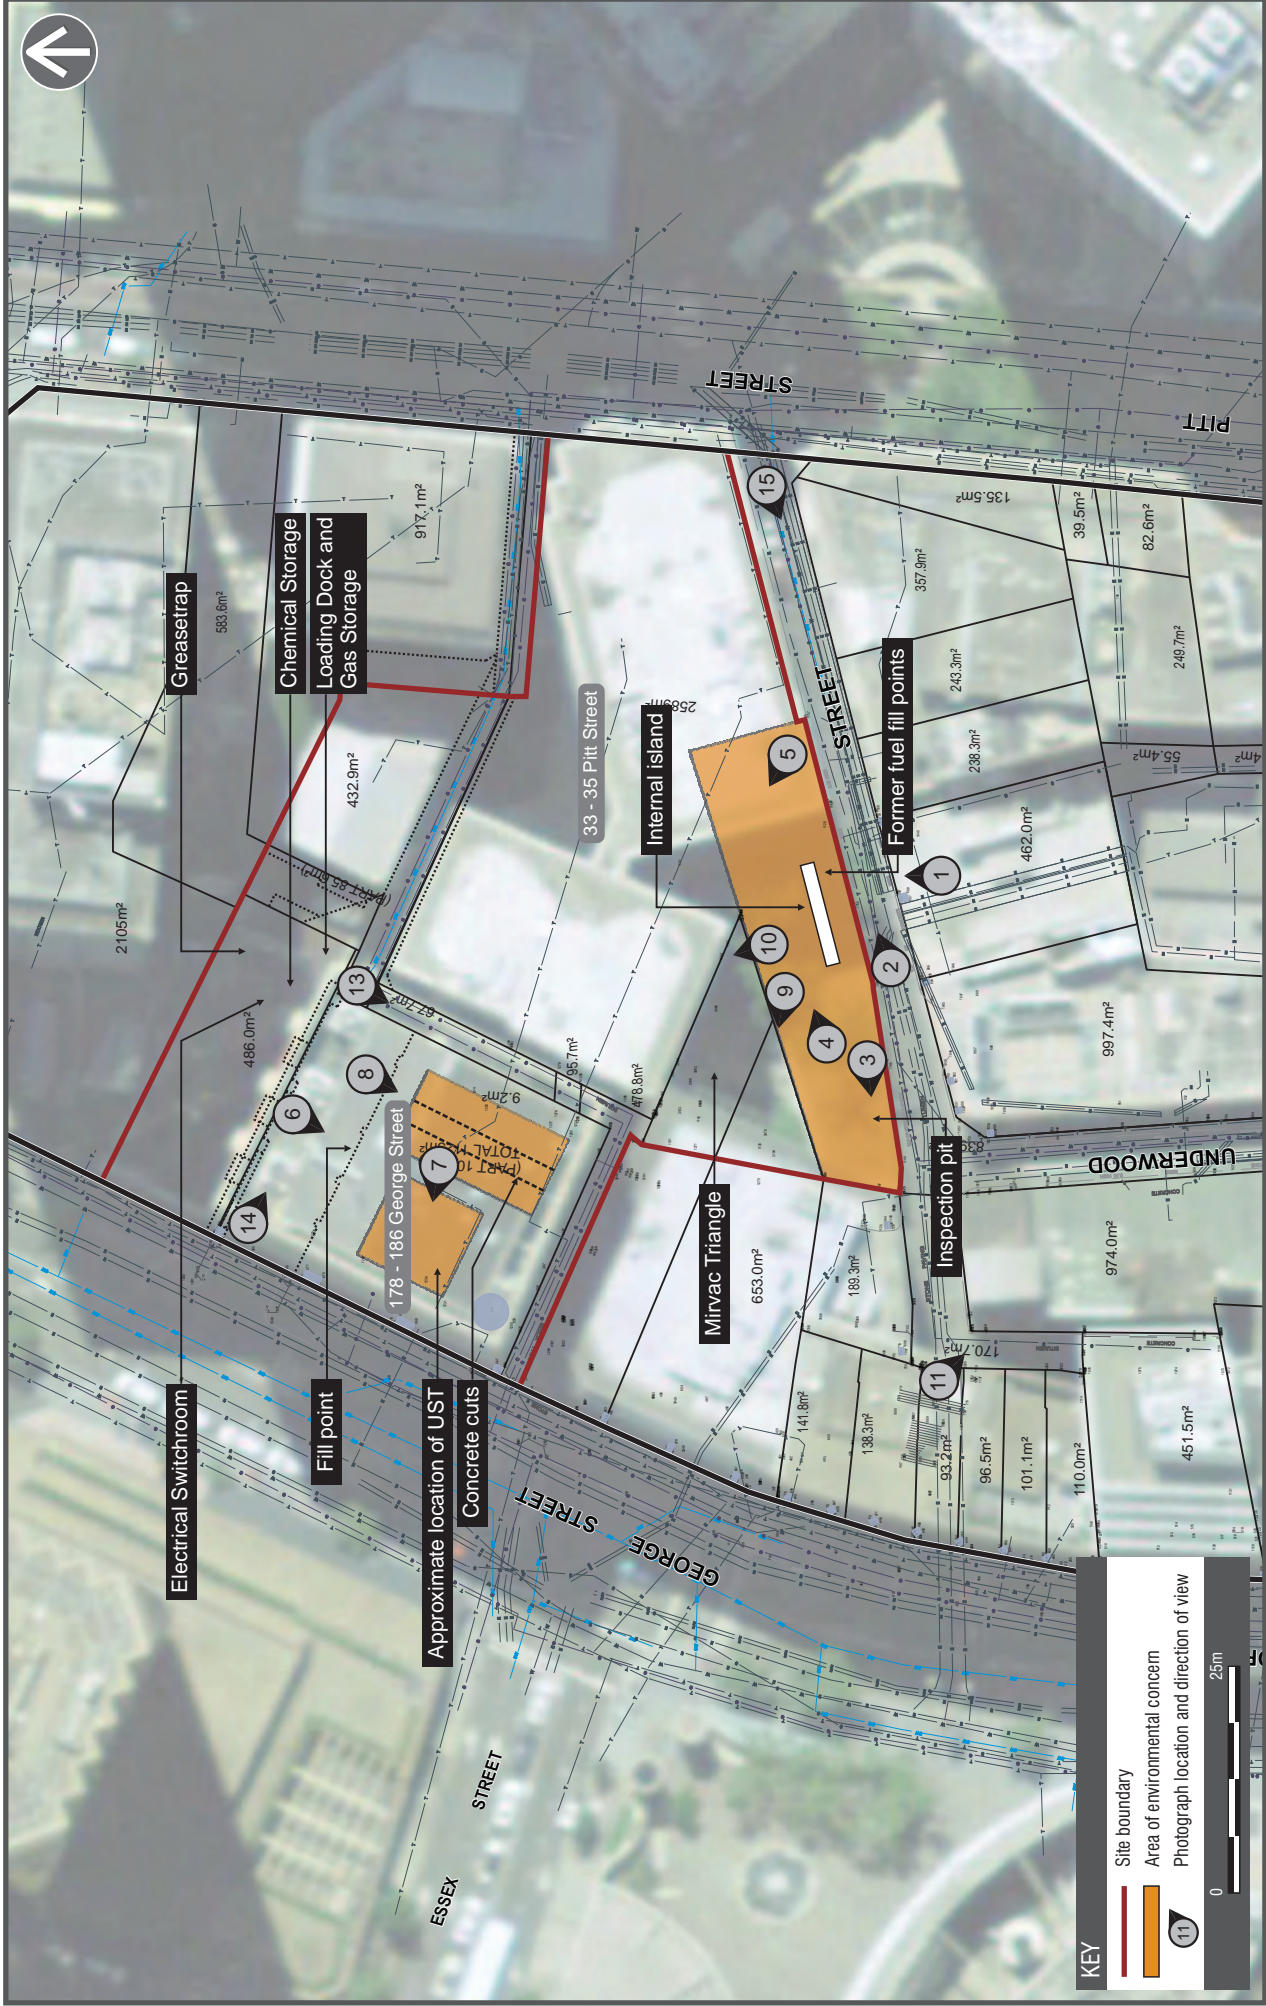
Groups\EN\GIS\1602 Projects\6022887 182 George Street\FIGURES\Combined Phase 1 ESA\6022887 F3 Site Inspection Observations 25 11 2013 TO Rev A

Two concreted UST fill points were observed adjacent to 33 Pitt Street on the Underwood Street footpath (Plate Nos. 1 and 2). A covered "inspection pit" was observed within the western side of building (Plate No. 3). A raised island, which appeared to have housed fuel bowsers, was present east of the inspection pit and north of the fill points (Plate No. 4). There were cars parked over the area where an associated UST would have been located. A number of areas of concrete repairs were observed in the area east of the possible bowser island (Plate No. 5).

Additional operational UST fill points were observed at the western end of Underwood Street (Plate 11), consistent with the description in Coffey (2012b and c).

Two monitoring well covers were observed in the southern end of Underwood Street near the intersection of Dailey Street (Plate No. 12). There is no indication of the presence of these well in the Coffey reports.
