7. ABOVE GROUND DEFECTS

ATTACHMENT A: PHOTOS

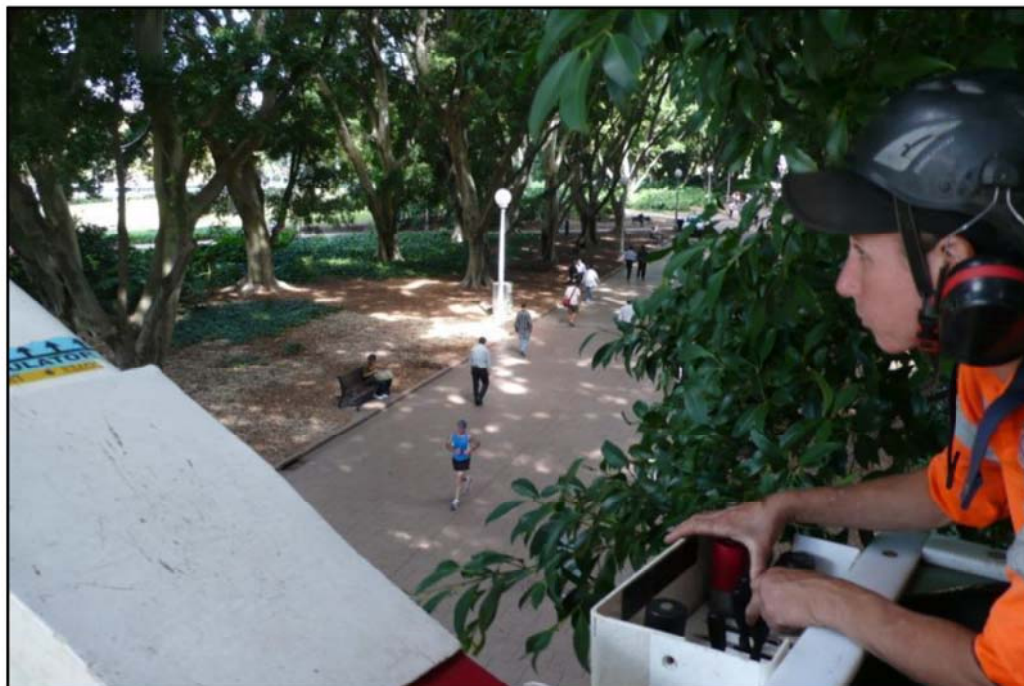
Photo A: Use of the 25m elevated Work Platform (EWP) to access all areas of the canopy for aerial inspection.

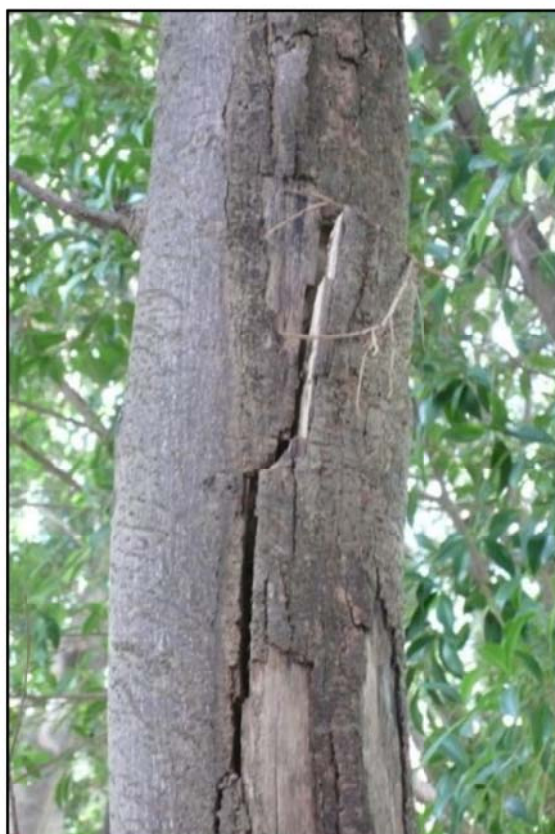
Photo B: Advanced sunscald damage leading to branch fracture (T242N).

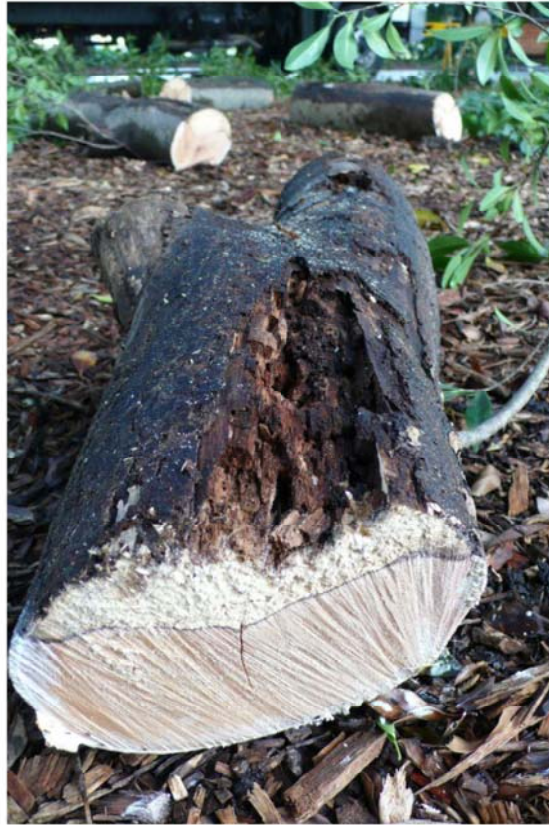
Photo C: Typical sunscald damage showing advanced wood decay and associated structural defect (Tree 242N).

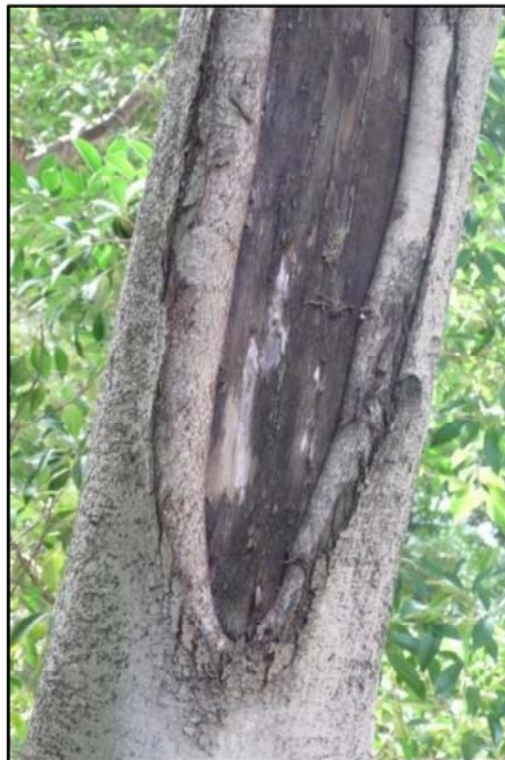
Photo D: Typical sunscald damage on the top surface of branches. This damage is often not visible from the ground due to the angle of the branch and the epicormic shoots in the view line. Degree of wound occlusion is variable and requires annual ongoing monitoring.

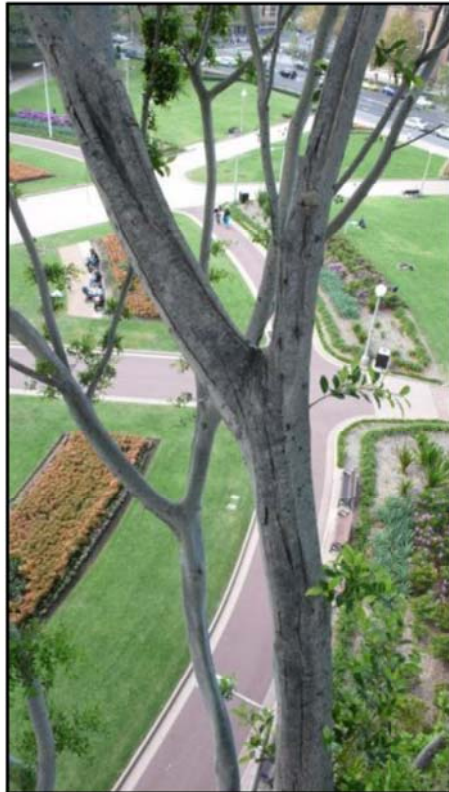
- 7.6.4 The tree removal in September 2005 (Spring) may have led to more sunscald damage during the Summer of 2005/2006 than if the works had been undertaken in Autumn.

Photo E: Sunscald on Tree 144N in 2007. This damage is a result of the removal of Tree 254N in September 2005.

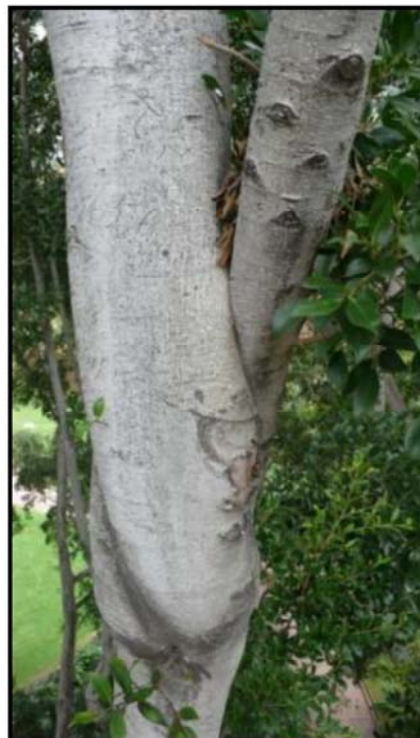
Photo F: Typical included branch junction (rare 3rd Order limb) to be treated with caution due to failure (splitting) potential. Reduction pruning to approximately 20% of leaf area of the crown beyond (distal) the junction has been recommended and undertaken.

- 7.2.9 A 20% reduction prune was recommended and undertaken on trees containing significant inclusions. These inclusions still exist in 2013, but the likelihood of failure has been reduced by the end load weight reduction. It is estimated that the individual trees will take approximately 3-5 years to replace the same leaf area as existed prior to the 2012 pruning. This estimation was supported by the Citywide AQF Level 5 staff who undertook the monitoring and pruning works in Central Avenue.

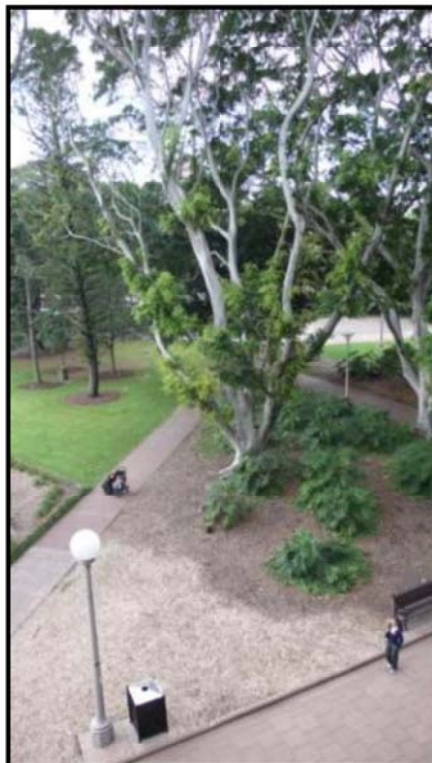
Photo G: Epicormic growth associated with increased light levels after adjacent tree removal. Overcrowding of epicormic growth has been recommended for thinning on select trees

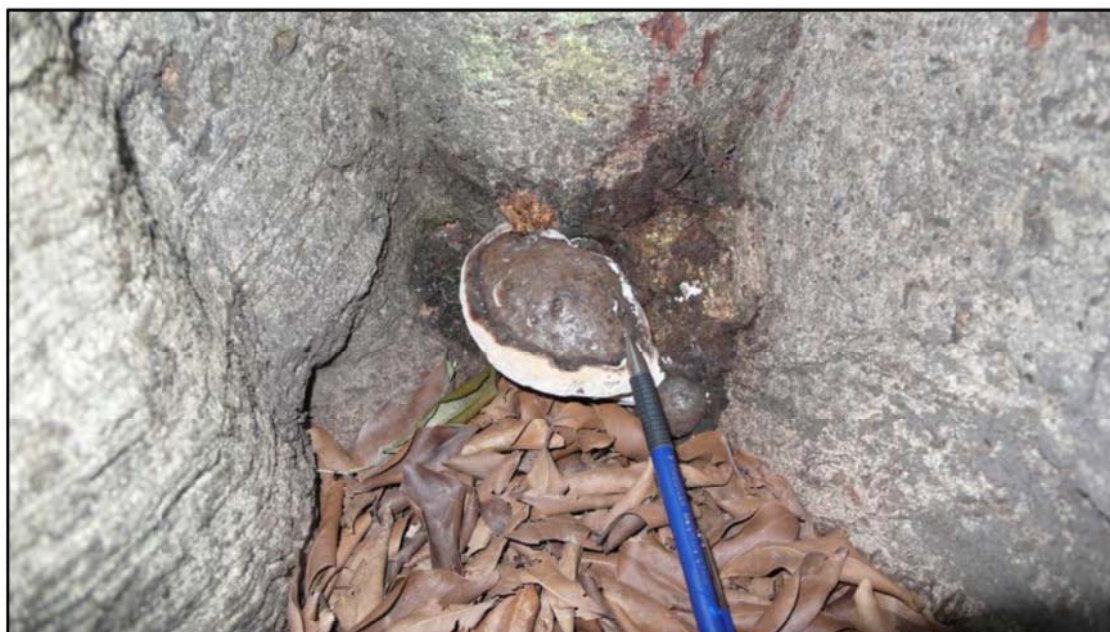
Photo H: Typical fruiting body of *Phellinus* sp. (Tree 1S). Ongoing rootcrown inspections and internal diagnostic testing is required to ensure the internal decay pocket does not become critical.

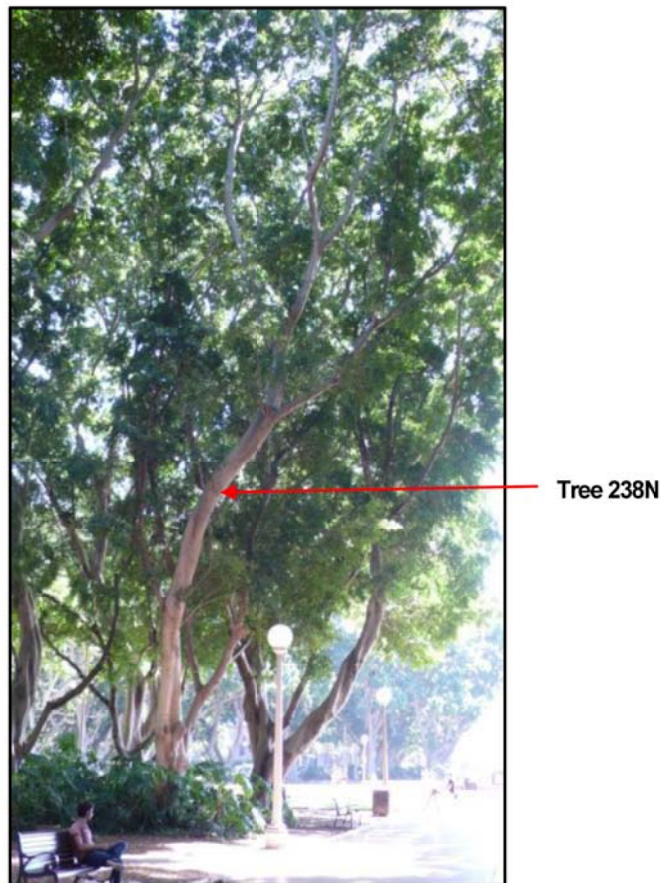
- 9.2.4 Similarly there several heavily suppressed Hill's Figs located in the inner two rows of the Central Avenue. Hill's Fig 238N (Photo I) displays heavy suppression due to the competition from adjacent Hill's Figs. This suppression has resulted despite all the surrounding trees being of the same age. If Tree 238N were to be removed and replanted, the level of suppression would be such that the new replacement tree would grow very poorly. It is likely that the form of the tree will be "forced" up towards the existing available light in the very small canopy gap overhead.

Photo I: Heavily skewed (suppressed) form of existing Tree 238N (25.03.13). If a new tree were to be planted in this location the growth of the new tree would be significantly more skewed (suppressed).

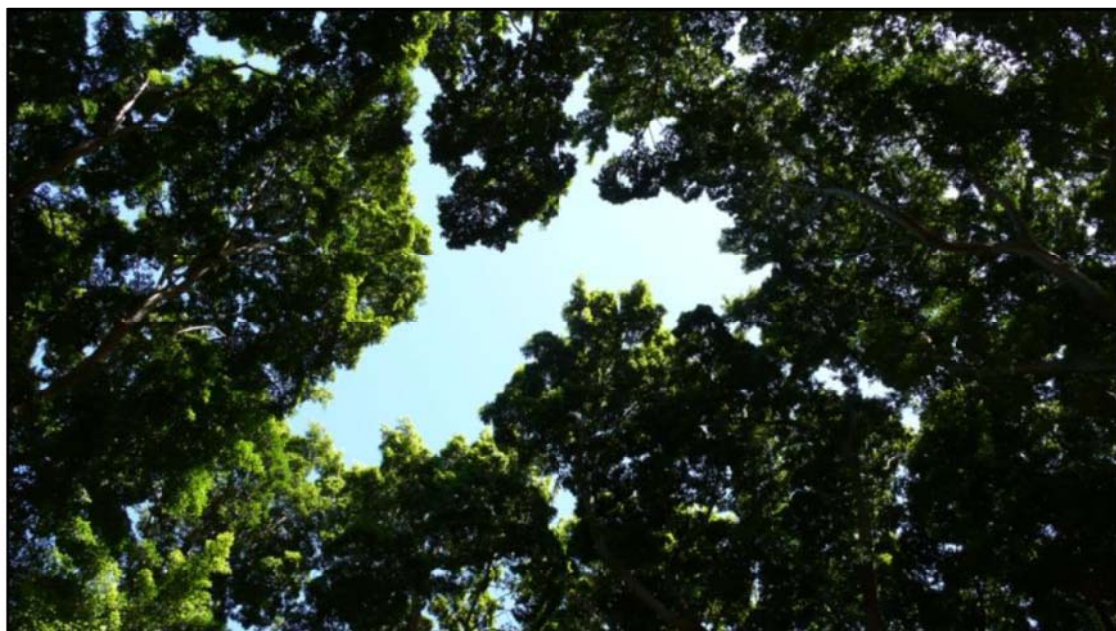
Photo J: View of the small crown gap above Tree 238N (Photo H). A new planting in this location would “reach” for this very small gap overhead. The growth of the new tree would be significantly suppressed.

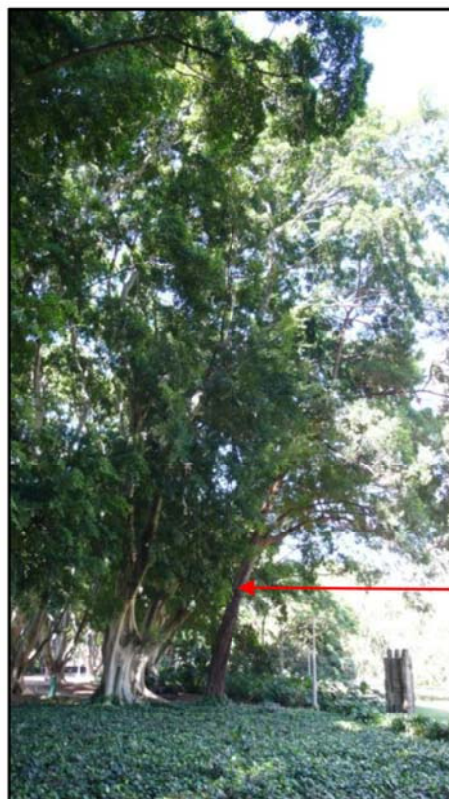
Photo K: Heavily skewed (suppressed) form of existing Tallowwood Tree 10N (25.03.13) adjacent to Hill's Figs T248N and T246N. New Hill's Fig plantings in gaps on the outside rows will grow with an even greater level of crown skew due to the competition for available light

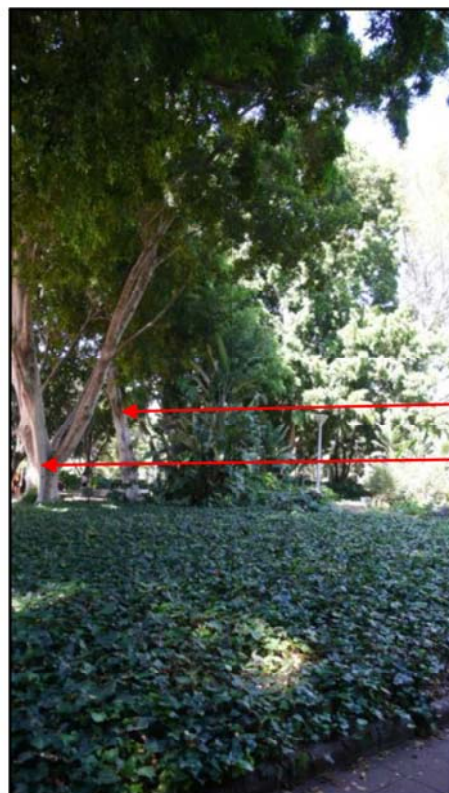
- 9.2.5 The gap adjacent to Trees 58N, 60N and 61N was created by recent tree failures and removals due primarily to an *Armillaria luteobubalina* hot spot (as indicated on page 47 of the TMP). It is unknown whether the disease has been eradicated from this area. Tree 58N (Photo M) still displays rootcrown symptoms typical of *Armillaria luteobubalina* activity. Planting new trees into this gap without the opportunity for extensive soil removal or remediation could result in the premature death of the new trees. The block removal proposal allows for such soil remediation works to be undertaken.

Photo L: Existing gap (outer row) adjacent to Trees 58N, 60N and 61N. The canopy of adjacent trees has enveloped a major portion of the air space over the gap such that a new planting will be heavily suppressed due to limited available light.

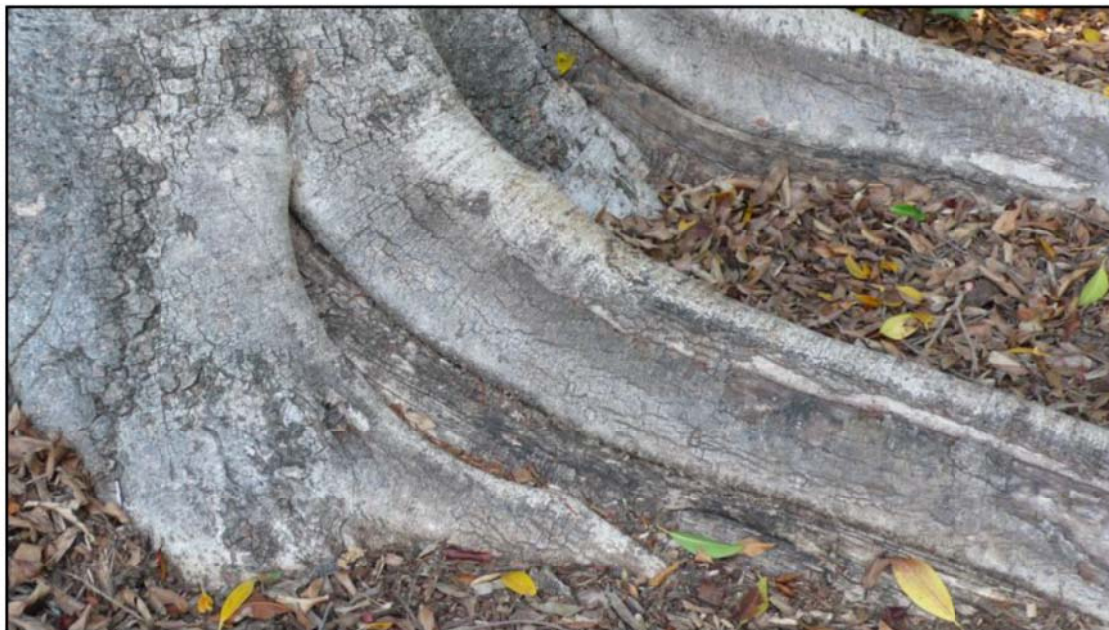
Photo M: Base of Tree 58N (25.03.13) showing typical symptoms of *Armillaria luteobubalina* damage. An *Armillaria luteobubalina* hot spot is recorded (TMP 2006) in this locality. In-fill planting of a new tree in this locality without complete soil removal, soil remediation could result in the death of the new planting and further root damage to Tree 58N.

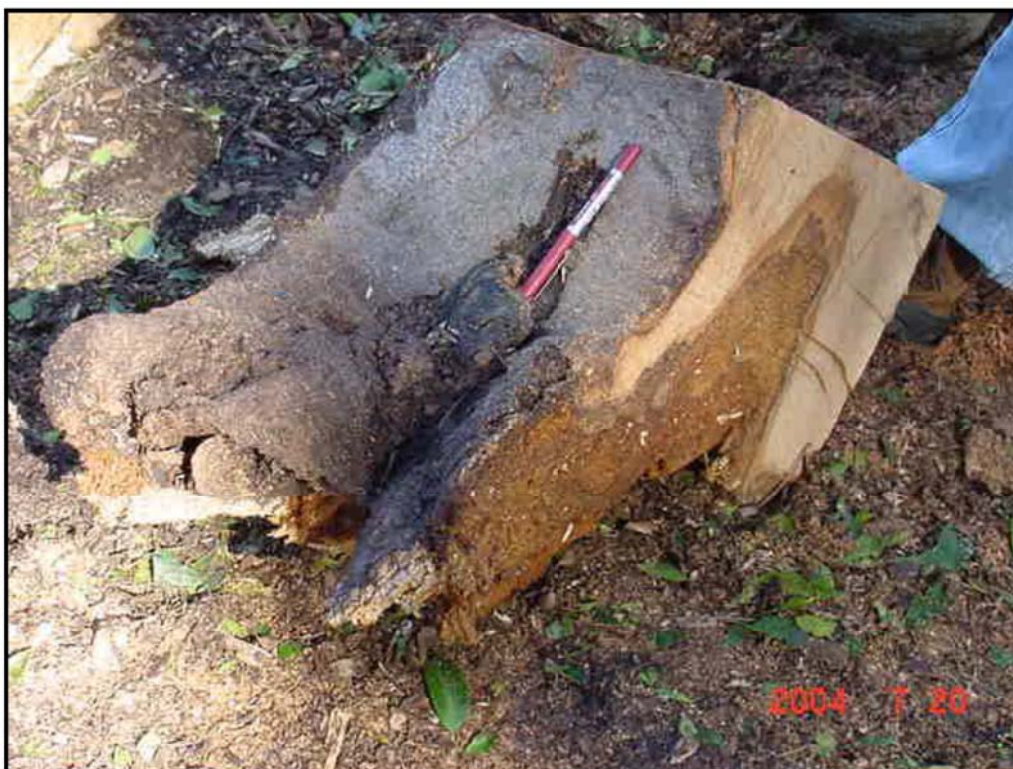
Photo N: Photo D from TWM Report 1458 dated 16/8/04 indicating advanced decay within the root crown of Tree 64N.

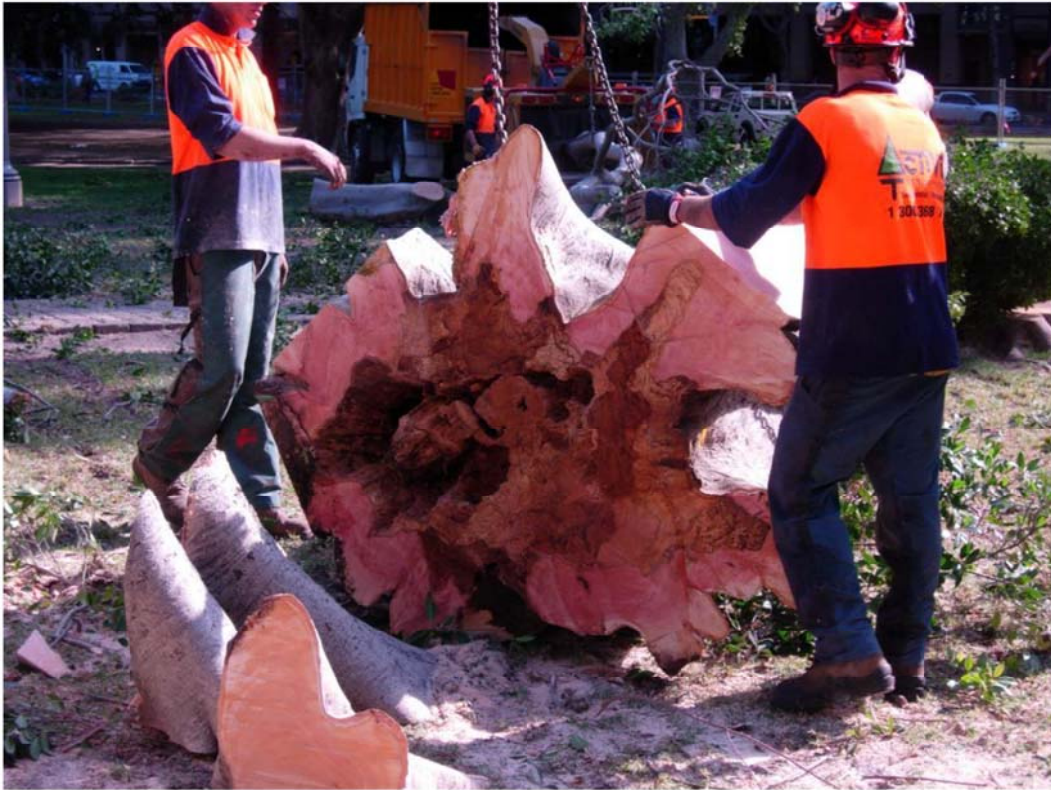
Photo O: Cut stump (September, 2005) showing internal decay as mapped in the report of Tree Wise Men® Australia Pty Ltd (ref. 1487 dated September 2004).
