**THE SUGAR FACTORY – REPORT
ON INCLUDED BRANCHES**

Inspection of Included Bark on Twenty-two
Hill's Weeping Fig *Ficus microcarpa* var. *hillii*
In Hyde Park North & South, Sydney CBD

9 August 2103

Ref: cos020

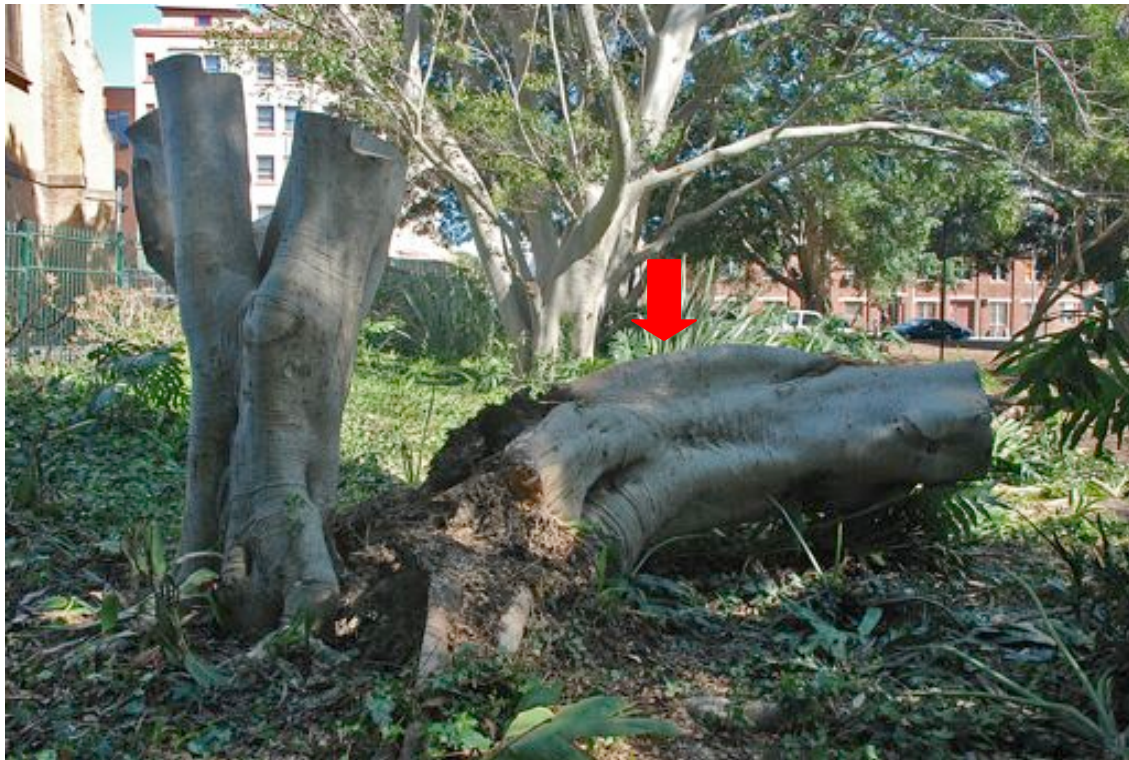
This particular pattern of growth has been a major factor in stem failure of multi-stemmed Hill’s Figs in Newcastle Precinct (photograph A, below).

Photograph A. Stem failure due to ‘cluster wedge’ configuration. Note large ridge of reaction wood on tensile side of failed stem (arrow).

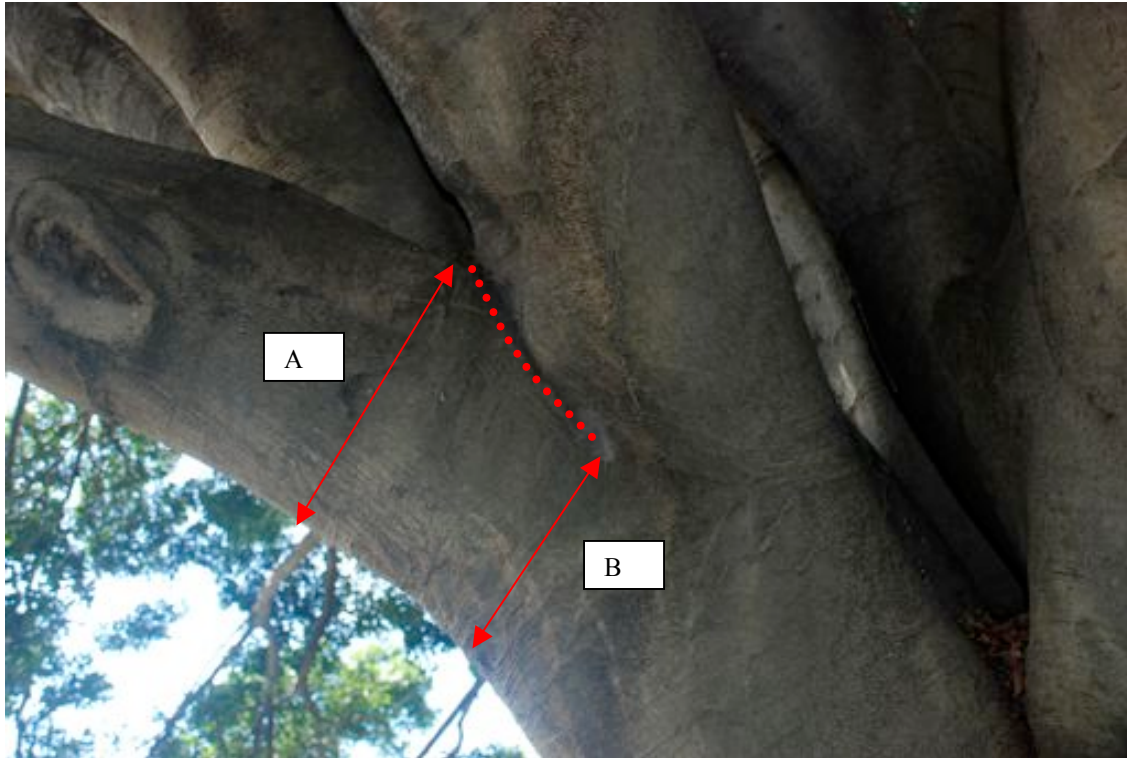
Photograph B. ‘Notch’ defect in Tree #5/108.

Note the difference in branch diameters at Line A and Line B. The dotted line shows the seam of included bark. From the photograph it should be clear that a tensile force or downward-bending load applied to that particular branch will result in a tensile force flow along the topside of the branch with the force flow then being deflected along the concave seam of the inclusion. The stress of the force flow is greatly intensified in the notch between points A and B.

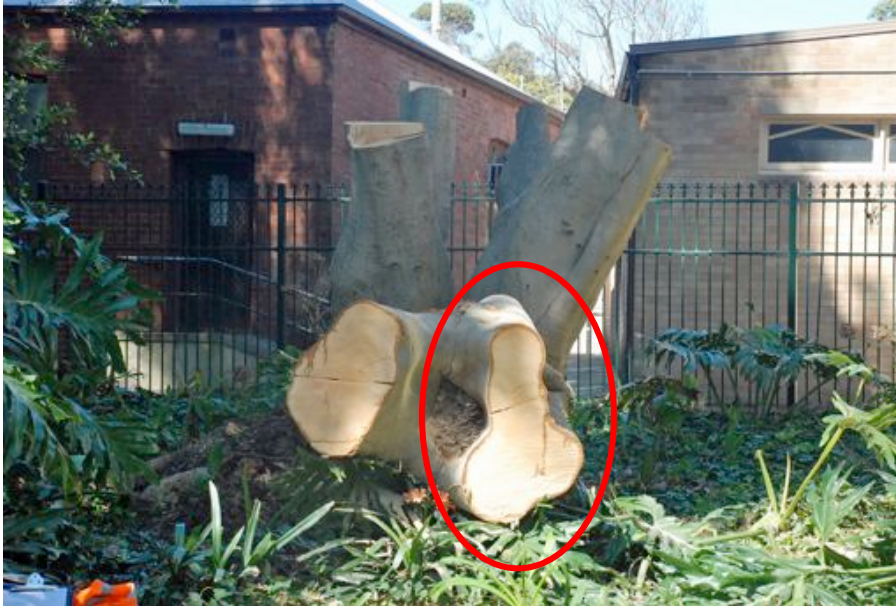
Photograph C. I-beam shape of failed stem, September 2008.

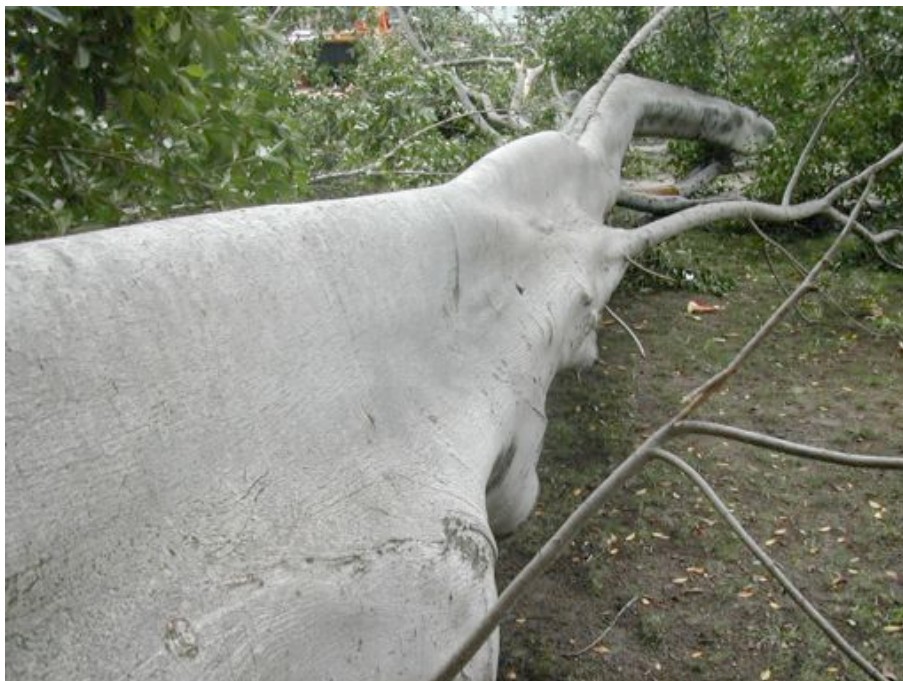
Photograph D. I-beam shape of failed stem, April 2004.
