**One Investment Management Pty Ltd AFT
The Recap IV Management No. 4 Trust**

Preliminary Site Investigation

4 – 6 Bligh Street, Sydney NSW

25 July 2017

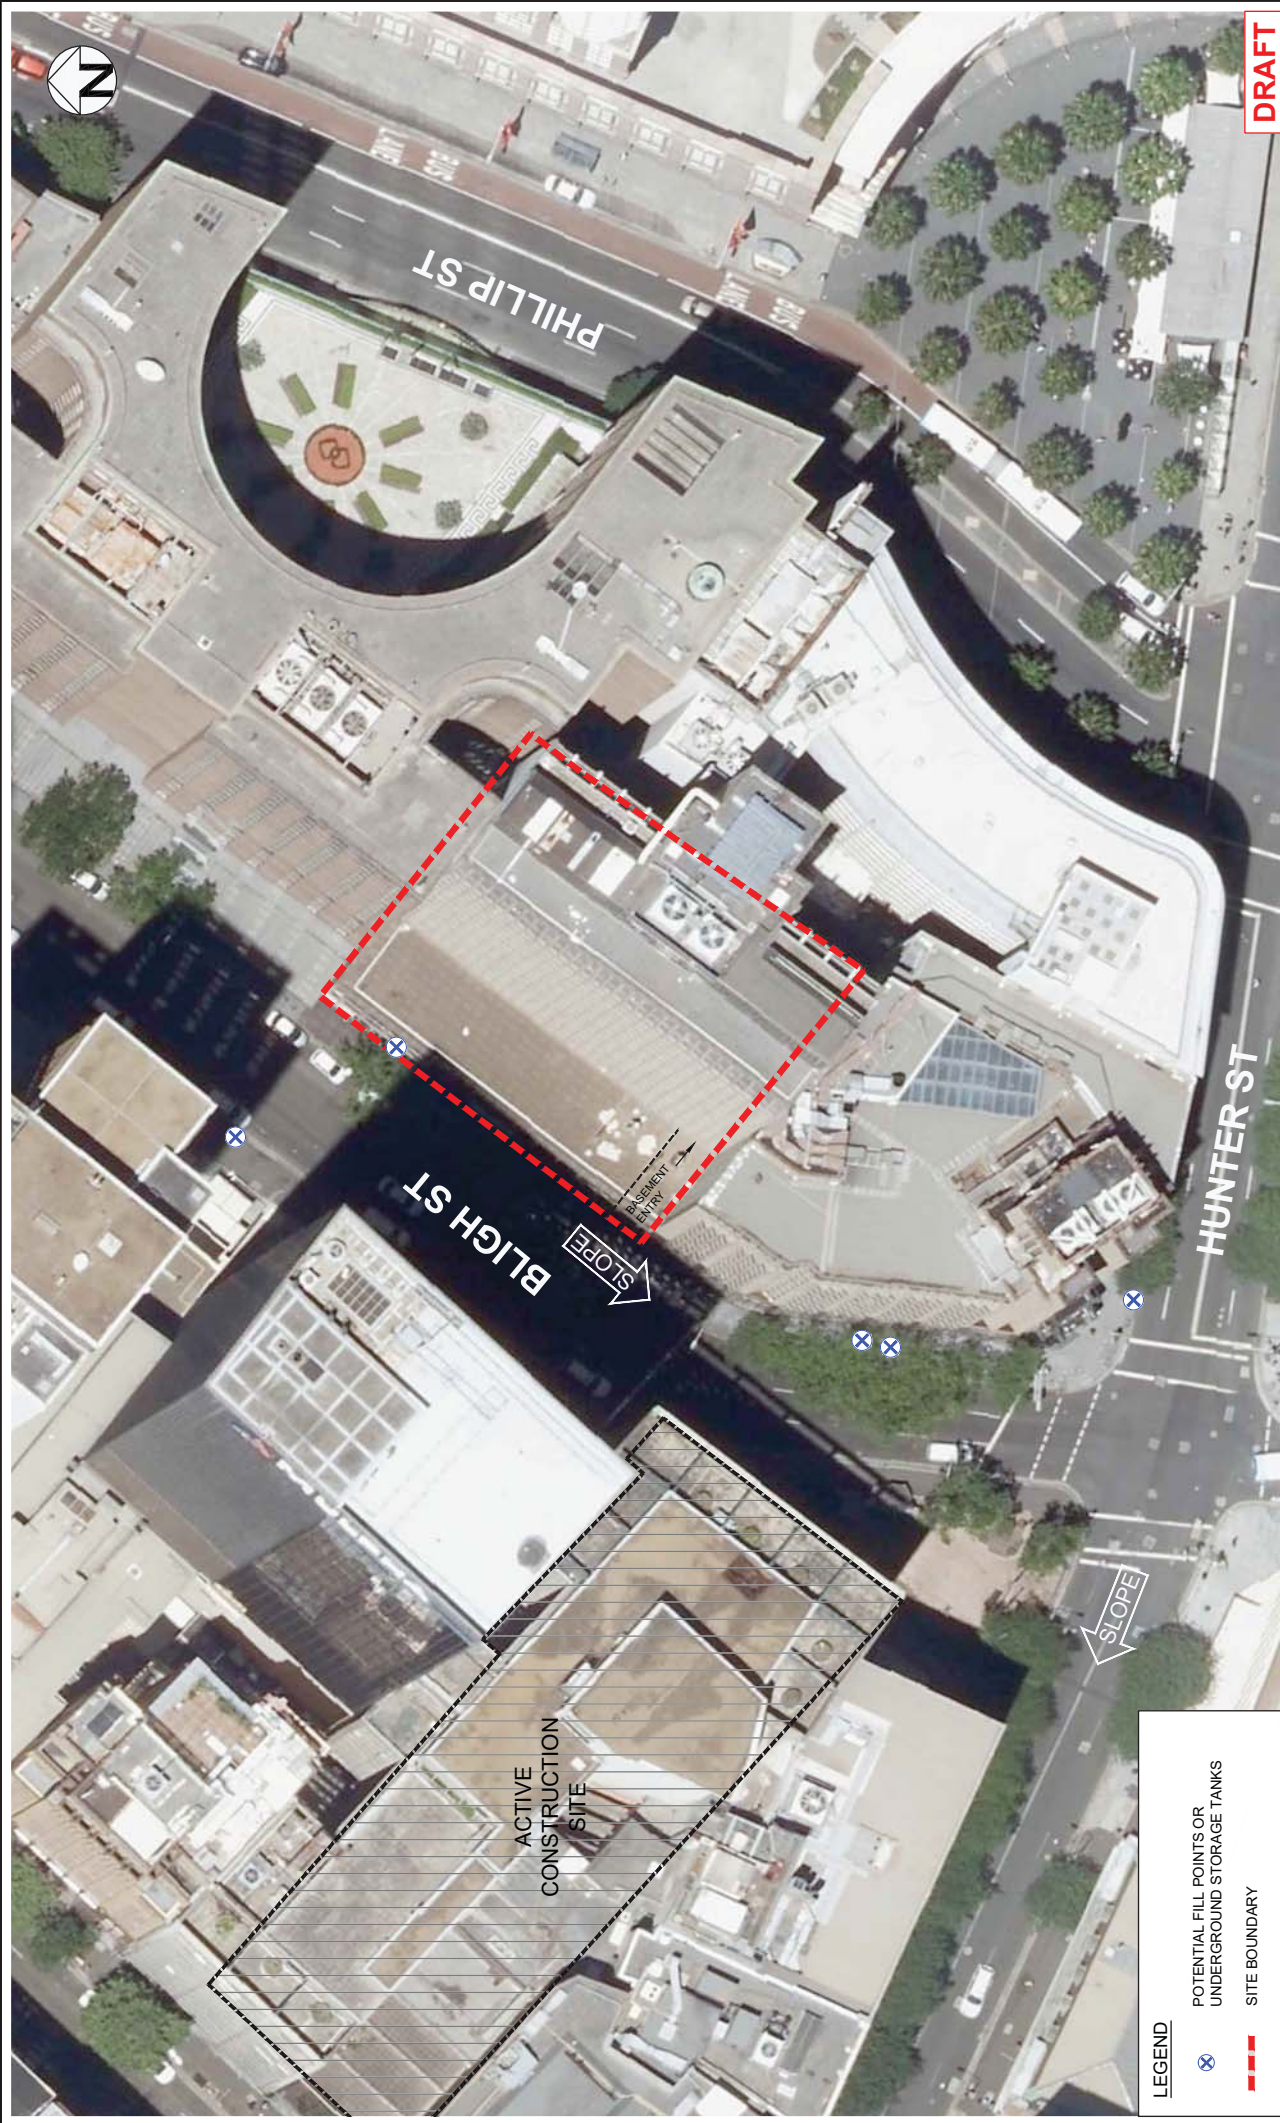
client:	ONE INVESTMENT MANAGEMENT PTY LTD ATF THE RECAP IV MANAGEMENT NO.4 TRUST
project:	PRELIMINARY SITE INVESTIGATION 4 - 6 BLIGH STREET, SYDNEY NSW
title:	SITE LAYOUT AND FEATURES
project no:	754-SYDEN2005070-R01
figure no:	FIGURE 2
rev:	A

- Four suspected tank access or tank fill points were observed on the footpath of Hunter and Bligh Street (refer Figure 2), indicating that an underground petroleum storage systems (UPSS) are (or had been) present at the site.

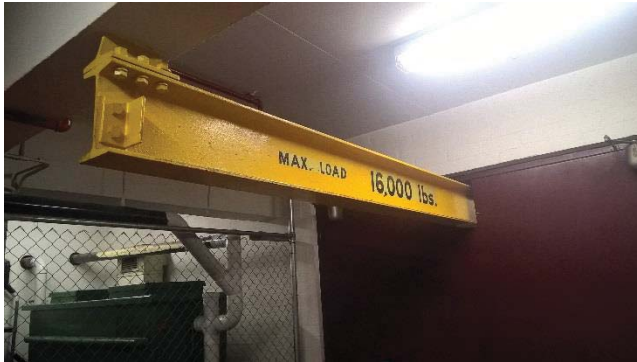
- A possible hoist system (max load 16,000 lbs) was observed within the basement carpark. Access to one side was only available (Photograph 3).
- An inspection of foot paths surrounding the site and adjoining buildings identified flush fitting steel caps within the footpath at four separate locations along Hunter Street and Bligh Street which are commonly identified as fill points for underground storage tanks (USTs), with one being identified within the north western corner of the site (Photograph 9). The location of the steel caps are provided on Figure 2.

Photograph 3:
Possible hoist system observed within the basement car park

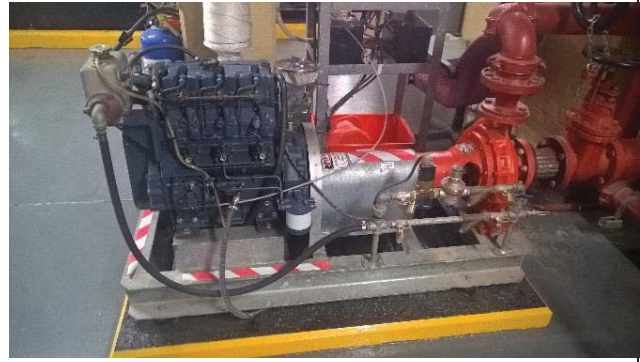
- Multiple pumps, compressors and refrigeration units were observed within the plant room, the majority of which were installed within bunding. Evidence of former leakages was noted although such was contained within the bunding (Photographs 4 – 8).

Photograph 4:
A pump located within the basement plant room with fuel lines and oil filters observed and placed on bunding.

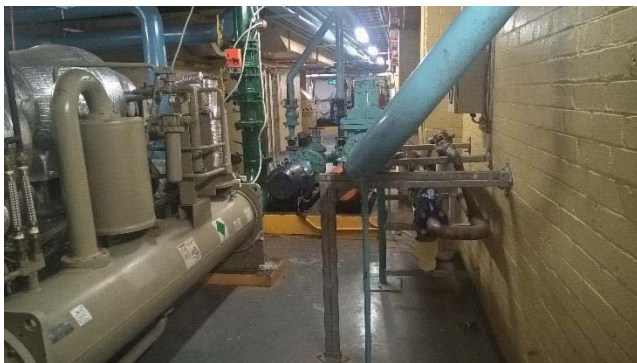
Photograph 5:
Plant infrastructure located within the basement plant room.

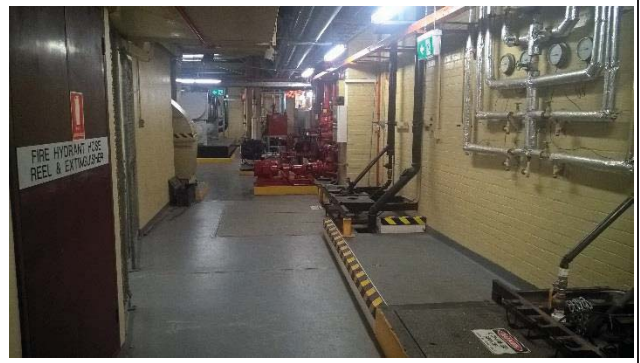
- The concrete of the basement plant room was observed to be in good condition, with no signs of cracking observed (Photograph 6). Drains were observed, which likely flowed into the separator pits, however, this was not evident (Photograph 8).

Photograph 6:
Plant equipment and underground storage pits located within the basement plant room.

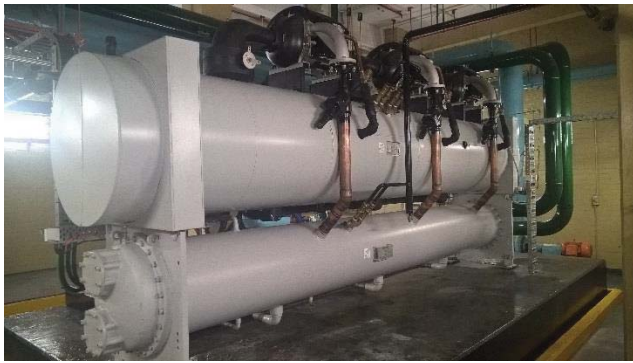
Photograph 7:
Compressor / refrigerant unit observed on bunding within the basement plant room.

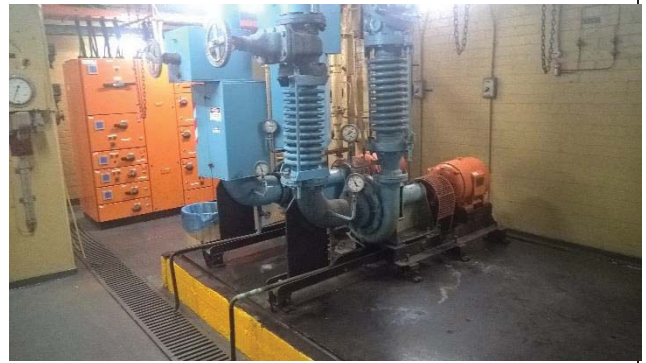
Photograph 8:
Plant equipment installed on bunding and a drain within the basement floor.

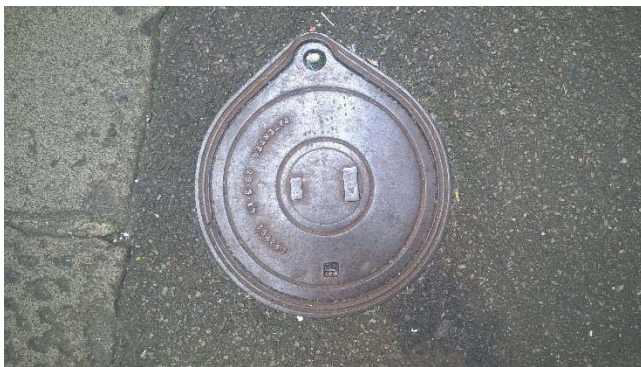
Building management representatives were not aware of underground storage tanks (UST) being present within the building, yet suspected fill points were noted along Bligh and Hunter Streets. These fill points were considered to be an indicator that tank(s) are, or have been present within the building. Records provided by SafeWork NSW indicate no licenses to store dangerous goods (i.e. fuels) had been issued to the property, although it is noted that not all tanks were licensed historically. The presence of UST within the site remains a data gap.

Photograph 9:
Potential underground storage tank cap observed on the footpath of Bligh Street within the north west corner of the site.

- **Detailed Site Investigation (DSI)** –to effectively characterise the site. The DSI will aim to assess the condition of site soils and groundwater and the suitability for the use as commercial and residential land. Coffey notes that this investigation can be undertaken in conjunction with geotechnical works, with soil and groundwater samples collected from geotechnical boreholes, where possible.
