Transport, Heritage and Planning Committee

Agenda

- 1. Confirmation of Minutes**
- 2. Statement of Ethical Obligations and Disclosures of Interest**
- 3. Fire Safety Reports**

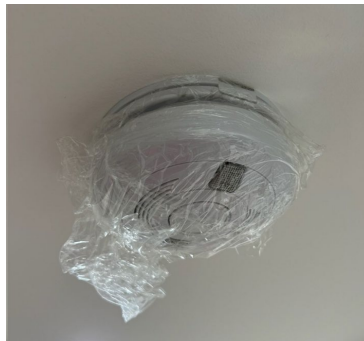
- *This is an airbnb and they have the smoke alarm covered in plastic. It has been reported to airbnb and they said to lodge a complaint here. We were just concerned that not only was it illegal but could cause a fatality in the future.*

A photograph was provided with the correspondence and has been attached below.
