**Inspection Report
10-14 Oxford Square, Darlinghurst**

Council Investigation Officer Inspection and Recommendation Report; Clause 17(2) Part 8 of Schedule 5 of the Environmental Planning and Assessment Act 1979 (the Act)

Premises: 10-14 Oxford Square, Darlinghurst

**Re: INSPECTION REPORT
THE CLIFF DIVE
10-18 OXFORD SQUARE DARLINGHURST ("the premises")**

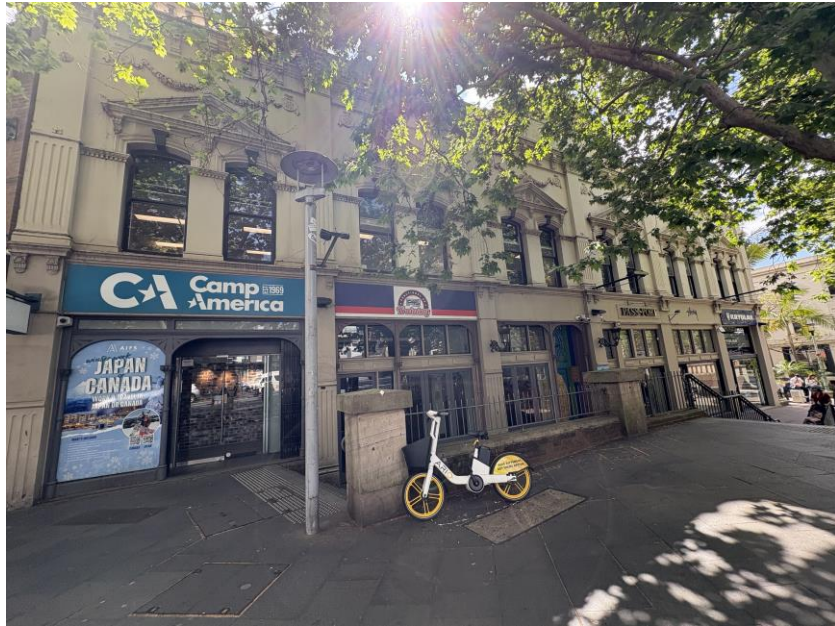
Figure 1: 10-14 Oxford Square, Darlinghurst, viewed from the south
