# **Attachment B**

**Inspection Report  
12 Ithaca Road, Elizabeth Bay**

## **Council Investigation Officer Inspection and Recommendation Report; Clause 17(2) Part 8 of Schedule 5 of the Environmental Planning and Assessment Act 1979 (the Act)**

**Premises:** 12 Ithaca Road, Elizabeth Bay

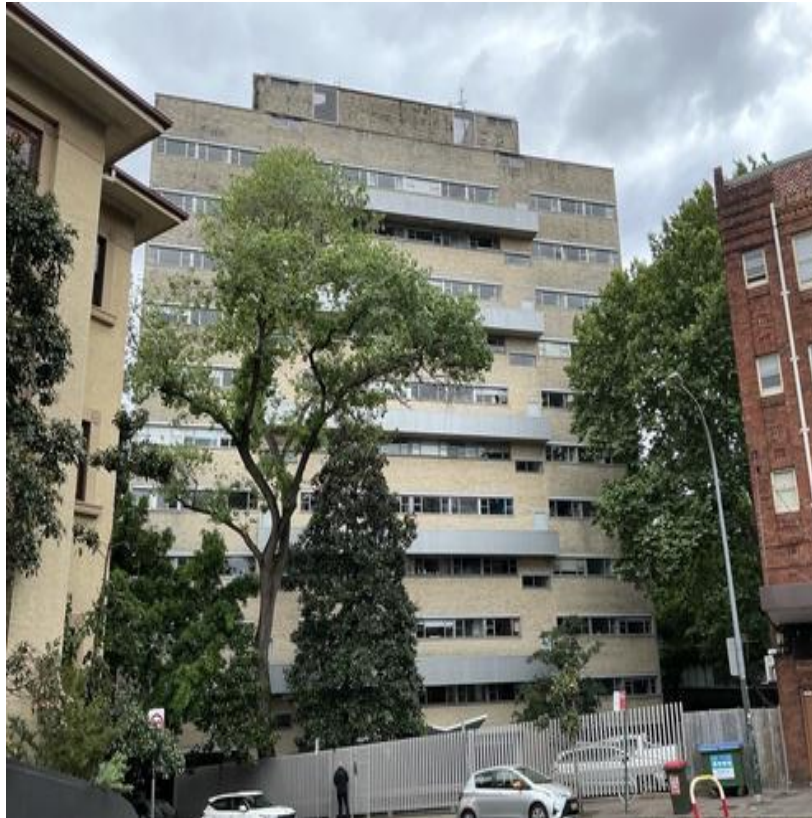
**Figure 1:** 12 Ithaca Road, Elizabeth Bay viewed from the south
