# **Attachment D**

| <p><b>Inspection Report</b><br/><b>44-44B Darlinghurst Road, Potts Point</b></p> |

**Council Investigation Officer Inspection and Recommendation Report; Clause 17(2) Part 8 of Schedule 5 of the Environmental Planning and Assessment Act 1979 (the Act)**

**Premises:** 44-44B Darlinghurst Road, Potts Point (AKA, 40 Kellett Way, Potts Point)

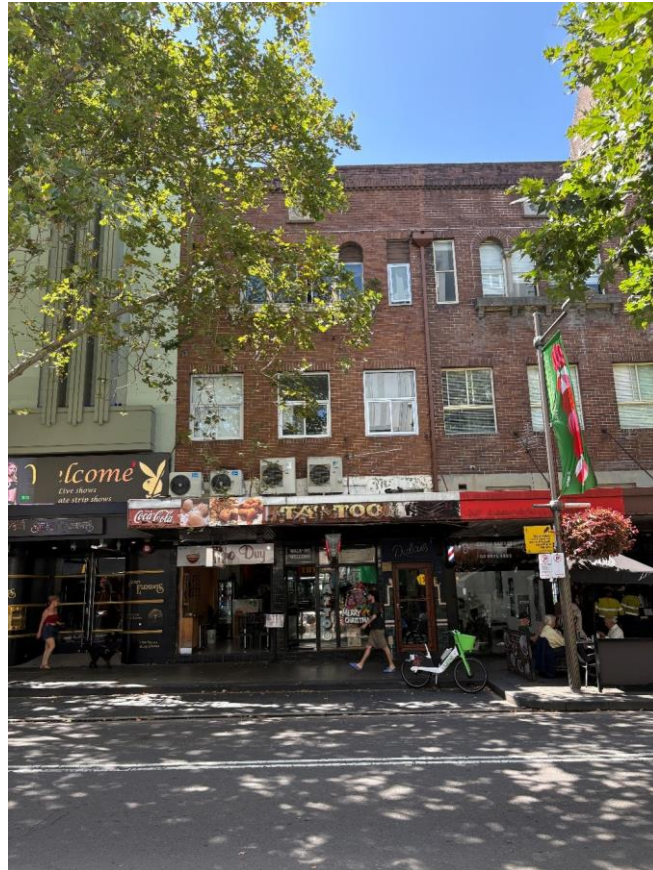
**Figure 1:** 44-44B Darlinghurst Road, Potts Point viewed north-west
