# **Attachment H**

**Inspection Report  
78-80 George Street, Redfern**

## **Council Investigation Officer Inspection and Recommendation Report; Clause 17(2) Part 8 of Schedule 5 of the Environmental Planning and Assessment Act 1979 (the Act)**

**Premises:** 78-80 George Street, Redfern

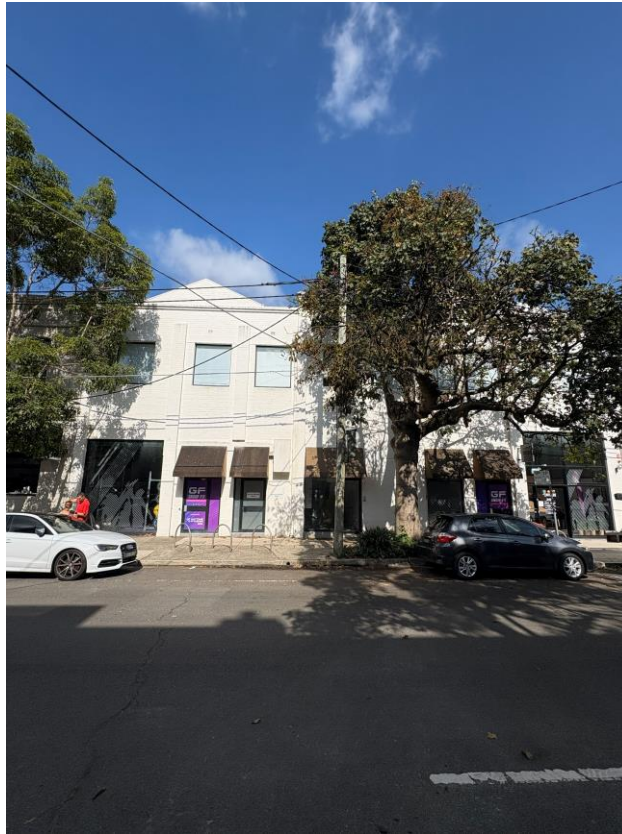
**Figure 1:** 78-80 George Street, Redfern, viewed from the east
