# **Attachment C**

**Inspection Report  
68-68A Darlinghurst Road, Potts Point**

**Council Investigation Officer Inspection and Recommendation Report; Clause 17(2) Part 8 of Schedule 5 of the Environmental Planning and Assessment Act 1979 (the Act)**

**Re: INSPECTION REPORT  
8 KELLETT STREET, POTTS POINT ("the premises")  
[AKA: 68 DARLINGHURST ROAD]**

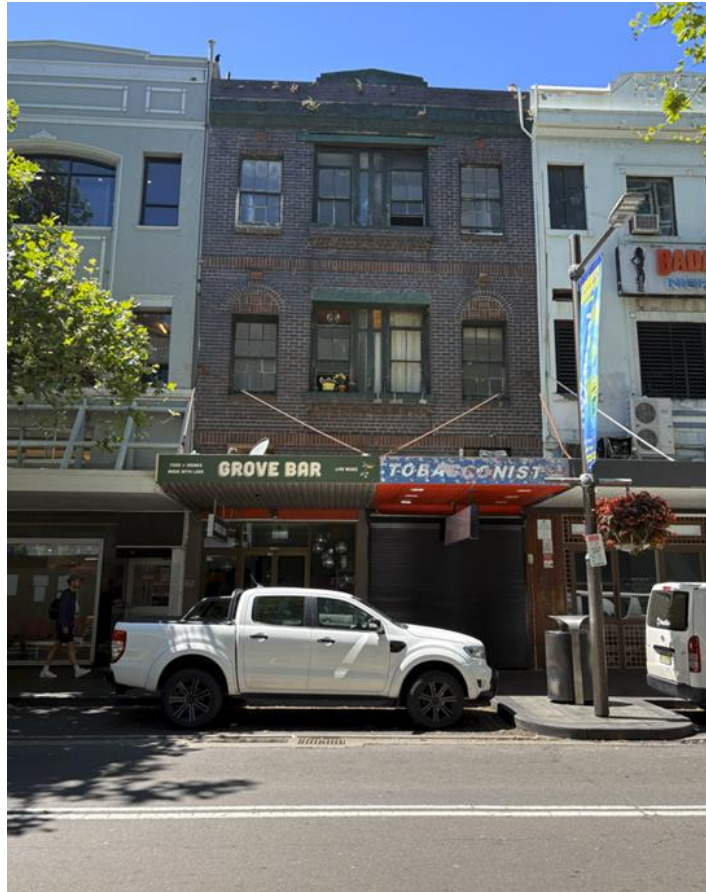
**Figure 1:** 68-68A Darlinghurst Road, Potts Point viewed from the north-west
