# **Attachment D**

**Inspection Report  
44-44B Darlinghurst Road, Potts Point**

# **Council Investigation Officer Inspection and Recommendation Report; Clause 17(2) Part 8 of Schedule 5 of the Environmental Planning and Assessment Act 1979 (the Act)**

**Premises:** 44-44B Darlinghurst Road, Potts Point (AKA, 40 Kellett Way, Potts Point)

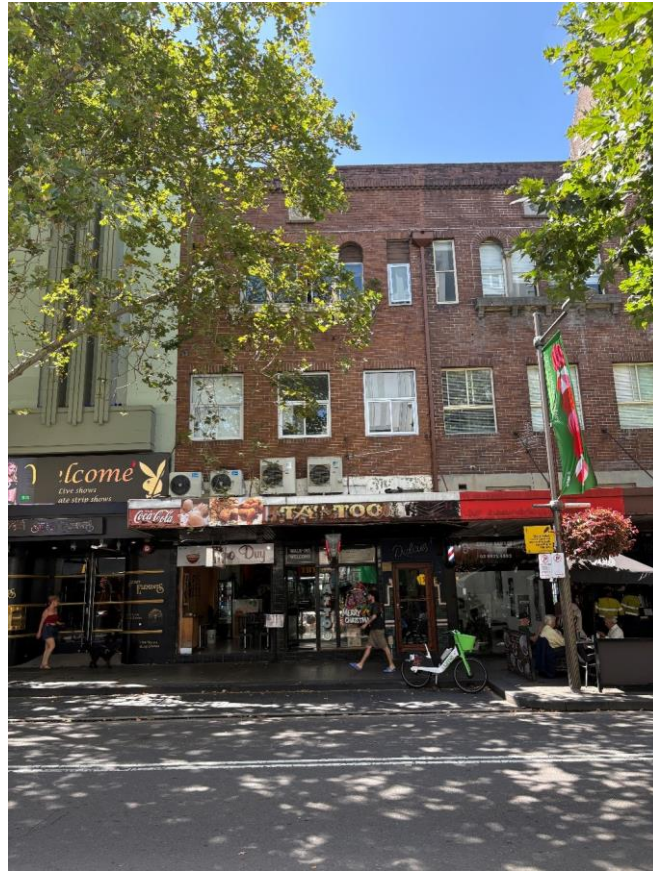
**Figure 1:** 44-44B Darlinghurst Road, Potts Point viewed north-west
