# **Attachment I**

**Inspection Report  
49-53 Regent Street, Chippendale**

# **Council Investigation Officer Inspection and Recommendation Report; Clause 17(2) Part 8 of Schedule 5 of the Environmental Planning and Assessment Act 1979 (the Act)**

**RE: INSPECTION REPORT  
49-53 REGENT STREET CHIPPENDALE ("the premises")**

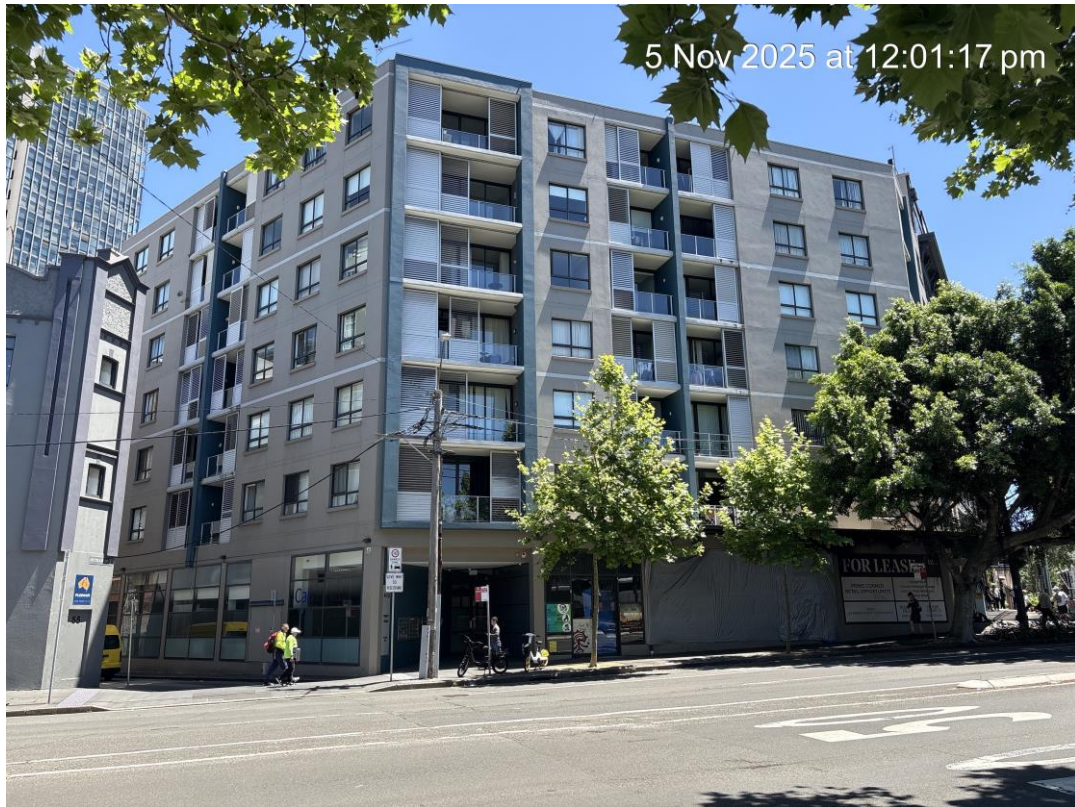
**Figure 1:** 49-53 Regent Street, Chippendale, viewed from the south-east
