| <p><b>Inspection Report</b><br/><b>2 Foster Street, Surry Hills</b></p> |

## **Council Investigation Officer Inspection and Recommendation Report; Clause 17(2) Part 8 of Schedule 5 of the Environmental Planning and Assessment Act 1979 (the Act)**

**Date:** 13 February 2026

**Re: INSPECTION REPORT  
HOLLYWOOD HOTEL  
2 FOSTER STREET, SURRY HILLS ("the premises")**

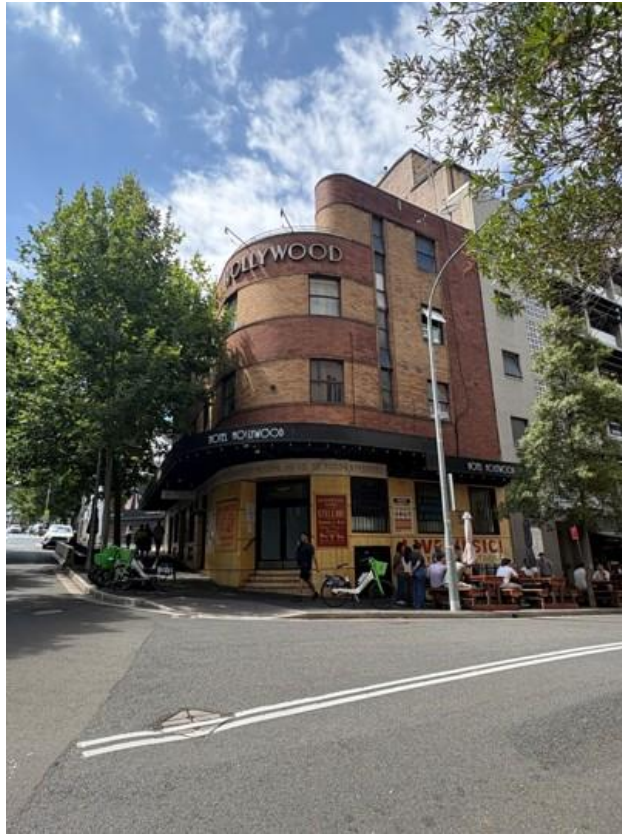
**Figure 1:** 2 Foster Street, Surry Hills, viewed from the north-west
