# **Attachment D**

**Inspection Report -  
10-24 Flinders Street, Darlinghurst**

# Council Investigation Officer Inspection and Recommendation Report; Clause 17(2) Part 8 of Schedule 5 of the Environmental Planning and Assessment Act 1979 (the Act)

**Re: INSPECTION REPORT  
AURA NIGHTCLUB  
10-24 FLINDERS STREET, DARLINGHURST & 2 STUART STREET,  
DARLINGHURST ("the premises")**

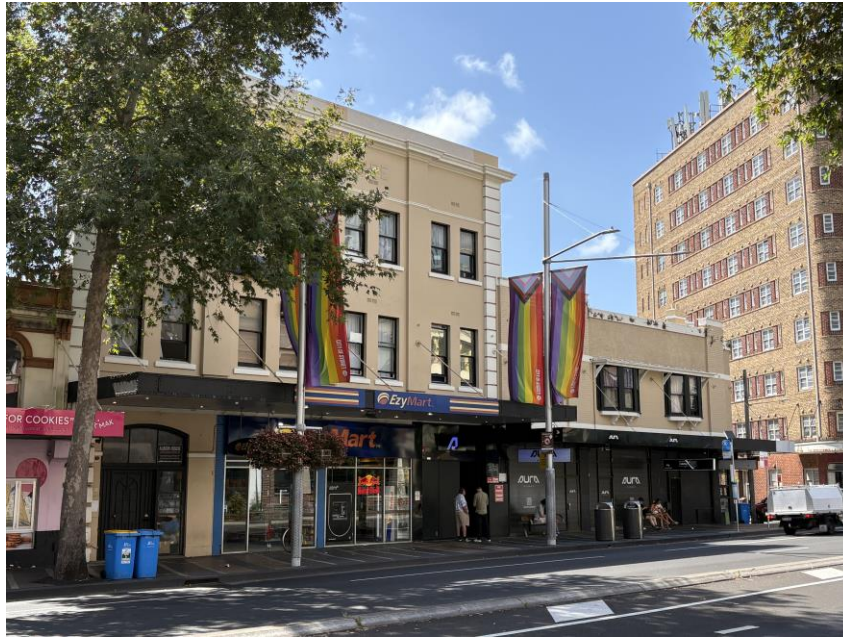
**Figure 1:** 10-24 Flinders Street, Darlinghurst viewed from the west
