# **Attachment G**

**Inspection Report  
6-18 Poplar Street, Surry Hills**

# Council Investigation Officer Inspection and Recommendation Report; Clause 17(2) Part 8 of Schedule 5 of the Environmental Planning and Assessment Act 1979 (the Act)

**Premises:** 6-18 Poplar Street, Surry Hills

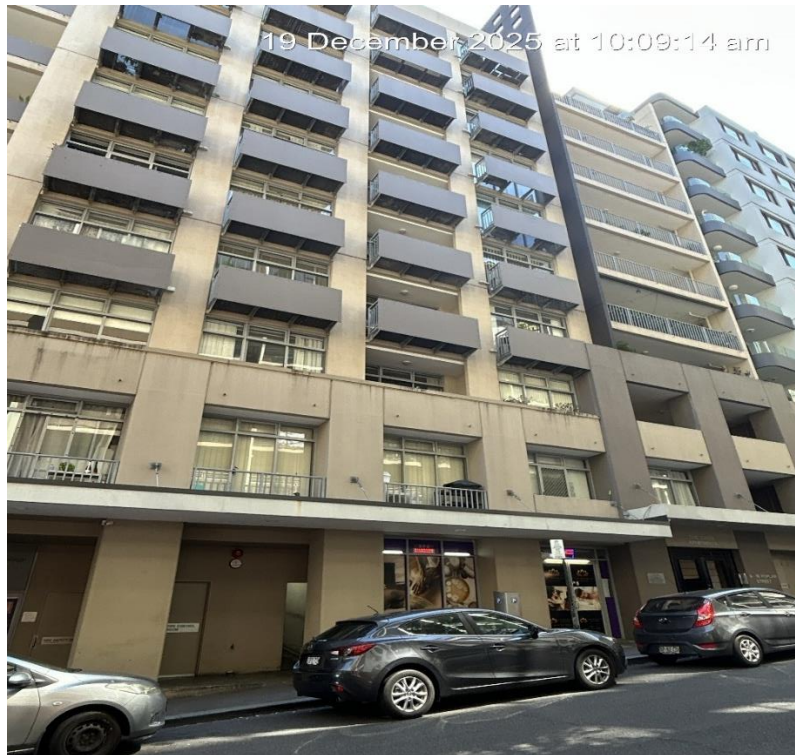
**Figure 1:** 6-18 Poplar Street, Surry Hills, viewed from the north
