# **Attachment D**

**Inspection Report  
95 Victoria Street, Potts Point**

## **Council Investigation Officer Inspection and Recommendation Report; Clause 17(2) Part 8 of Schedule 5 of the Environmental Planning and Assessment Act 1979 (the Act)**

**Premises:** 95 Victoria Street, Potts Point

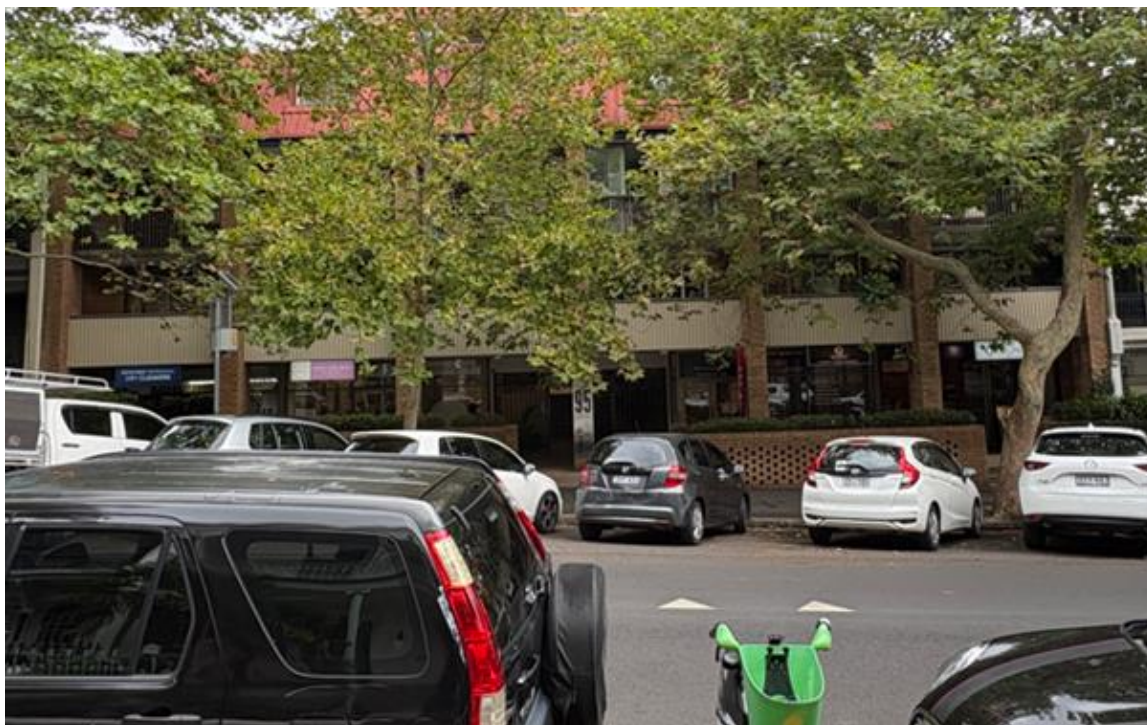
**Figure 1:** 95 Victoria Street, Potts Point viewed from the east
