# **Attachment D**

**Inspection Report  
95 Victoria Street, Potts Point**

# **Council Investigation Officer Inspection and Recommendation Report; Clause 17(2) Part 8 of Schedule 5 of the Environmental Planning and Assessment Act 1979 (the Act)**

**Premises:** 95 Victoria Street, Potts Point

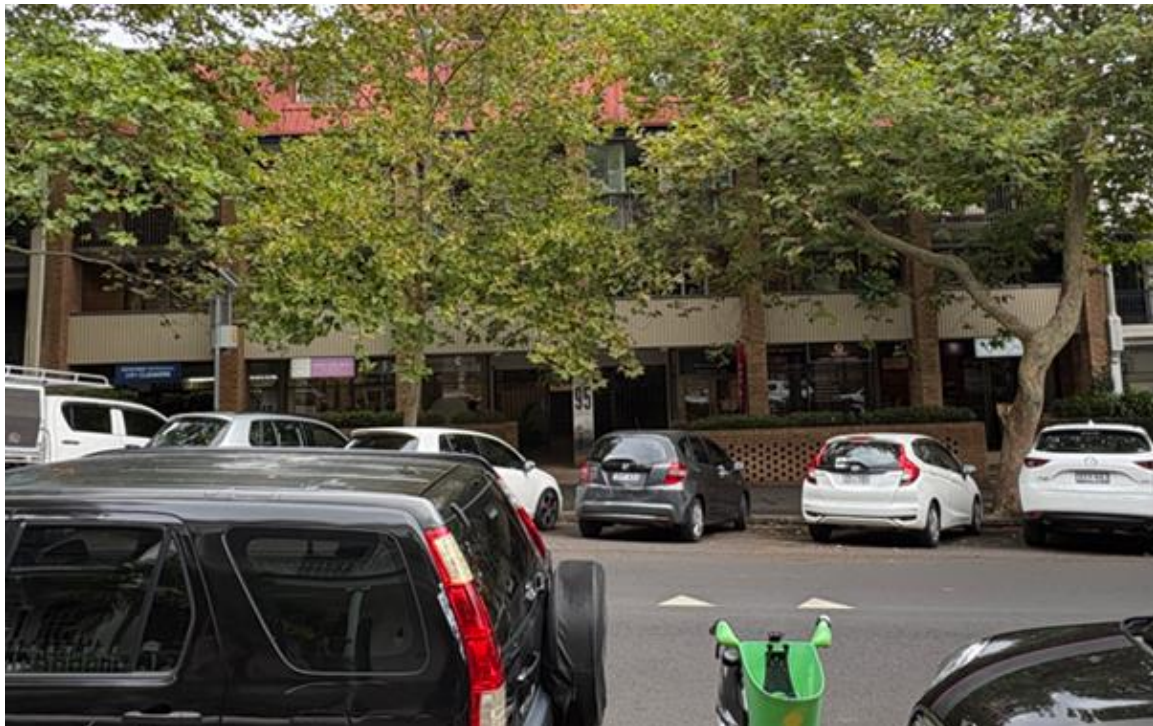
**Figure 1:** 95 Victoria Street, Potts Point viewed from the east
