**Inspection Report
1 Taylor Street, Glebe**

Council Investigation Officer Inspection and Recommendation Report; Clause 17(2) Part 8 of Schedule 5 of the Environmental Planning and Assessment Act 1979 (the Act)

Premises: 1 Taylor Street Glebe (Sydney Secondary College - Blackwattle Bay Campus)

**Re: INSPECTION REPORT
'SYDNEY SECONDARY COLLEGE – BLACKWATTLE BAY CAMPUS'
TAYLOR STREET AND FERRY ROAD, GLEBE (hereafter "the premises")**

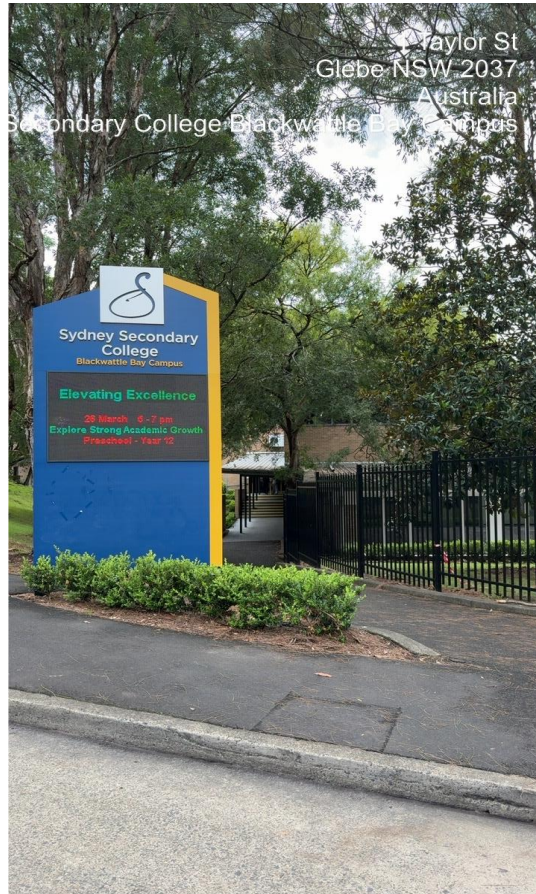
Figure 1: 1 Taylor Street, Glebe viewed from the west
