# **Attachment B**

**Inspection Report  
782 Bourke Street, Waterloo**

# **Council Investigation Officer Inspection and Recommendation Report; Clause 17(2) Part 8 of Schedule 5 of the Environmental Planning and Assessment Act 1979 (the Act)**

**Premises:** 782 Bourke Street Waterloo (AKA 1 Crystal Street, Waterloo)

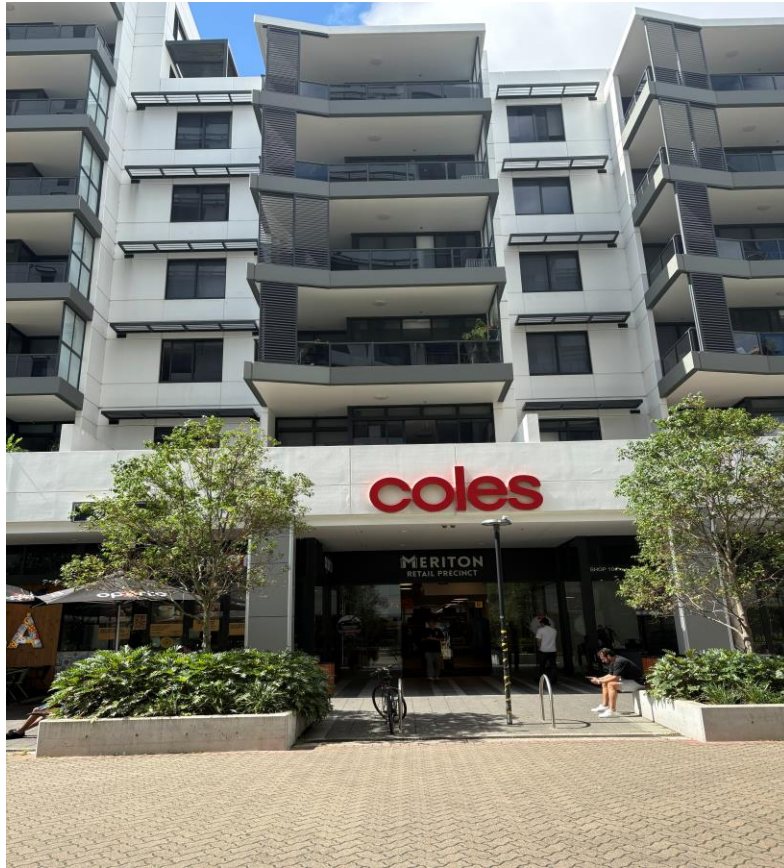
**Figure 1:** 782 Bourke Street, Waterloo viewed from the west
