# **Attachment D**

**Inspection Report  
12 Primrose Avenue, Rosebery**

# **Council Investigation Officer Inspection and Recommendation Report; Clause 17(2) Part 8 of Schedule 5 of the Environmental Planning and Assessment Act 1979 (the Act)**

**Premises:** 12 Primrose Avenue, Rosebery

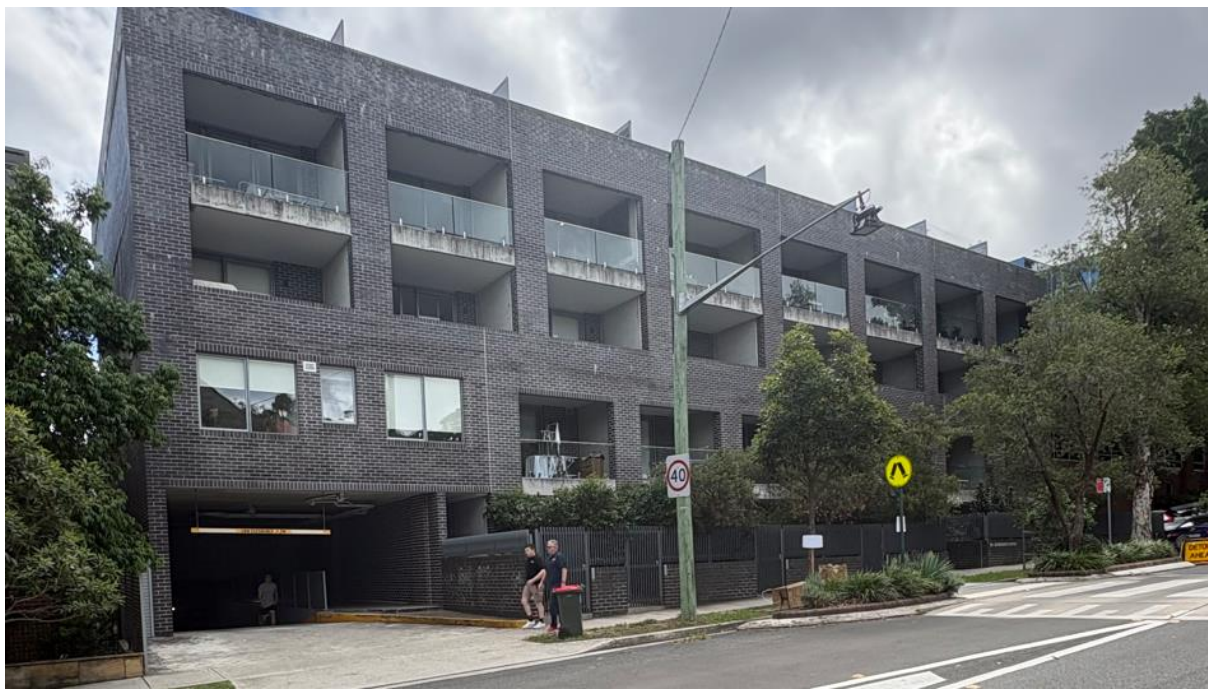
**Figure 1:** 12 Primrose Avenue, Rosebery, viewed from the south-east.
