# **Attachment E**

**Inspection Report  
25 Bligh Street, Sydney**

# **Council Investigation Officer Inspection and Recommendation Report; Clause 17(2) Part 8 of Schedule 5 of the Environmental Planning and Assessment Act 1979 (the Act)**

**Re: INSPECTION REPORT  
KINGSMEDE  
25 BLIGH STREET, SYDNEY ("the premises")**

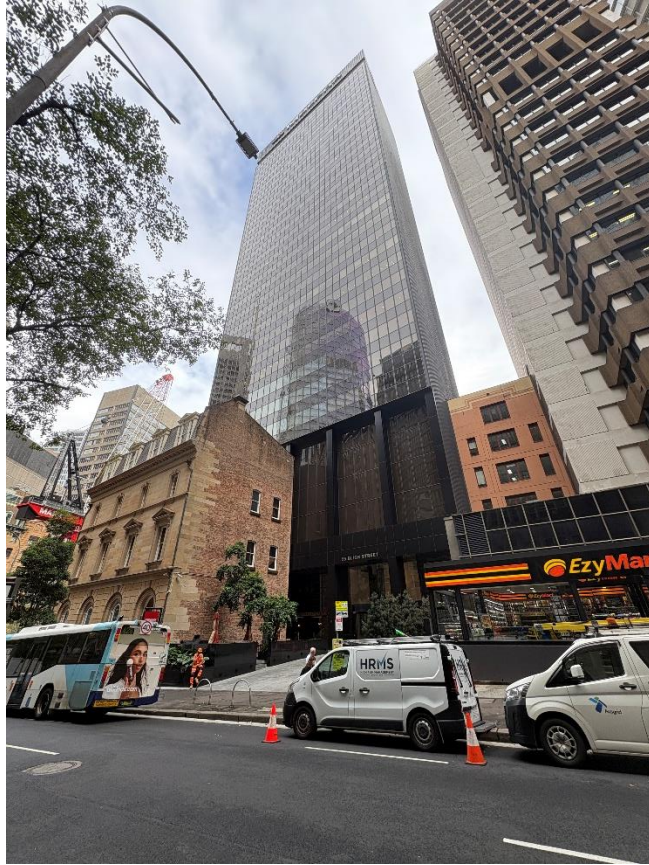
**Figure 1:** 25 Bligh Street Sydney, viewed from the east.
