# **Attachment C**

**Inspection Report  
16 Cope Street, Redfern**

**Council Investigation Officer Inspection and Recommendation Report; Clause 17(2) Part 8 of Schedule 5 of the Environmental Planning and Assessment Act 1979 (the Act)**

**Premises:** 16 Cope Street, Redfern

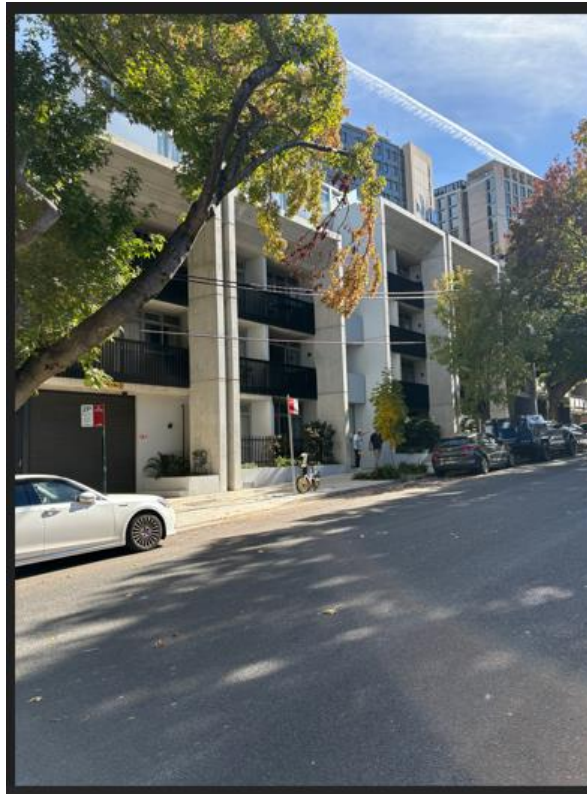
**Figure 1:** 16 Cope Street, Redfern, viewed from the south-east
