# **Attachment B**

**Inspection Report  
15 Springfield Avenue, Potts Point**

# **Council Investigation Officer Inspection and Recommendation Report; Clause 17(2) Part 8 of Schedule 5 of the Environmental Planning and Assessment Act 1979 (the Act)**

**Premises:** 15 Springfield Avenue, Potts Point

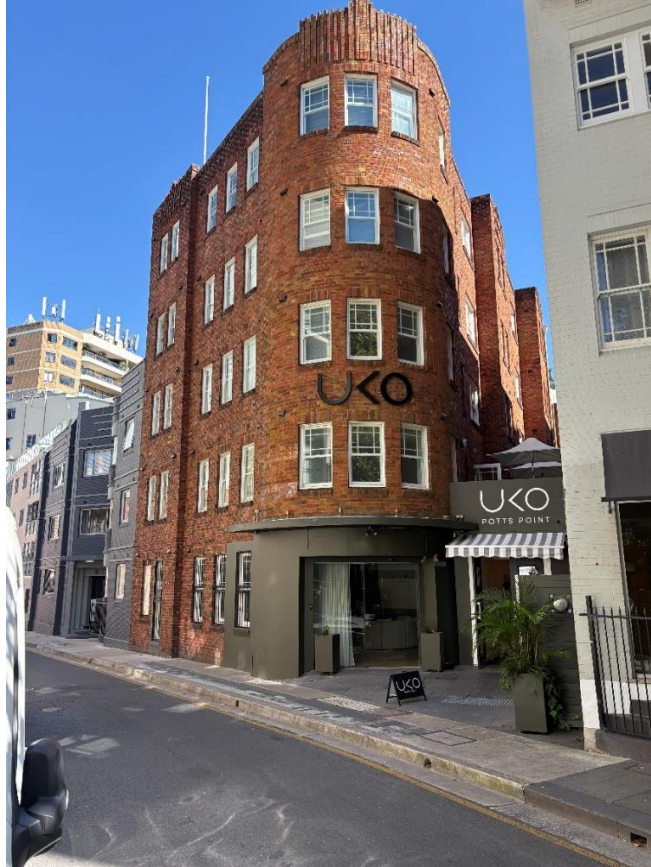
**Figure 1:** 15 Springfield Avenue, Potts Point, viewed from east
