# **Attachment B**

**Inspection report  
244-248 William Street, Potts Point**

## **Council Investigation Officer Inspection and Recommendation Report; Clause 17(2) Part 8 of Schedule 5 of the Environmental Planning and Assessment Act 1979 (the Act)**

**Re: INSPECTION REPORT  
KINGS CROSS HOTEL  
244-248 WILLIAM STREET, POTTS POINT (hereafter “the premises”)**

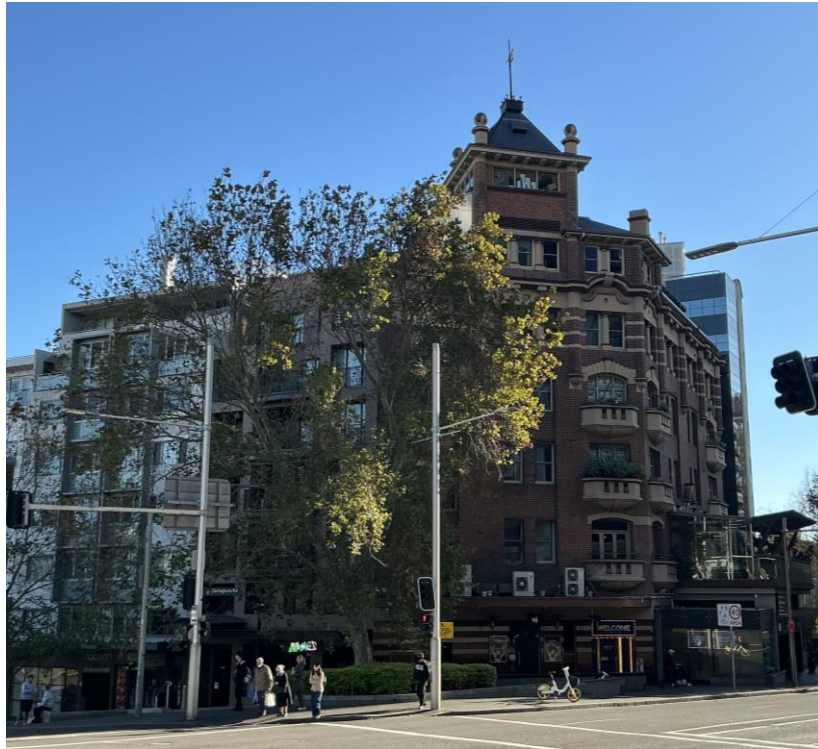
**Figure 1:** 244-248 William Street, Potts Point, viewed from the south-west
