# **Attachment C**

**Inspection report  
52-54 Kings Cross Road, Rushcutters Bay**

## **Council Investigation Officer Inspection and Recommendation Report; Clause 17(2) Part 8 of Schedule 5 of the Environmental Planning and Assessment Act 1979 (the Act)**

**Re: INSPECTION REPORT  
'THE WARDLIEGH'  
52-54 KINGS CROSS ROAD, RUSHCUTTERS BAY ("the premises")**

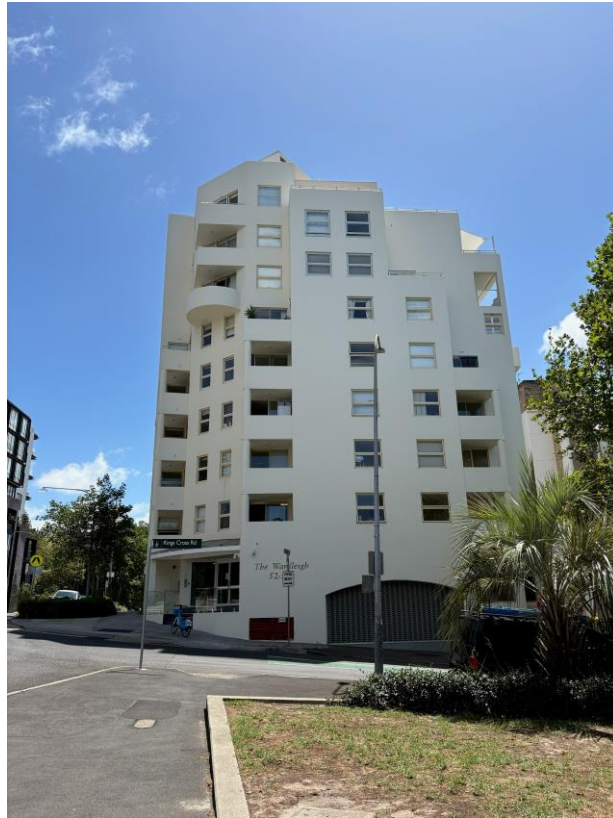
**Figure 1:** 52-54 Kings Cross Road, Rushcutters Bay, viewed from the south
