## **Report on Footing Investigation**

**Park Royal Hotel Redevelopment**

**150 Day Street, Sydney, NSW**

**Project 231572.00**

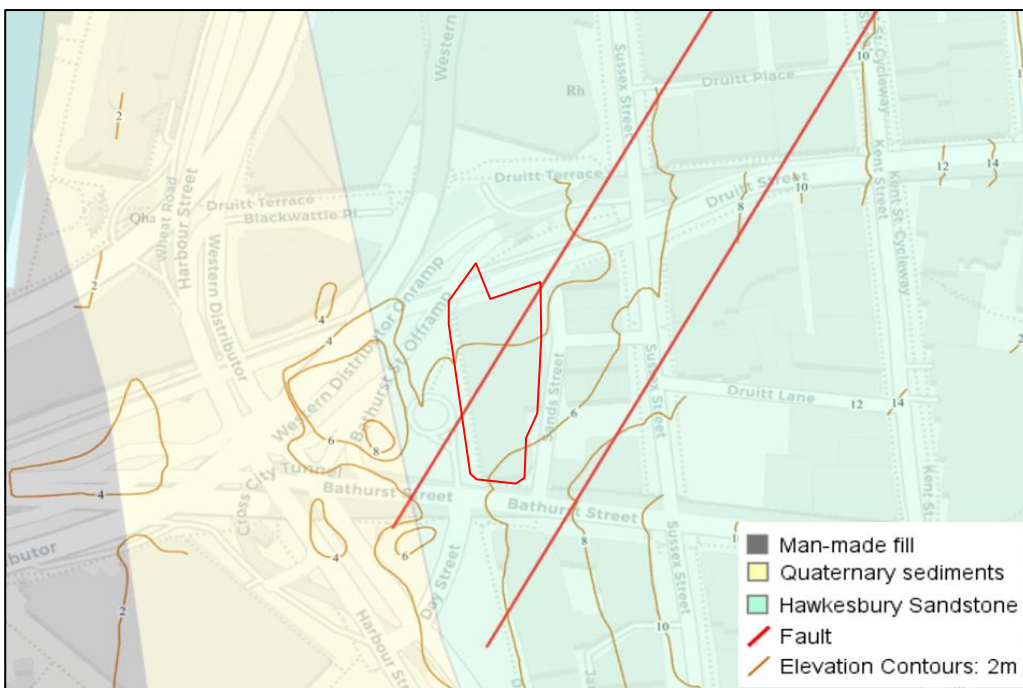
### Figure 1: Subject site geology detailing GPO fault zone

Reference to Sydney CBD fault zones map (Pells, Braybrooke & Och, 2004), indicates that the site is located within the G.P.O Fault zone. The fault zone extends from the north-east of the subject site to the south-west. Weaker rock and a higher degree of fracturing within the rock mass is expected in the fault zone. An extract from the geological map overlain by 2 m (AHD) contours is shown in Figure 1.
