# Existing Building Services Condition Report

**230655 PARK ROYAL HOTEL  
REDEVELOPMENT**

**Client:**  
UOL

**Date:**  
24/03/2025

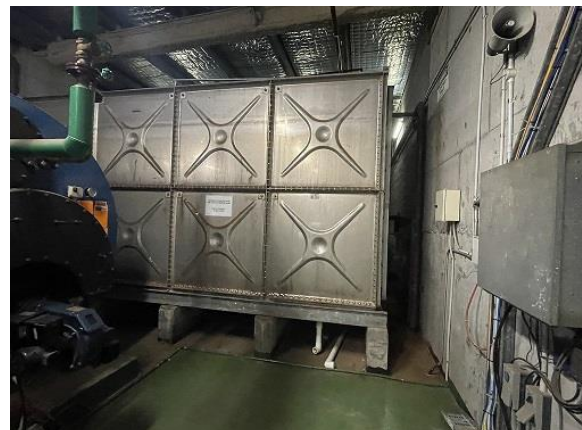
*Existing Combined CW. & FH water storage tank.*

| Asset | Service | Recommendations |
|---|---|---|
| <b>Potable Water Tanks</b> | Hydraulics | Replace to meet latest NCC Standards and to meet new increased demand |

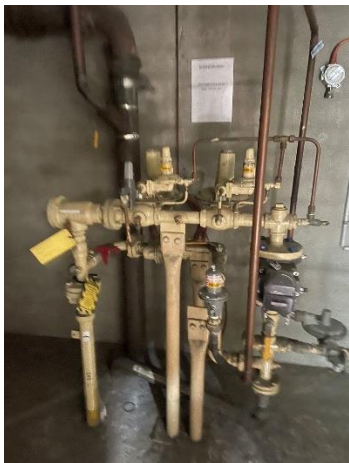
The existing natural gas services reticulates within the building at 100kpa, without being located within a ventilated fire rated shaft in accordance with AS5601. A new boundary regulator will be provided to limit the natural gas supply operating pressure to 7kpa once entering into the building. The building's existing natural gas pipework will be deemed to small to accommodate anticipated natural gas usage at the new lower pressure and will need to be decommissioned and removed. New natural gas service pipework will be run throughout the building to serve to the existing and new gas appliance, sized to cater for the lower gas pressure.

*Existing High pressure gas boundary regulator.*

*Existing Gas regulator serving Domestic HW. plant.*

| Asset | Service | Recommendations |
|---|---|---|
| <b>Gas Services</b> | Hydraulics | Replace to meet latest NCC Standards, City of Sydney Guidelines and to meet new increased demand |

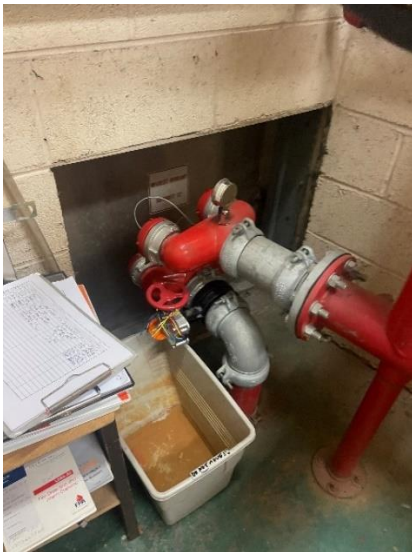
Figure 1: Existing fire hydrant booster assembly

| Asset | Service | Recommendations |
|---|---|---|
| <b>Booster Assembly</b> | Wet Fire | Replace to meet latest NCC Standards and to meet new increased demand |

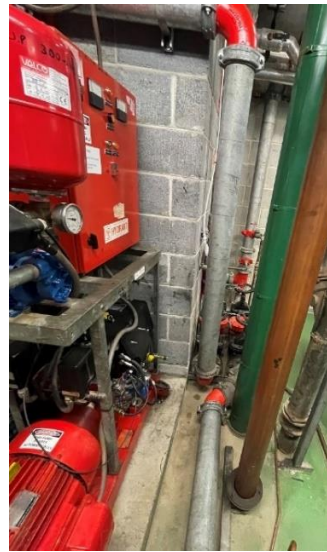
A single hydrant booster pump is located within the roof top plantroom. The pump is a horizontal end suction centrifugal type pump that incorporates both an electric and diesel motors. The hydrant pumps draws water from the fire hydrant storage tank and distributes water to the hydrant landing valves located on levels 11 through to level R. A gravity hydrant service line by-passes the hydrant pump set to serve the hydrants landing valves located on levels Ground floor through to Basement level.

Figure 2: Existing Diesel/Electric Hydrant pump

| Asset | Service | Recommendations |
|---|---|---|
| <b>Hydrant Pumps</b> | Wet Fire | Replace to meet latest NCC Standards and to meet new increased demand |

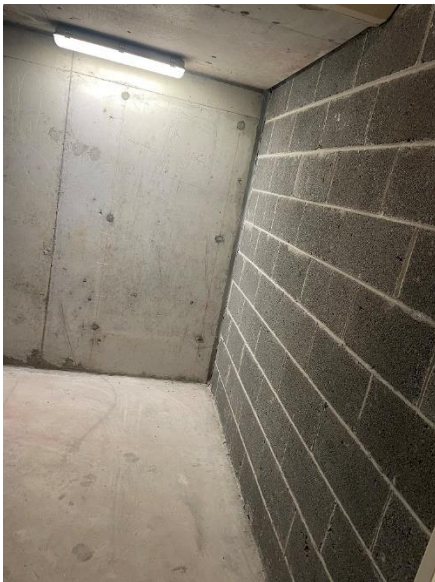
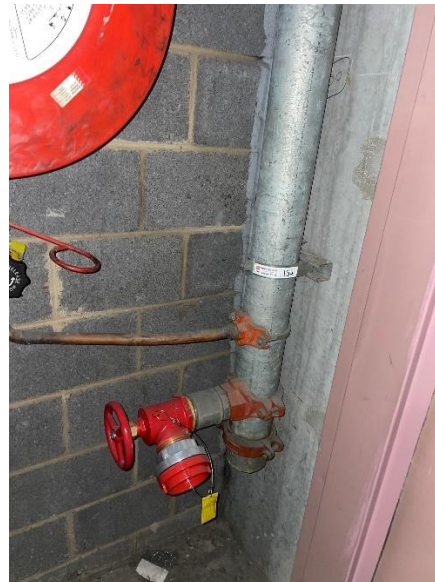
Hydrant landing valves are located on each level, within a dedicated cupboard that is located area adjacent to the door to each fire stair (outside the fire egress stairs).

Figure 3: Fire egress stair not containing fire hydrant.

Figure 4: Fire hydrant in cupboard.

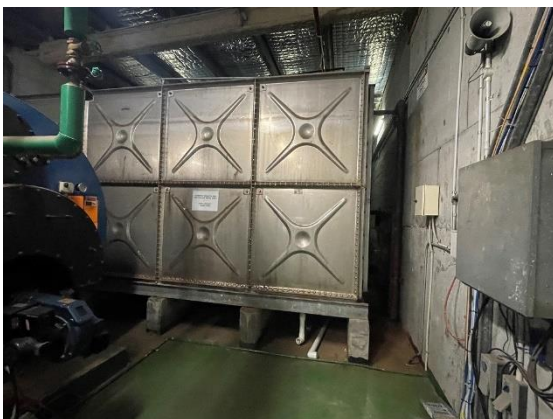
Figure 5: Roof top combined potable/fire hydrant tank.

| Asset | Service | Recommendations |
|---|---|---|
| <b>Hydrant Water Storage Tank</b> | Wet Fire | Replace to meet latest NCC Standards and to meet new increased demand |

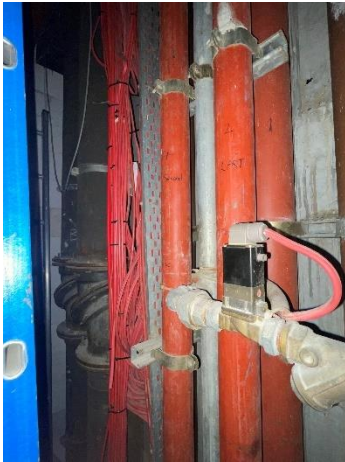
Each floor level contains a sprinkler control valve assembly that is located within a dedicated cupboard. The control valve assembly consists of a monitored isolation valve, flow switch and test/drain-down facilities. A main sprinkler service extends from the control valve assembly to serve the sprinkler services located on that floor level.

Figure 6: On-floor sprinkler control valve assembly

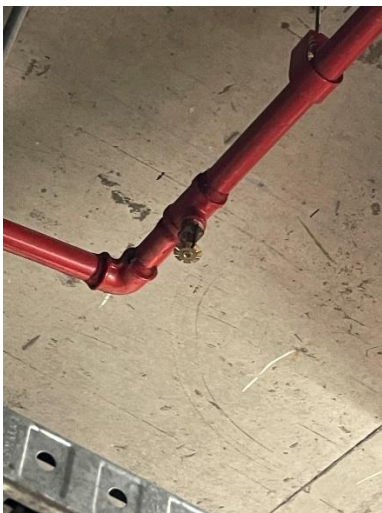
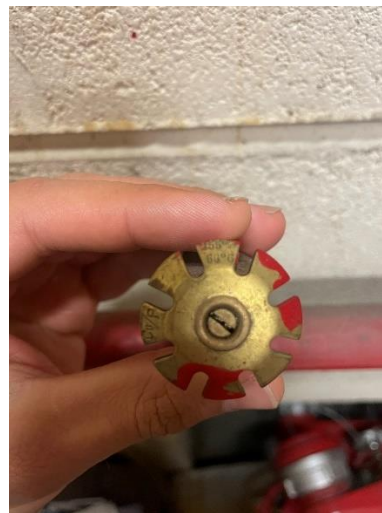
Figure 7: Sprinkler heads example and sprinkler pipes

Figure 8: Sprinkler heads example and sprinkler pipes

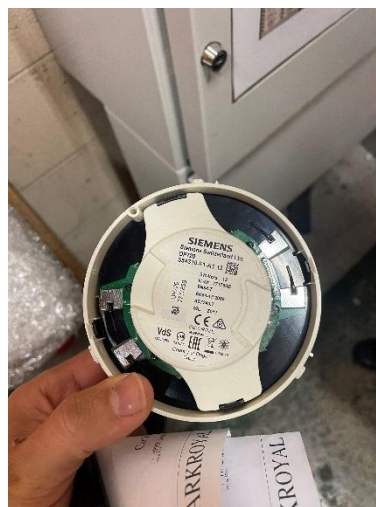
Figure 17: Existing smoke detector.

| Asset | Service | Recommendations |
|---|---|---|
| <b>Smoke Detectors</b> | Dry Fire | Replace to meet latest NCC Standards |

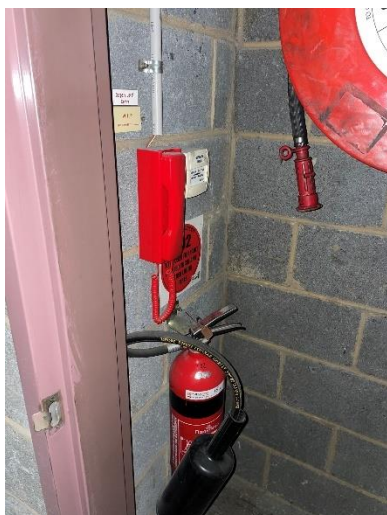
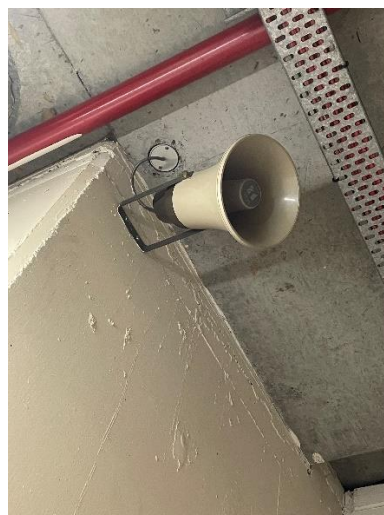
Multiple WIP and ECP's are provided on each level, located within the fire hydrant/hose reel cupboard adjacent to the female amenities.

Figure 18: WIP/ECP points within cupboard.

Figure 19: EWIS horn speakers and strobe lights

| Asset | Service | Recommendations |
|---|---|---|
| <b>EWIS Speakers, Phones</b> | EWIS | Replace to meet latest NCC Standards |

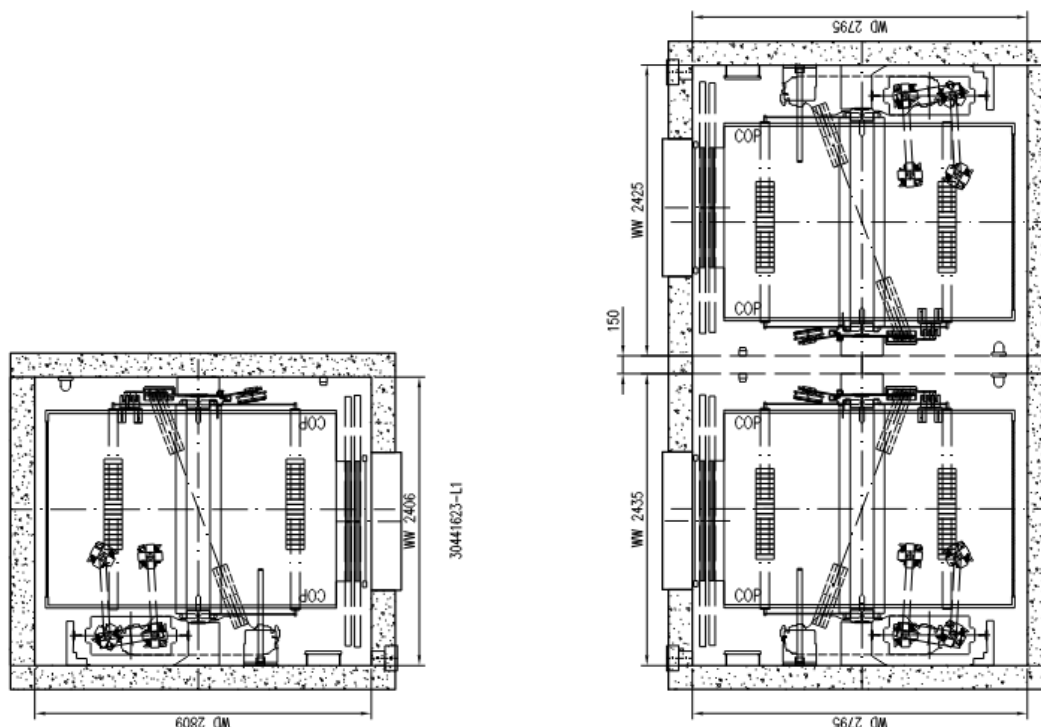
Lift No. 1, 2 & 3

The lift equipment is installed certified complying to AS1735.1:2003 and appears compliant to the current NCC/BCA 2022 mandatory requirements for **C4D11 - Openings in fire-isolated lift shafts** and **E3D8 - Accessible features required for passenger lifts** with the exception of a handrail complying with the provisions for a mandatory handrail in AS 1735.12.

The design life for this model lift is in the order of 20 years subject to usage and continued ongoing maintenance with OEM service schedule. On this basis the current operational life for these lifts should provide for ongoing continuous operation up to approx. 2033 with the view that there will upgrade to Kone LCE controllers and KDM90 drives, and user interface fixturs and fittings with new interior finishes fitout within this period.
