# Existing Building Services Condition Report

**230655 PARK ROYAL HOTEL  
REDEVELOPMENT**

**Client:**  
UOL

**Date:**  
24/03/2025

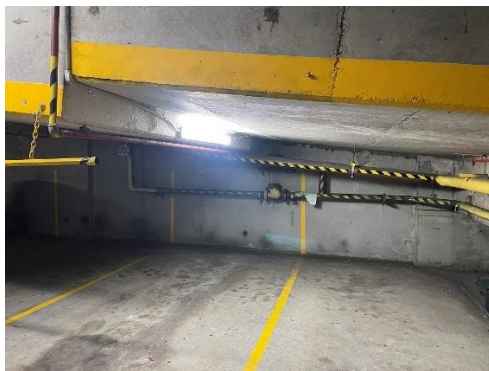
*Existing incoming CW. service.*

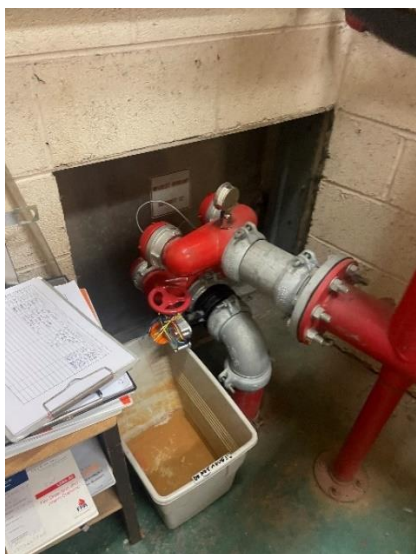
Figure 1: Existing fire hydrant booster assembly

| Asset | Service | Recommendations |
|---|---|---|
| <b>Booster Assembly</b> | Wet Fire | Replace to meet latest NCC Standards and to meet new increased demand |

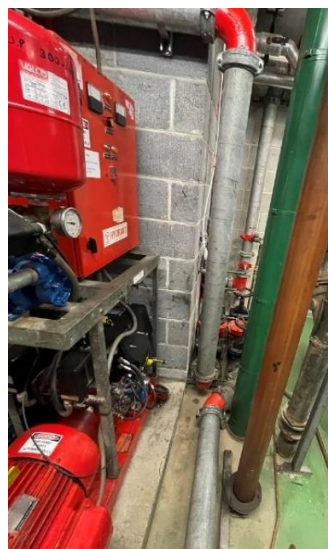
Figure 2: Existing Diesel/Electric Hydrant pump

| Asset | Service | Recommendations |
|---|---|---|
| <b>Hydrant Pumps</b> | Wet Fire | Replace to meet latest NCC Standards and to meet new increased demand |

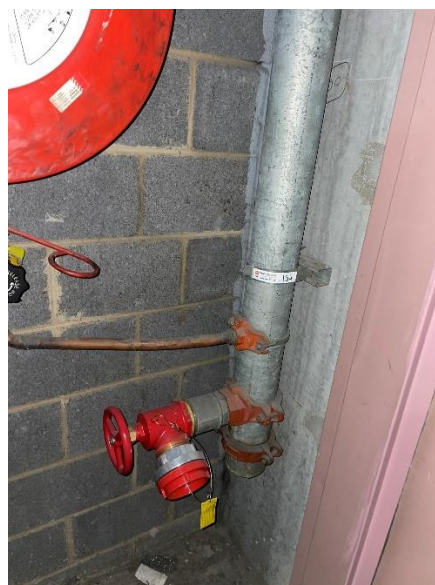
Figure 4: Fire hydrant in cupboard.

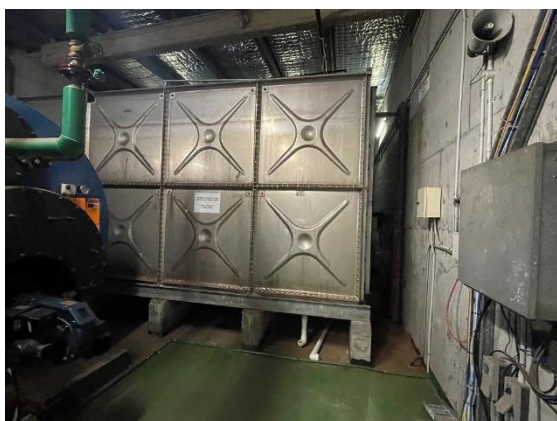
Figure 5: Roof top combined potable/fire hydrant tank.

| Asset | Service | Recommendations |
|---|---|---|
| <b>Hydrant Water Storage Tank</b> | Wet Fire | Replace to meet latest NCC Standards and to meet new increased demand |

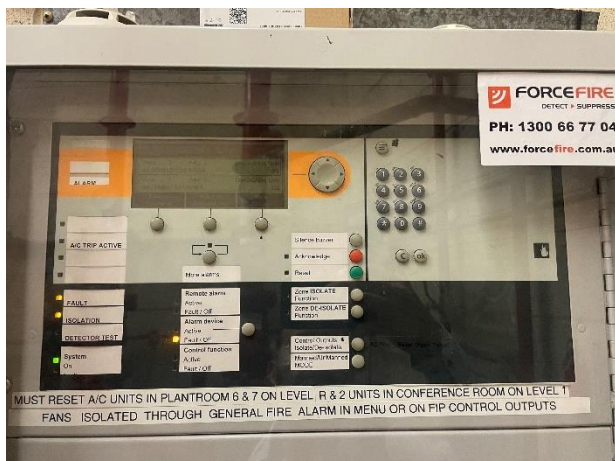
Figure 13: Existing fire indicator panel.

| Asset | Service | Recommendations |
|---|---|---|
| <b>Fire Indicator Panel</b> | Dry Fire | Replace with newer model |

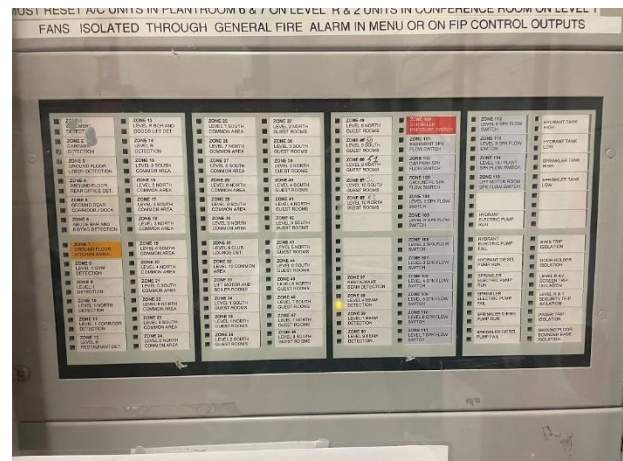
Figure 14: Existing addressable fire indicator panel inc. FFCP

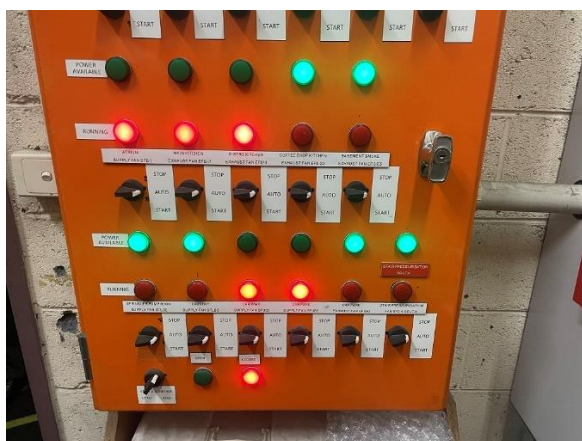
Figure 15: Existing Fire Fan Control panel (FFCP).

| Asset | Service | Recommendations |
|---|---|---|
| <b>Fire Functional Control Panel</b> | Dry Fire | Replace with newer model |

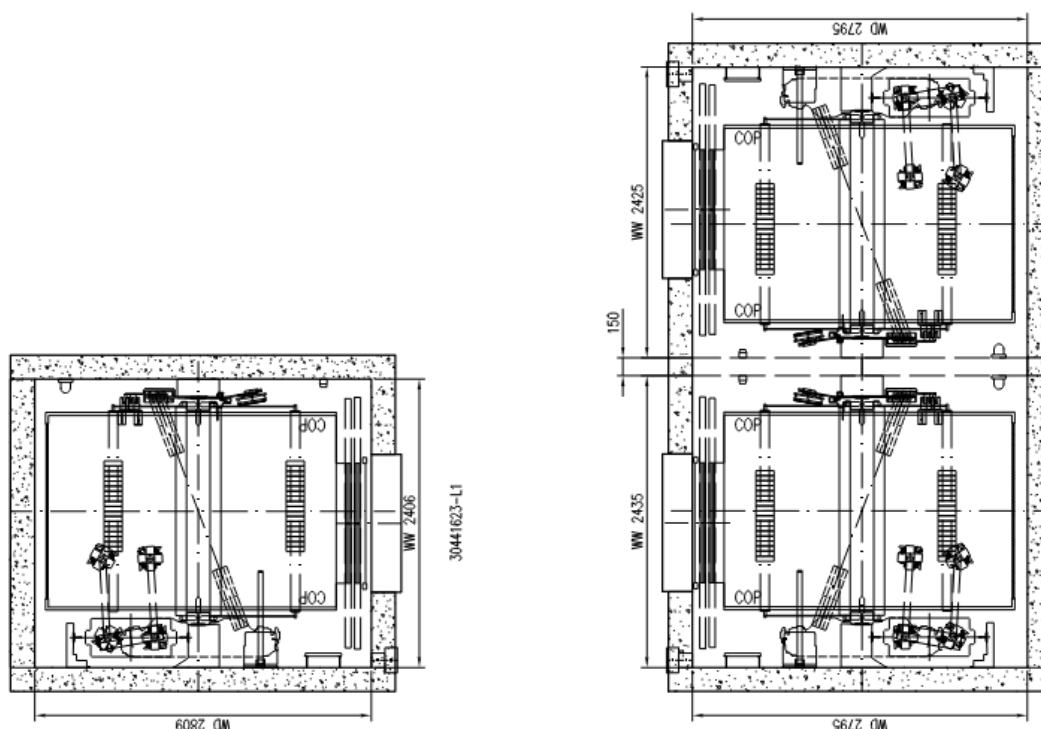
Lift No. 1, 2 & 3

The lift equipment is installed certified complying to AS1735.1:2003 and appears compliant to the current NCC/BCA 2022 mandatory requirements for **C4D11 - Openings in fire-isolated lift shafts** and **E3D8 - Accessible features required for passenger lifts** with the exception of a handrail complying with the provisions for a mandatory handrail in AS 1735.12.

The design life for this model lift is in the order of 20 years subject to usage and continued ongoing maintenance with OEM service schedule. On this basis the current operational life for these lifts should provide for ongoing continuous operation up to approx. 2033 with the view that there will upgrade to Kone LCE controllers and KDM90 drives, and user interface fixturs and fittings with new interior finishes fitout within this period.
