**Inspection report  
244-248 William Street, Potts Point**

# **Council Investigation Officer Inspection and Recommendation Report; Clause 17(2) Part 8 of Schedule 5 of the Environmental Planning and Assessment Act 1979 (the Act)**

**Premises:** 244-248 William Street, Potts Point

**Re: INSPECTION REPORT  
KINGS CROSS HOTEL  
244-248 WILLIAM STREET, POTTS POINT (hereafter “the premises”)**

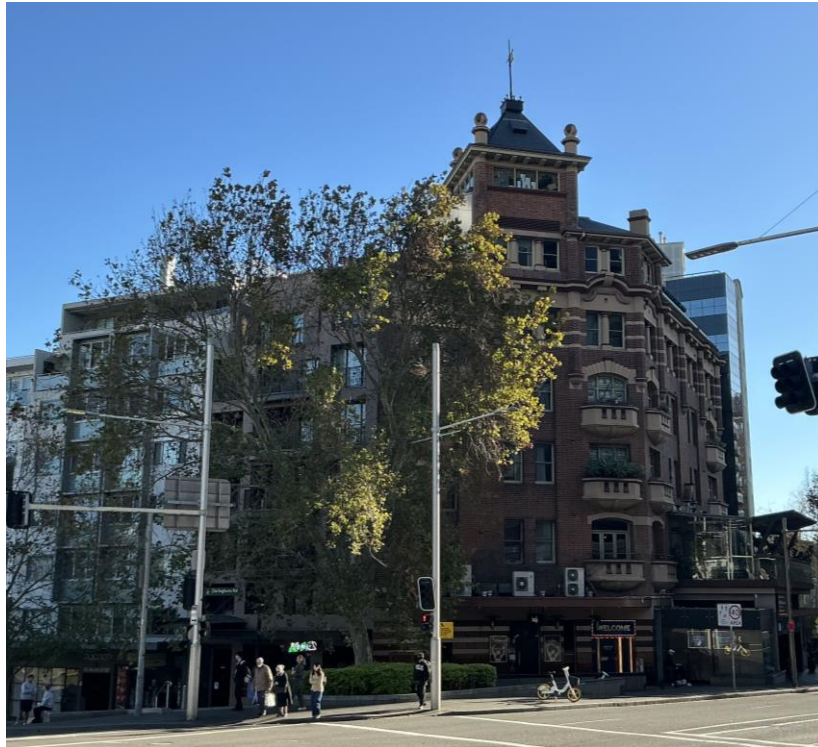
**Figure 1:** 244-248 William Street, Potts Point, viewed from the south-west
