# **Attachment J**

**Inspection report  
22 Allen Street, Pymont**

# **Council Investigation Officer Inspection and Recommendation Report; Clause 17(2) Part 8 of Schedule 5 of the Environmental Planning and Assessment Act 1979 (the Act)**

**Re: INSPECTION REPORT  
HOTEL AZZURRO  
22 ALLEN ST PYRMONT ("the premises")**

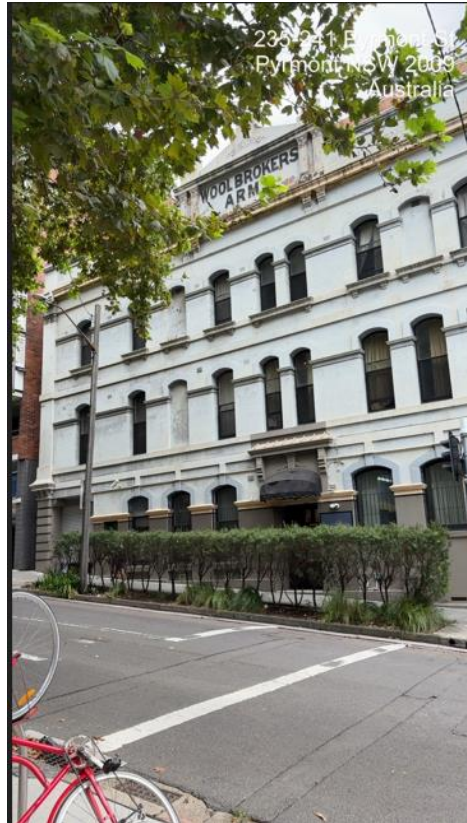
**Figure 1:** 22 Allen Street, Pyrmont, viewed from the south
