Attachment C

Scope of Works: Stained Glass

Attachment C - Scope of Works: Stained Glass

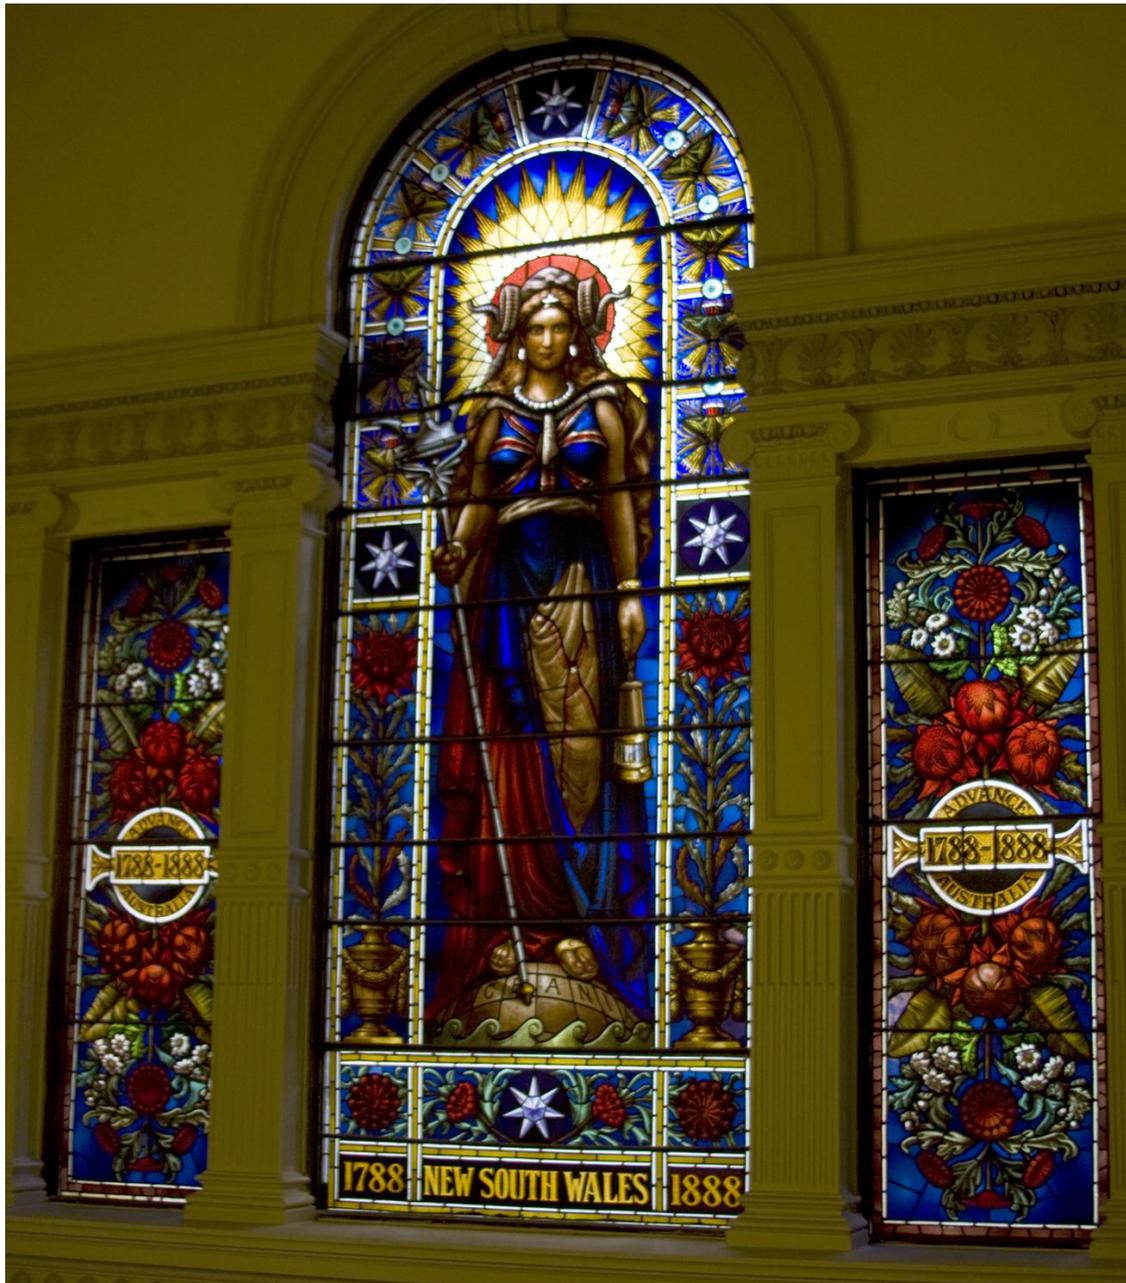
The 'Oceania' window is the only Goodlet and Smith window in the Town Hall still contained within its original lead matrix. It has had some minor in situ repairs in the past and is sitting straight in its frame. It is apparent that water has entered the space between the window and the protective glazing creating a corrosive environment that is causing water staining of the glass and corrosion of the lead comes. The leadlight cement that bonds and waterproofs the window has deteriorated and is no longer performing its function.

“Oceania” at the south stair of the Centennial Hall.

- Removal of gallery and lower ground floor windows to the workshop for straightening, repairs and preventive conservation works.
- In situ preventive conservation works to the Oceania window.
- Reconfiguration of outer glass protective layer to allow venting of interstitial space on Oceania, Captain Cook and gallery windows.
- Preventive conservation works include cleaning of interior and exterior surfaces, repair of broken glass, repair of cracked solder joints, re-cementing of lead/ glass structure, replacement of broken or stressed wire ties to saddle bars, rust treatment and painting of saddle bars.
