# **Attachment B**

**Photographs of Required Works**

**Haymarket Library**

**744-744B George Street, Haymarket**

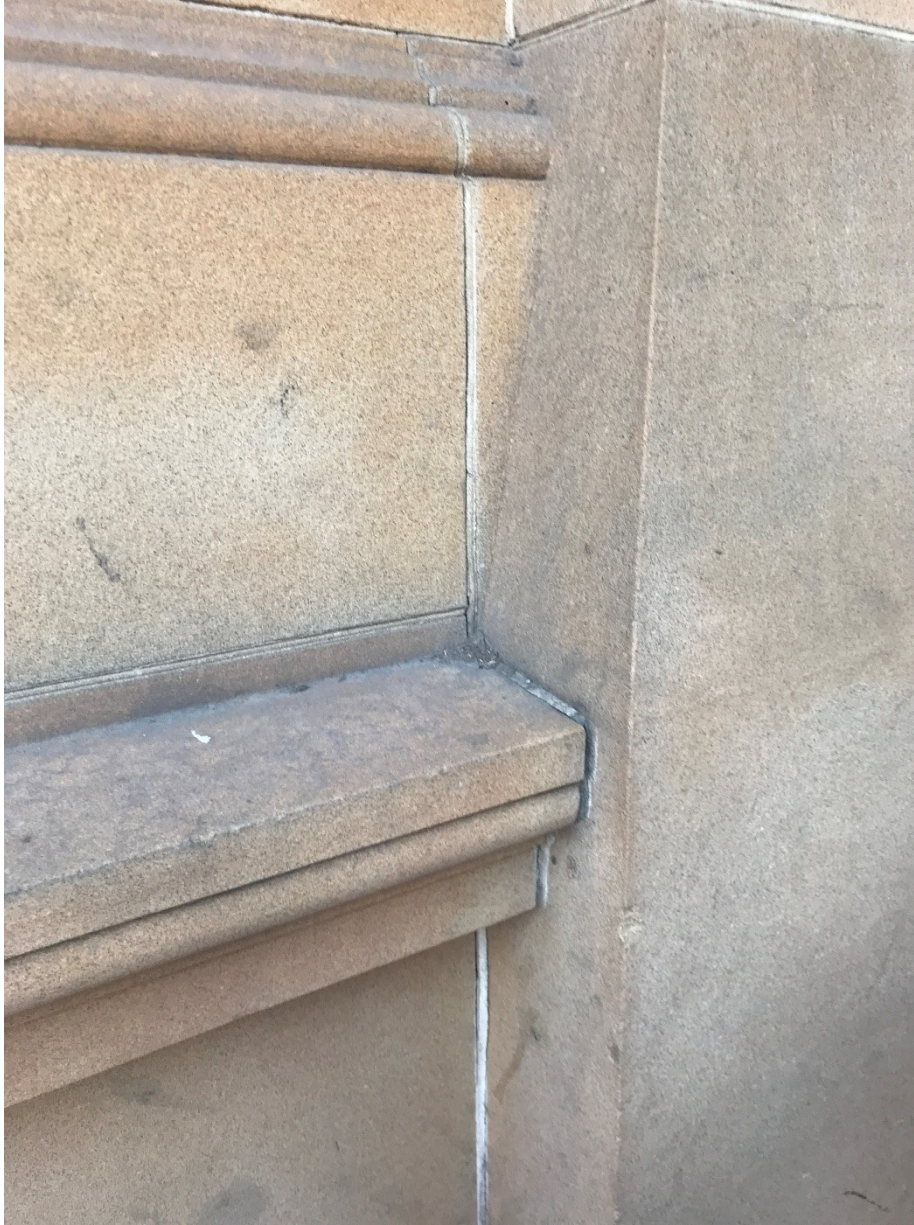
Figure 1 – Loose and missing exterior pointing.

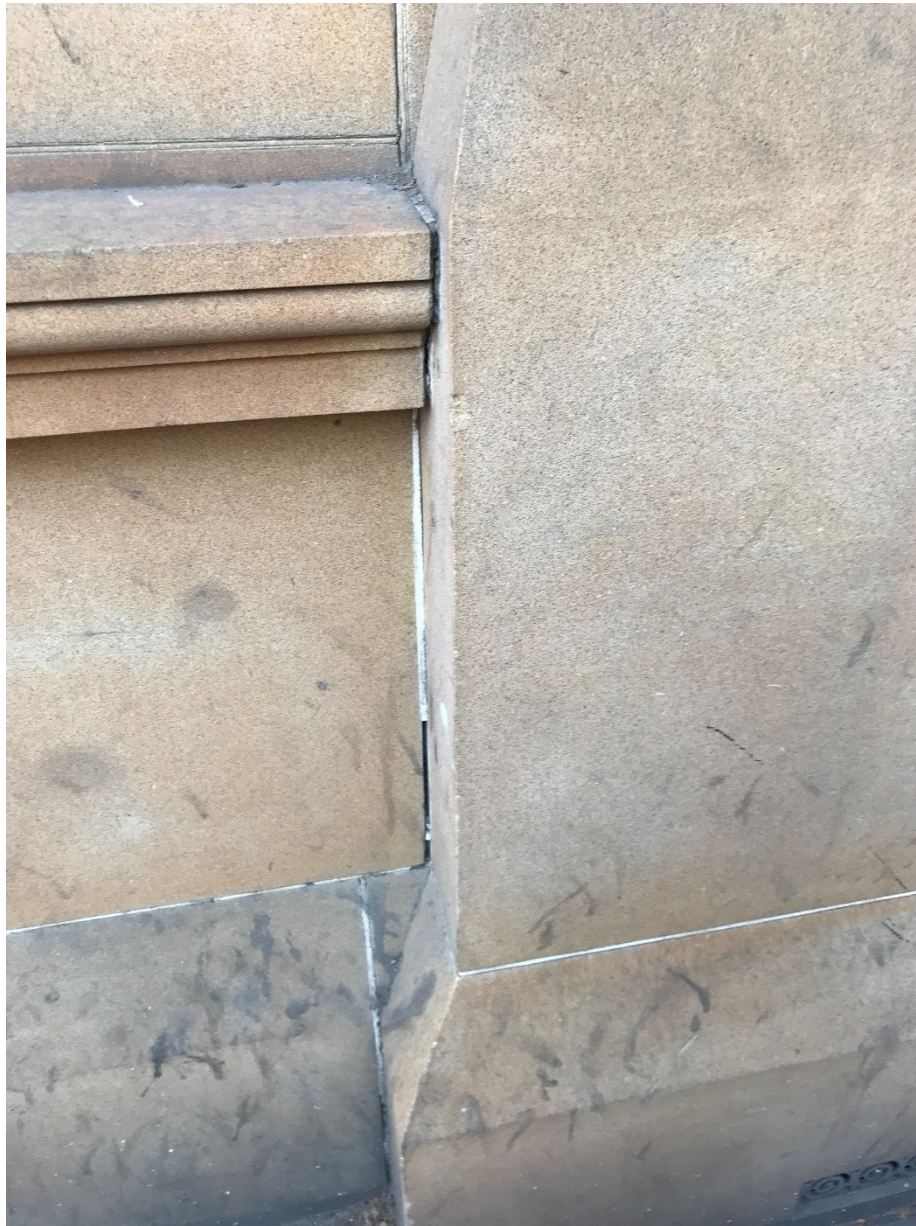
Figure 2 – Superficial dirt on lower courses of stonework

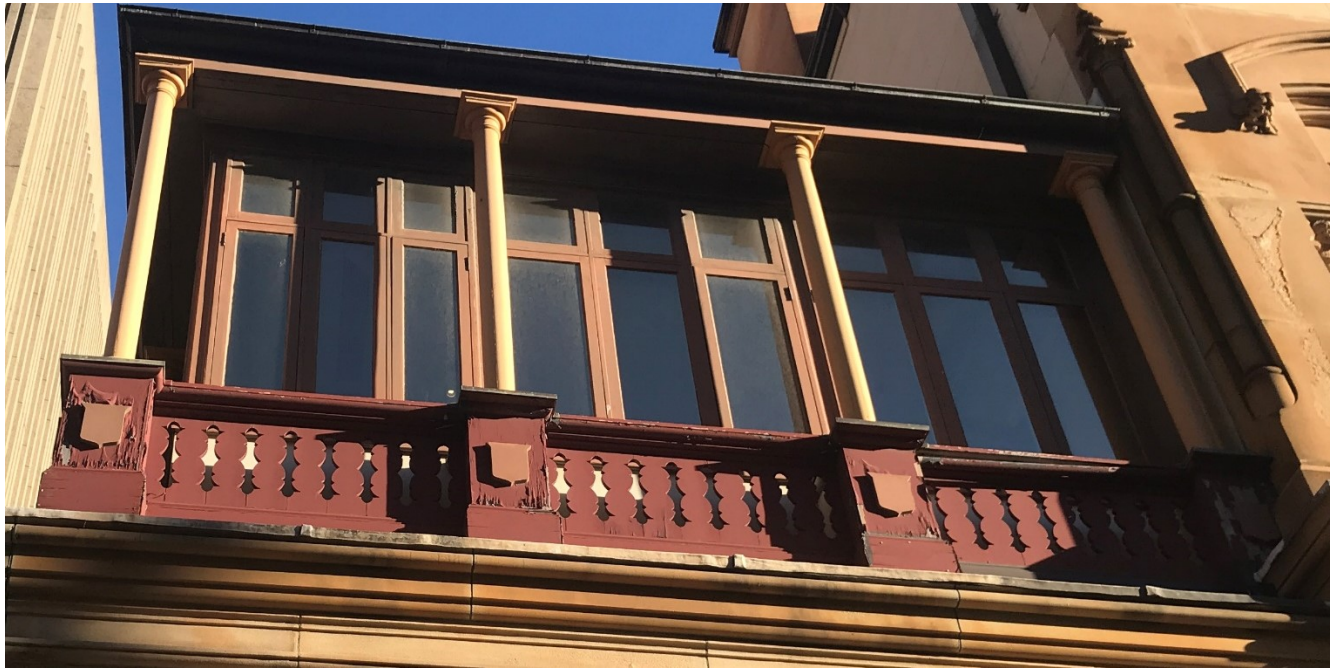
Figure 3 – Paint flaking on timber of enclosed veranda.

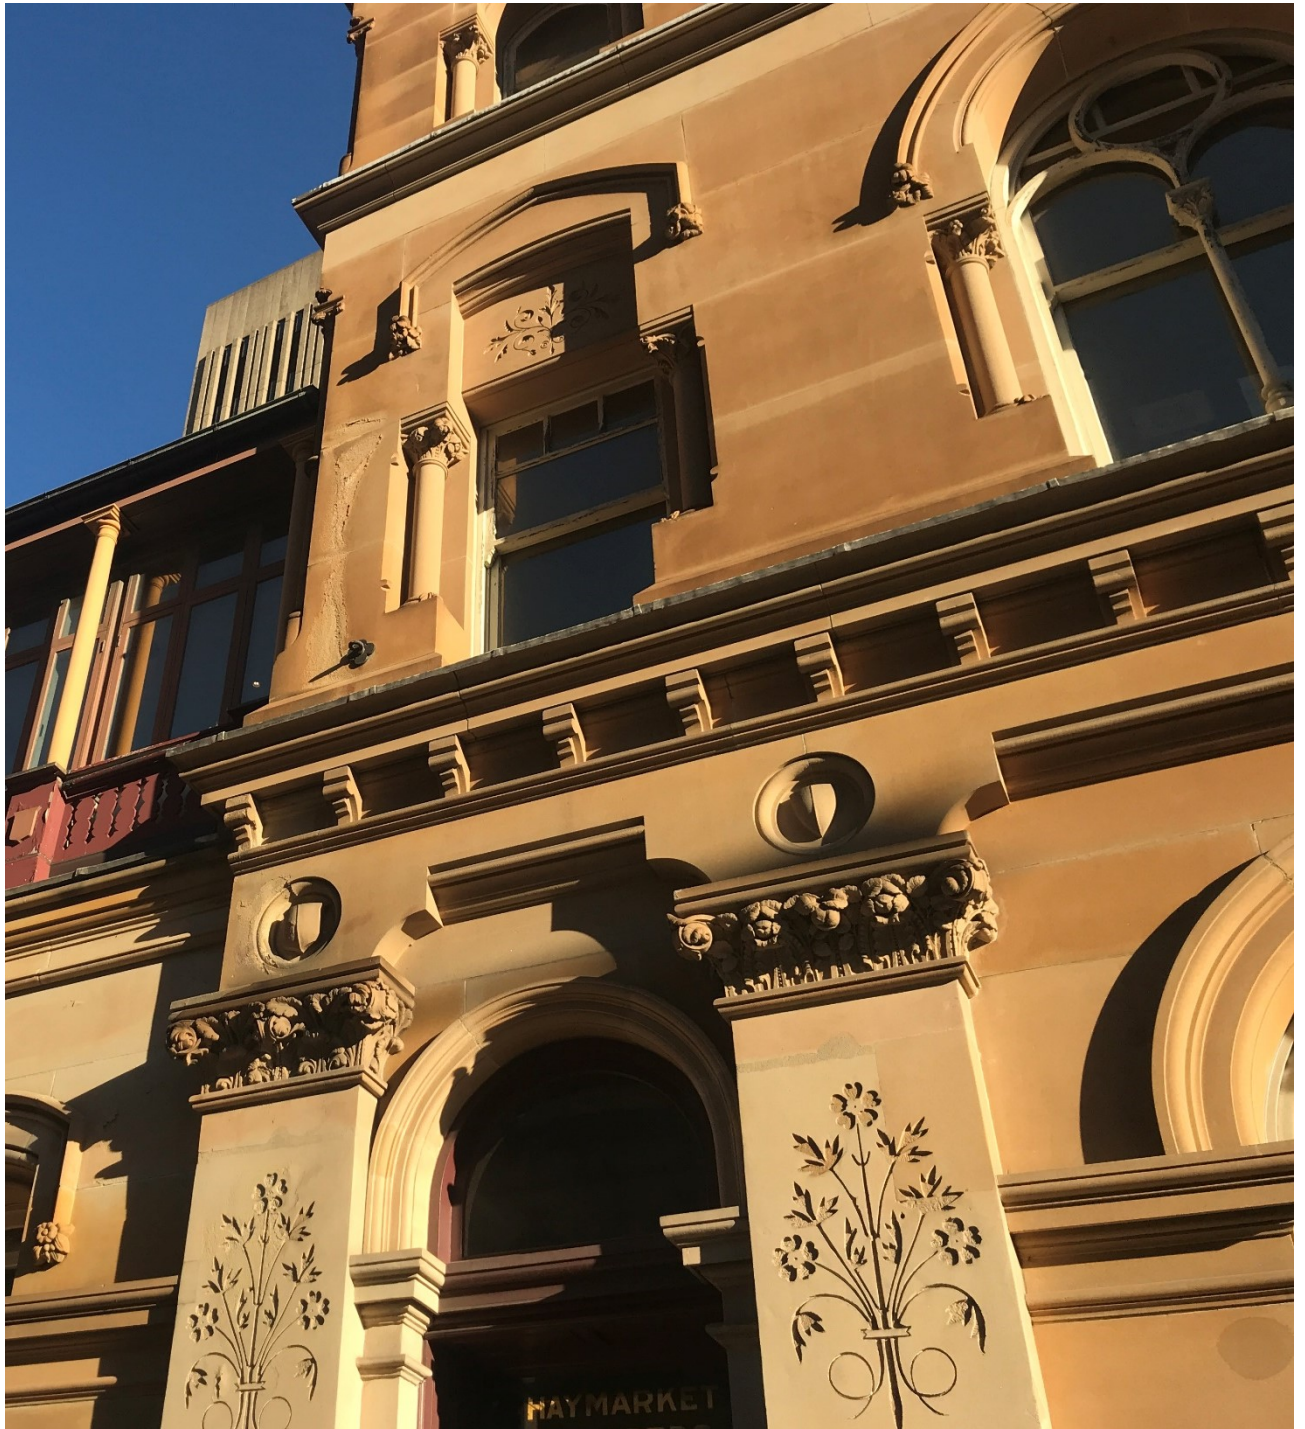
Figure 4 – Lateral damp affecting stonework at eastern end of north façade, possibly failing.

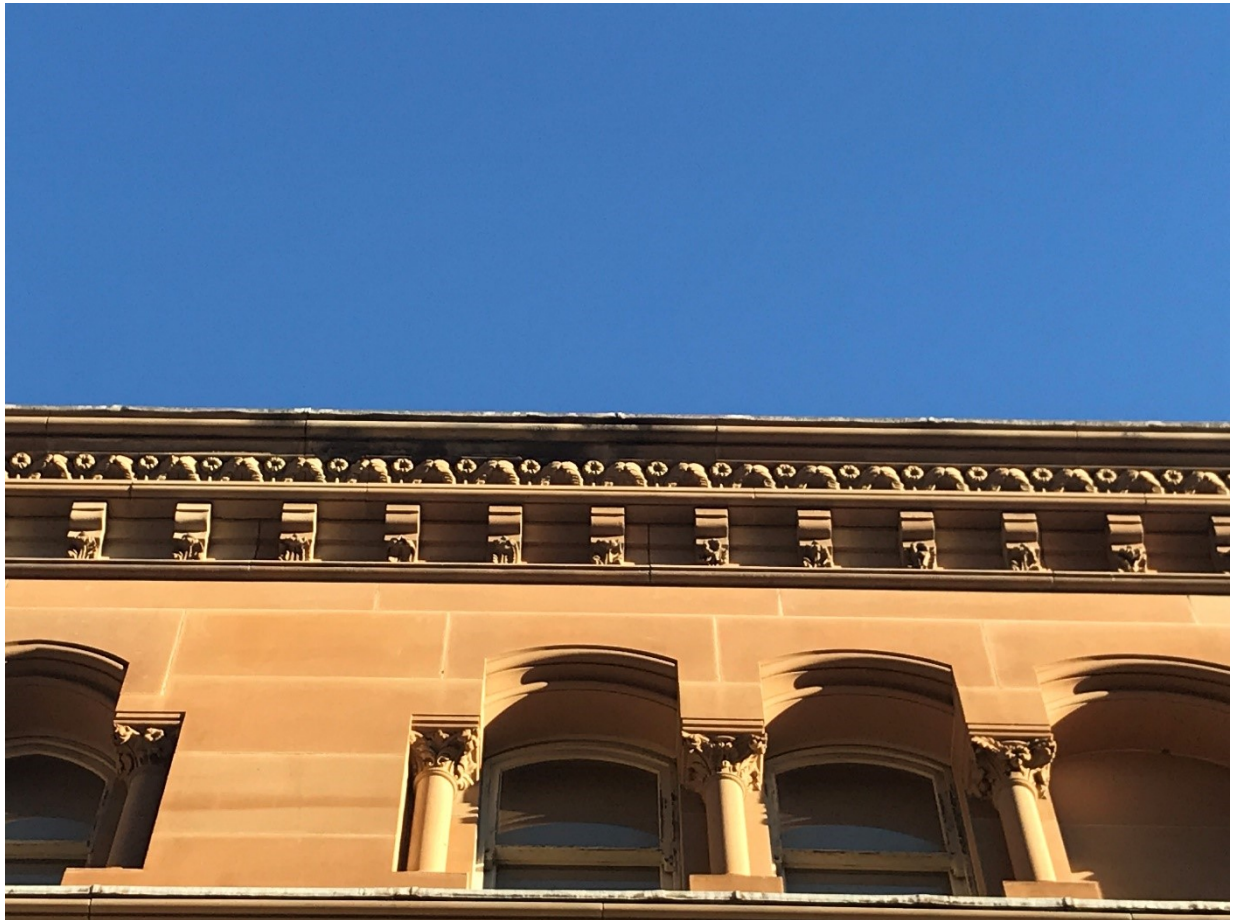
Figure 5 - Evidence of water and active decay in cornice on north façade. Lead lifting off coping.

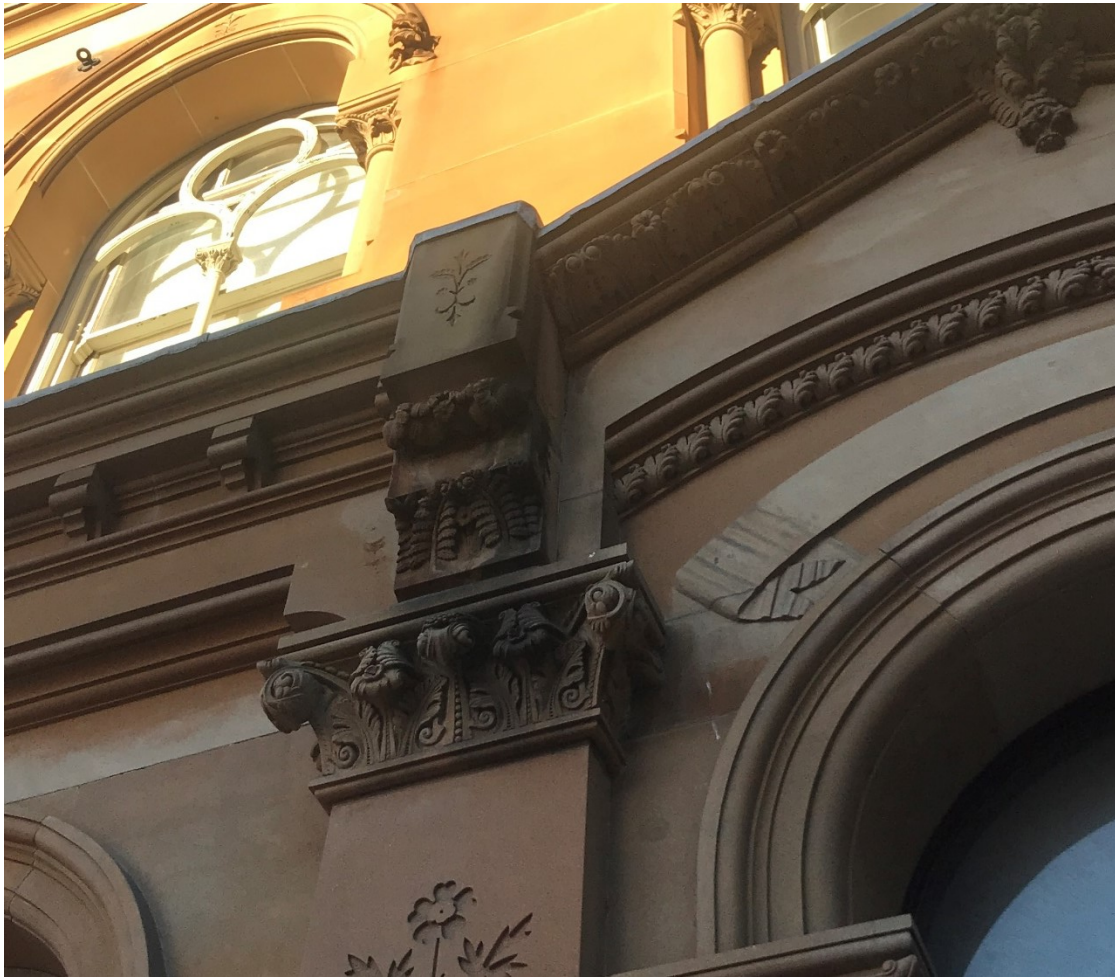
Figure 6 – Polluted water running over brackets on either side of front door.

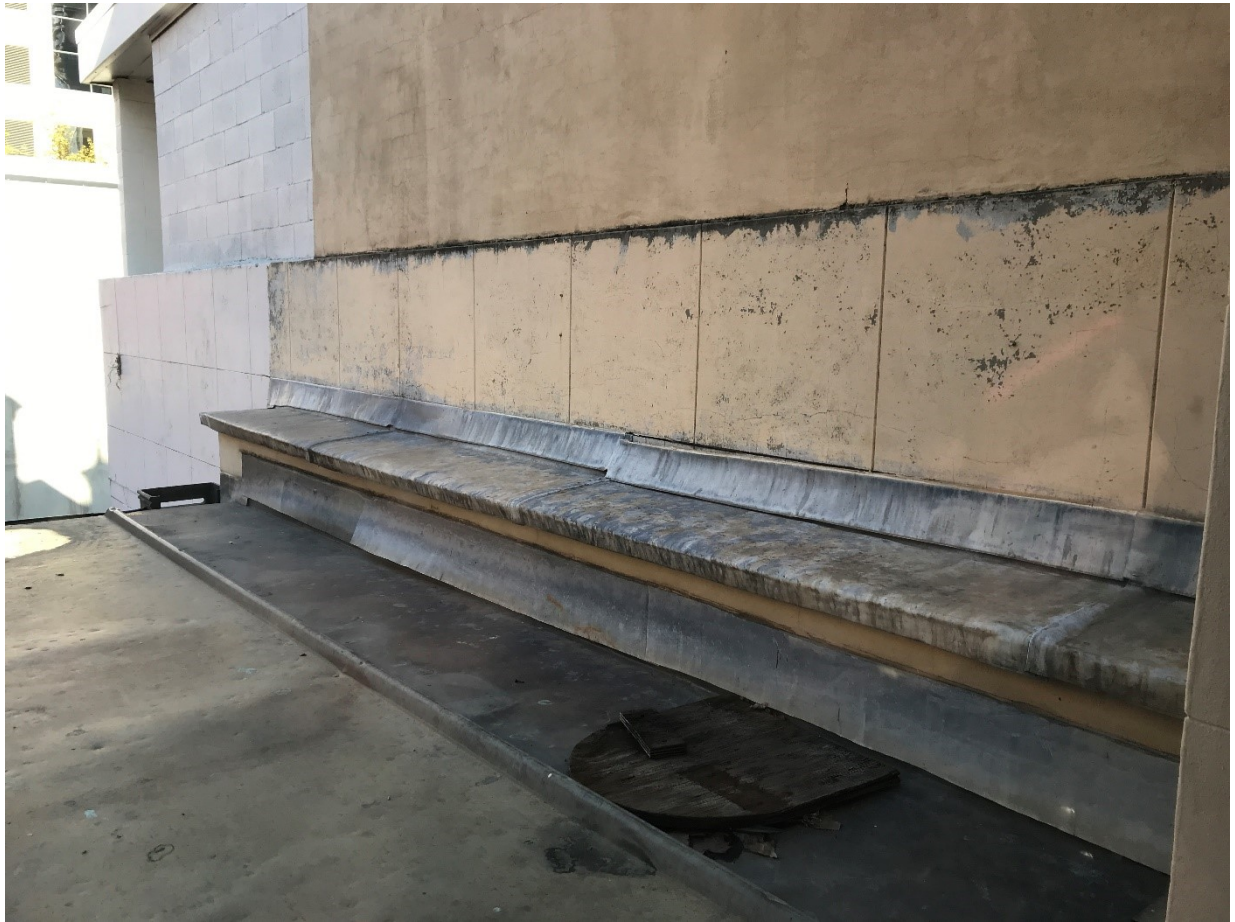
Figure7 – Apron flashing on southern boundary wall has slipped.

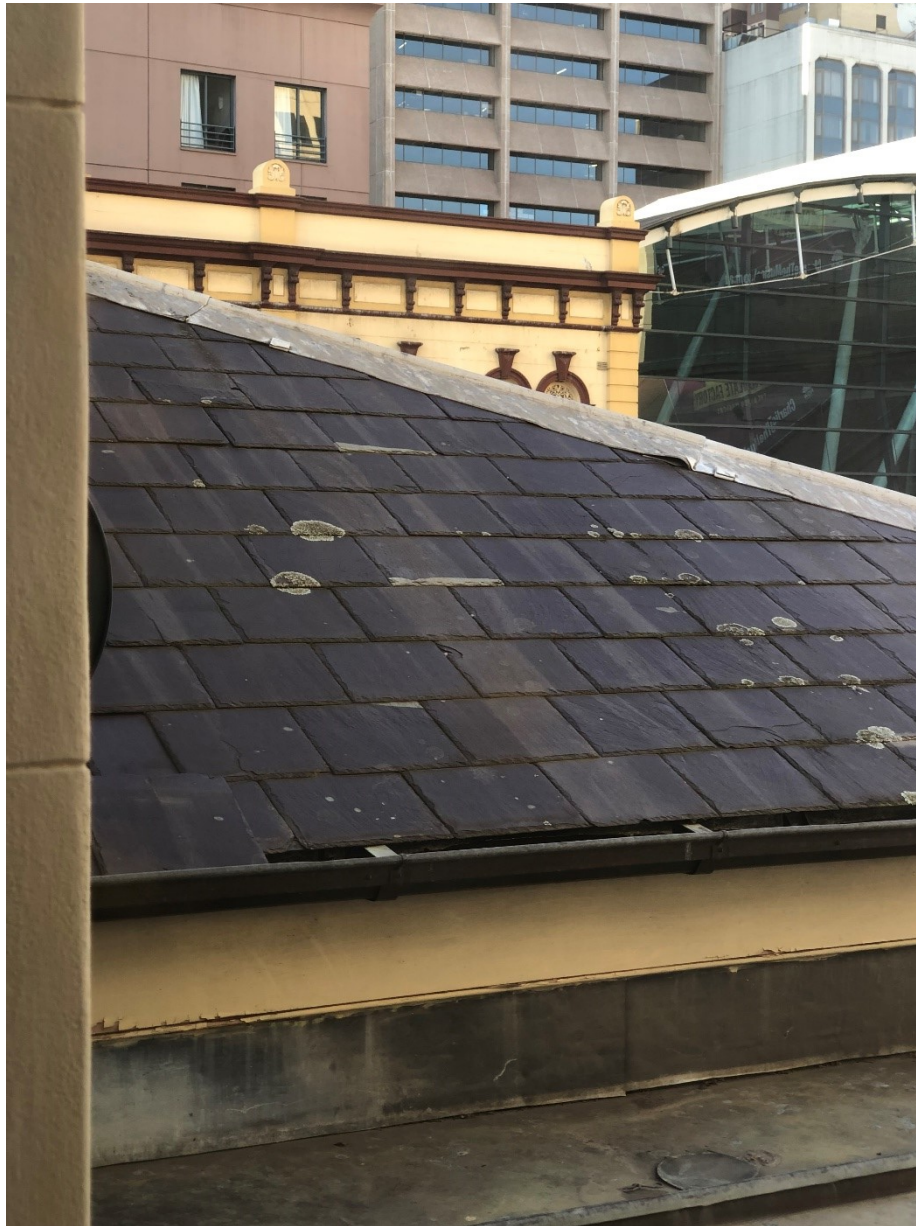
Figure 8 – Slate has slipped on veranda roof, lead hip flashing is lifting.

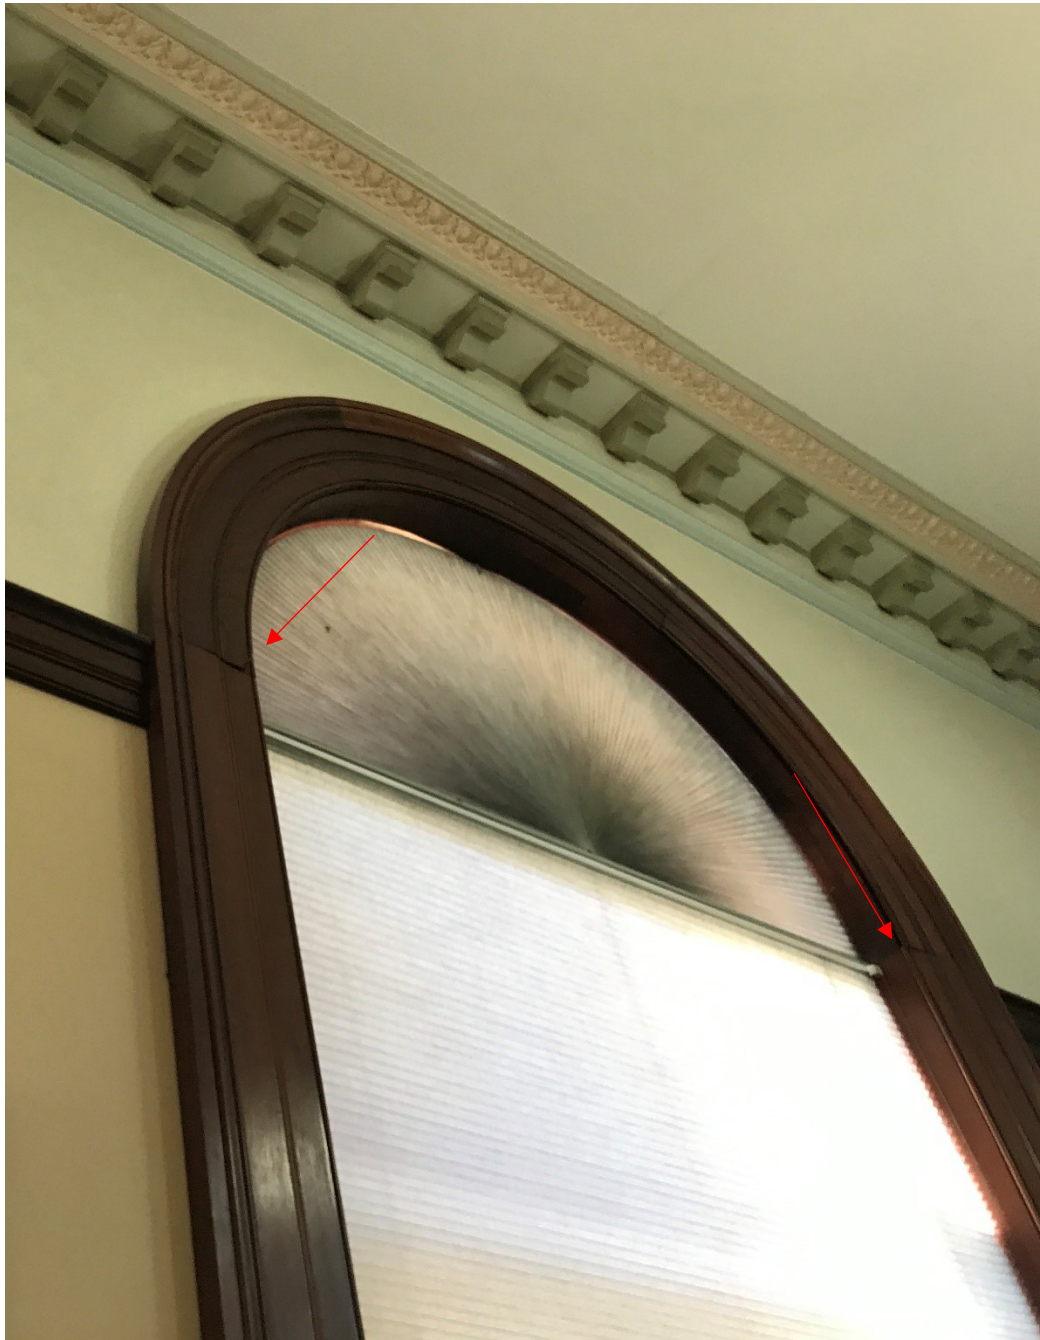
Figure 9 – Architraves misaligned where vertical meets rounded section, likely due to movement.

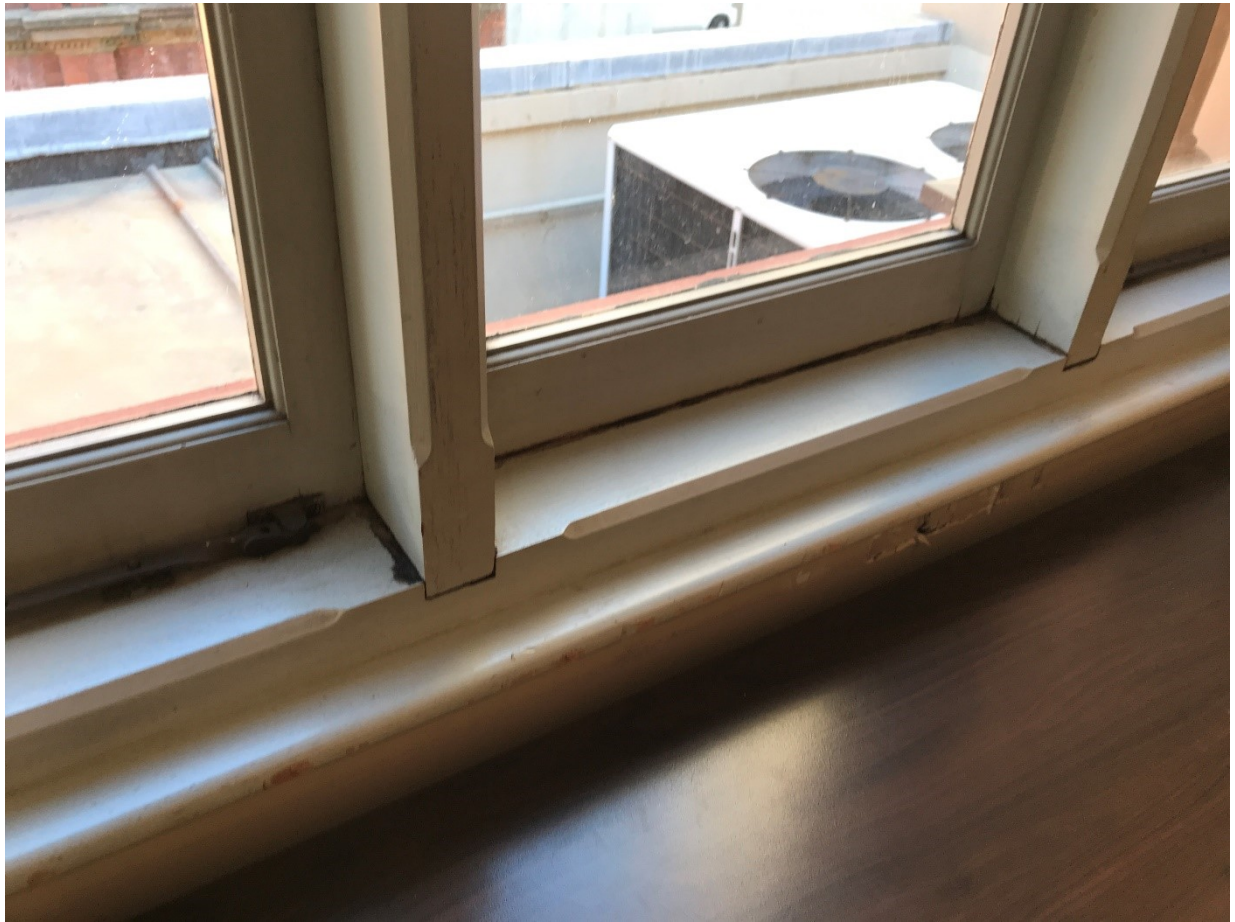
Figure 10 – Signs of leaking window sills in glazed veranda.
