**Conservation Management Plan**

**Haymarket Library**

**744-744B George Street, Haymarket  
NSW 2000**

7 DECEMBER 2018  
SH1373  
PREPARED FOR CITY OF SYDNEY COUNCIL

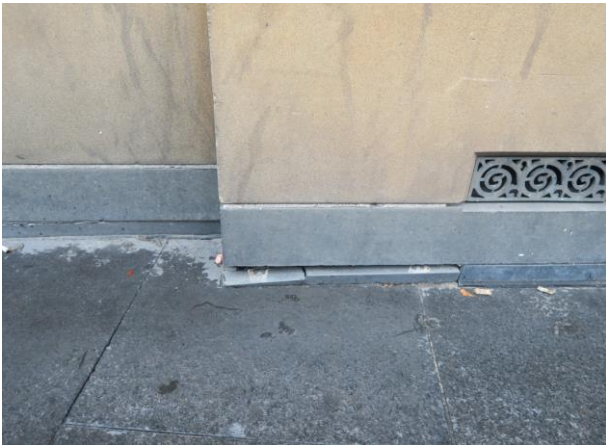
- The later addition bluestone base course to the northern façade appears to be failing.
- Possible evidence of damp to southern wall of principal building form (visible from timber frame structure) requires further investigation.
- Some internal timber window sills are loose and require refixing
- Minor cracking to coffered ceilings

Figure 27 – Failing bluestone basecourse (left image) Cracking to coffered ceiling at Ground Floor (right image).

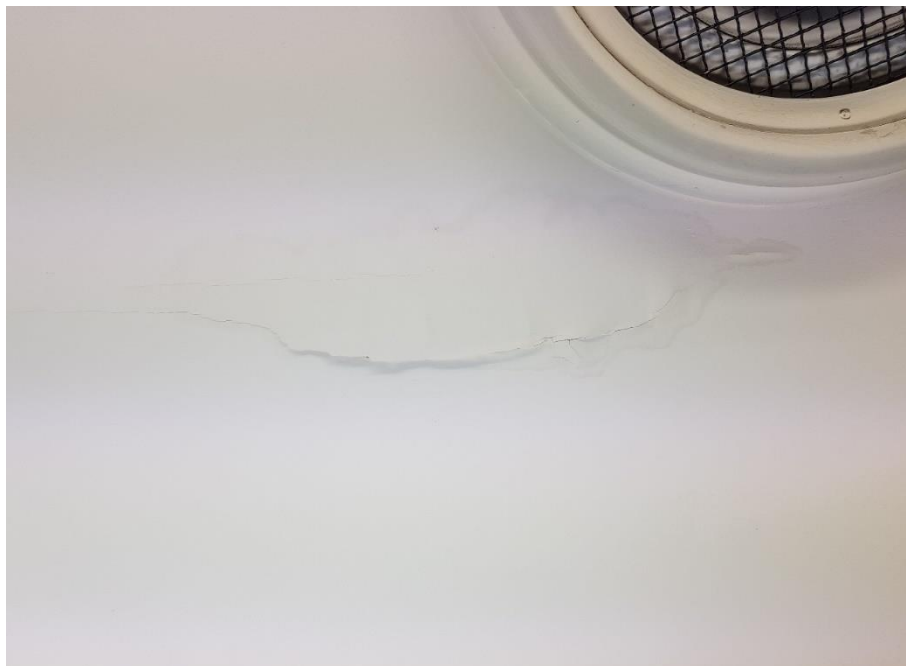
**Figure 1: Leak Through Ceiling Near Air Conditioning Vent**

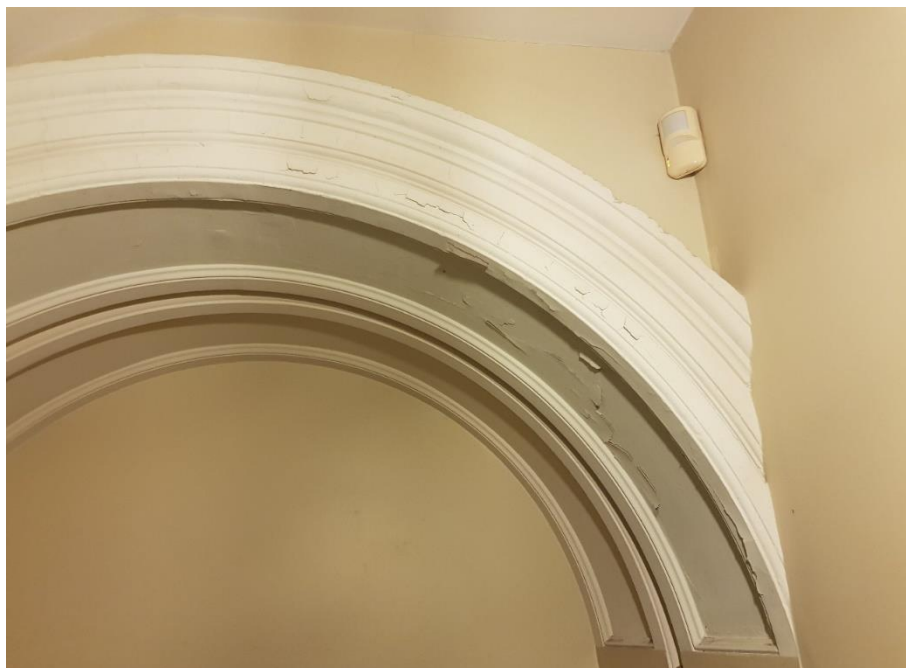
**Figure 2: Cracked Paint Around Arch, Non-Structural**

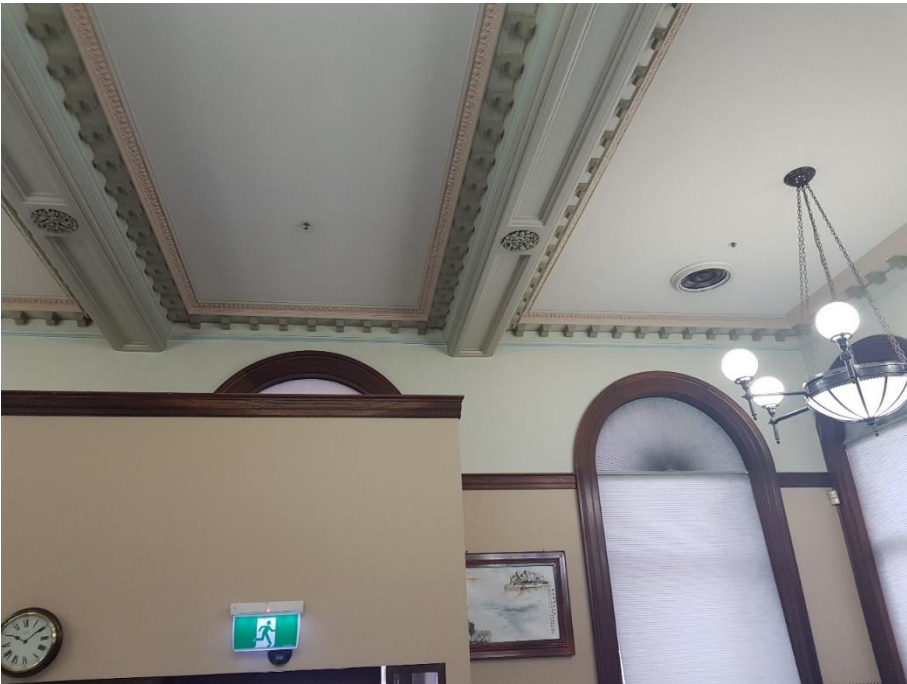
**Figure 3: Minor Vertical Crack Under Beam**

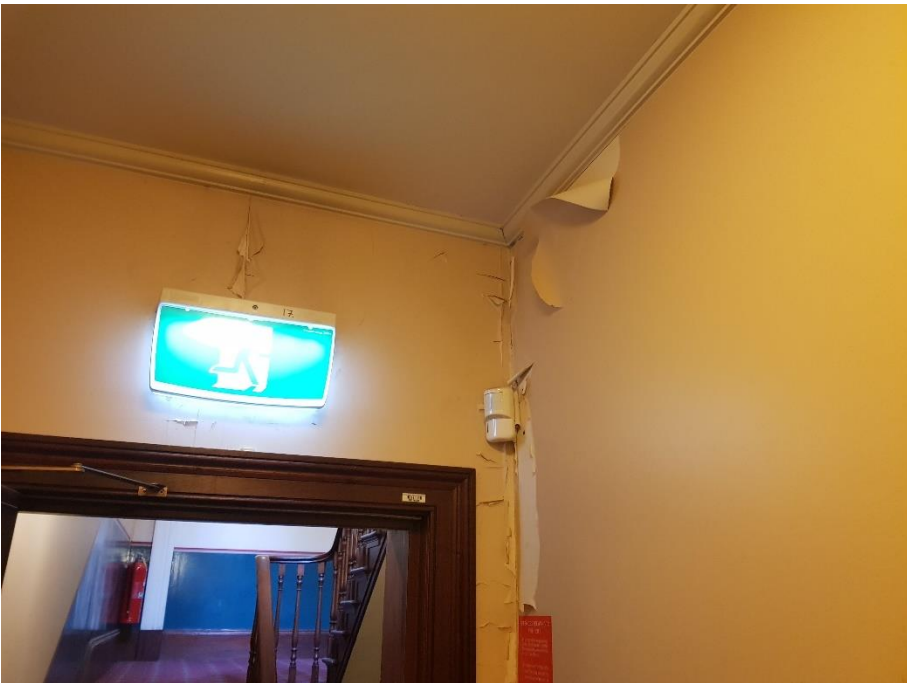
**Figure 4: Leak in Roof at Stair Landing Level**

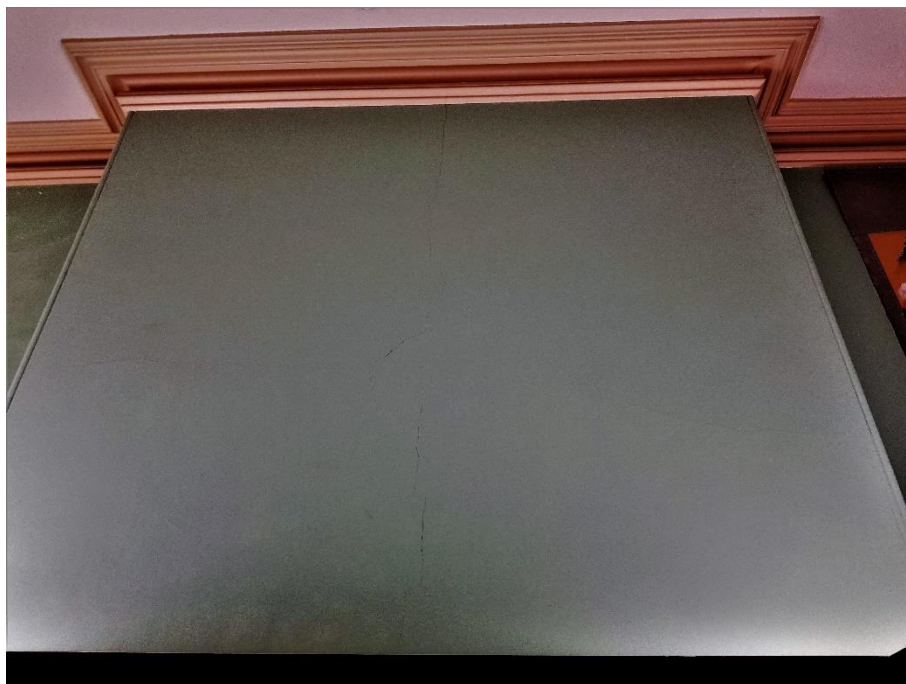
**Figure 5: Minor Cracking on Chimney Breast ~1mm**

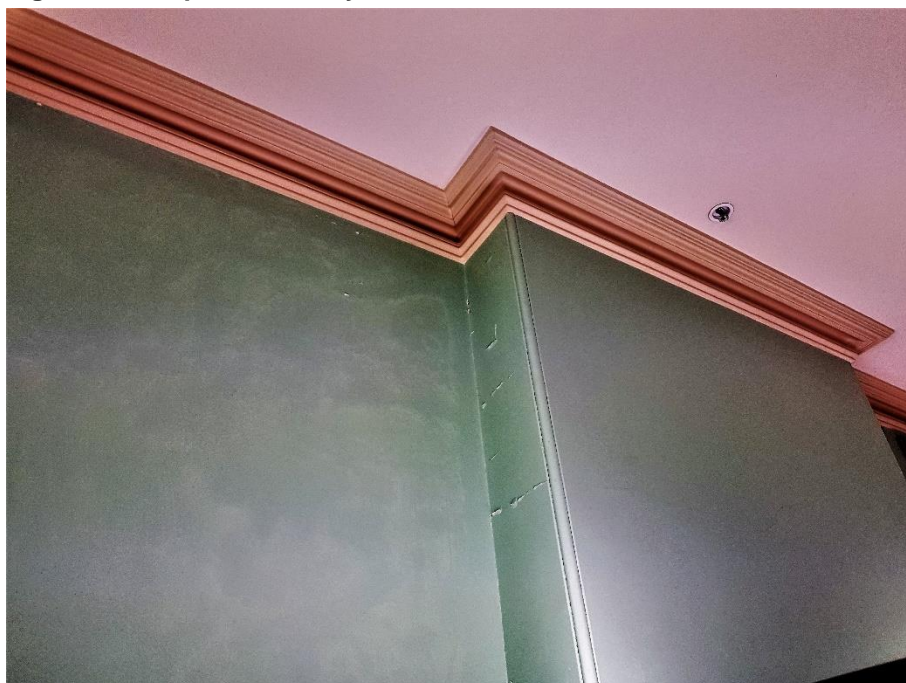
**Figure 6: Damp on Chimney Breast**
