Roof Report

Haymarket Library

**744 George Street, Haymarket NSW
2000**

29/10/2019

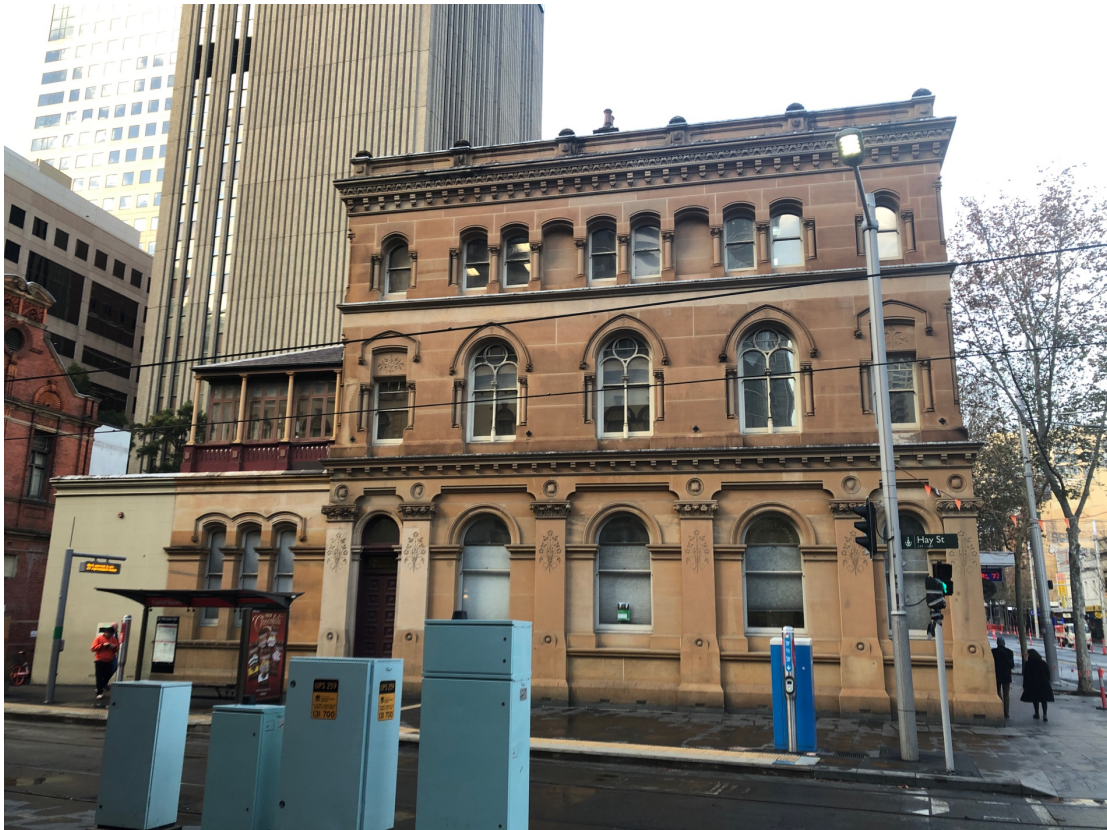
Photo 1.

- Photo 1: Haymarket Library was generally constructed of a sandstone structure and has a Welsh Penrhyn 20 x 10 slate roof, copper box gutters, copper standing seam panels on the internal side of the parapet walls and lead weathering's to the top of the South, West and Northern parapet walls, the current roof was apparently removed and replaced 20 years ago

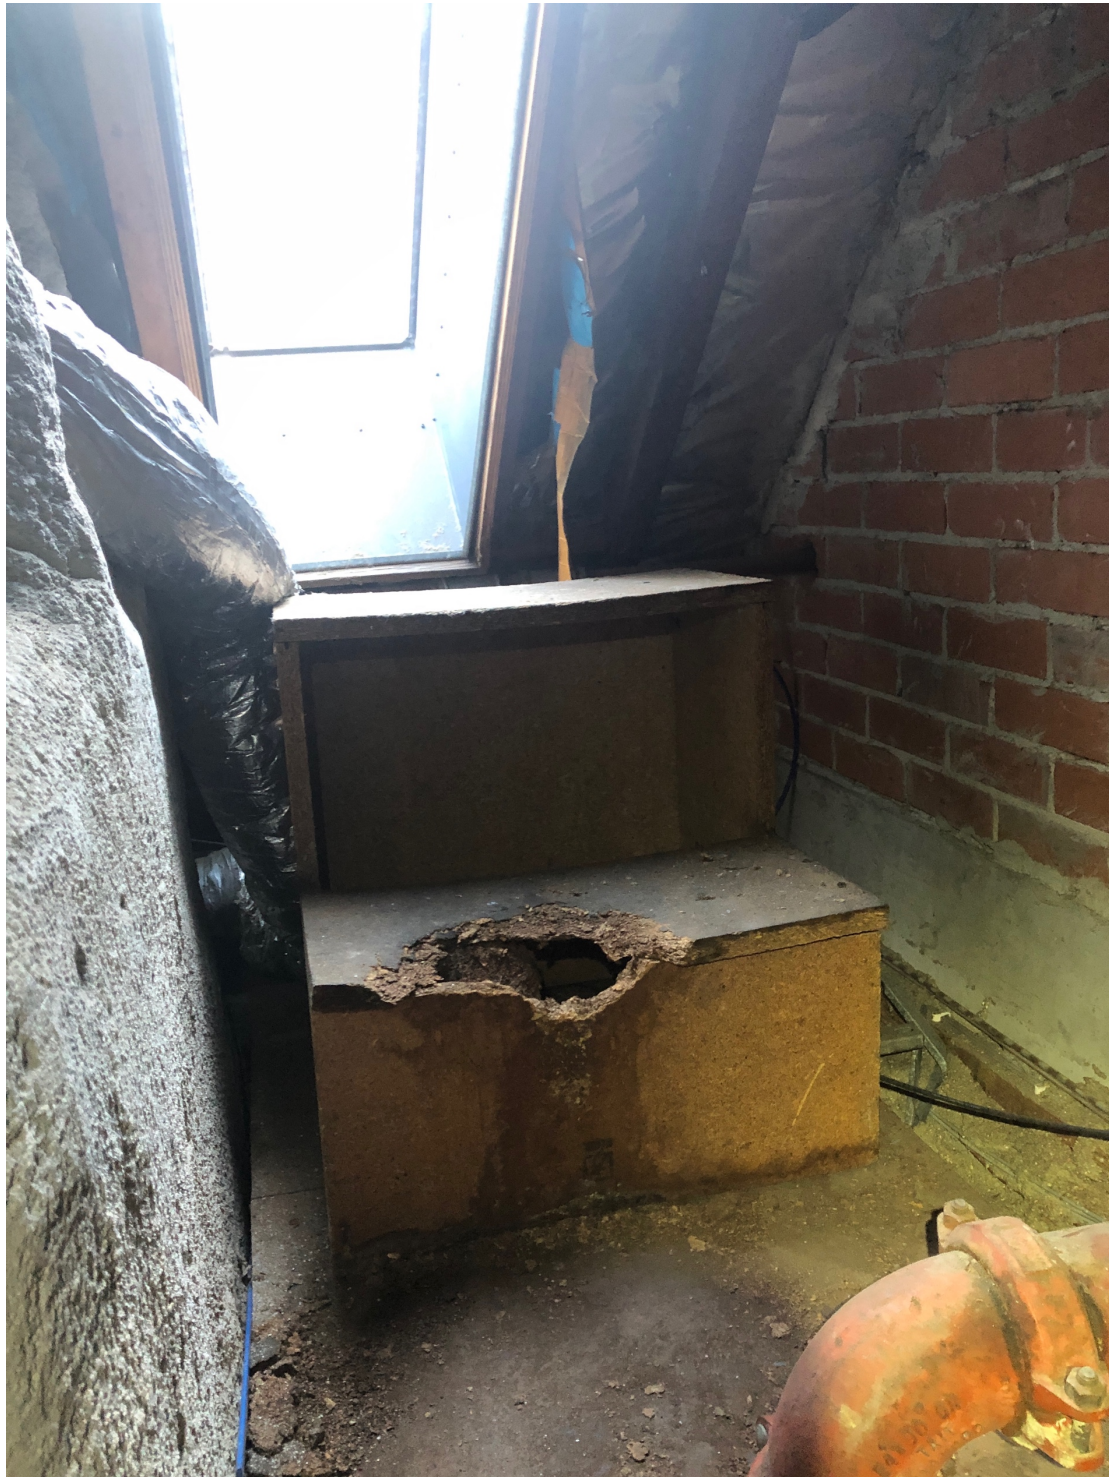
- Photo 2: Access to the roof area is gained via the ceiling manhole which is located in the stairwell of the building. This leads to the access hatch on the Northern elevation. As you can see in the photo, the chipboard steps that have been made are in a poor condition and should be replaced, possibly in aluminium. The access hatch was made of sheet metal and had a hinged side which opens to the east

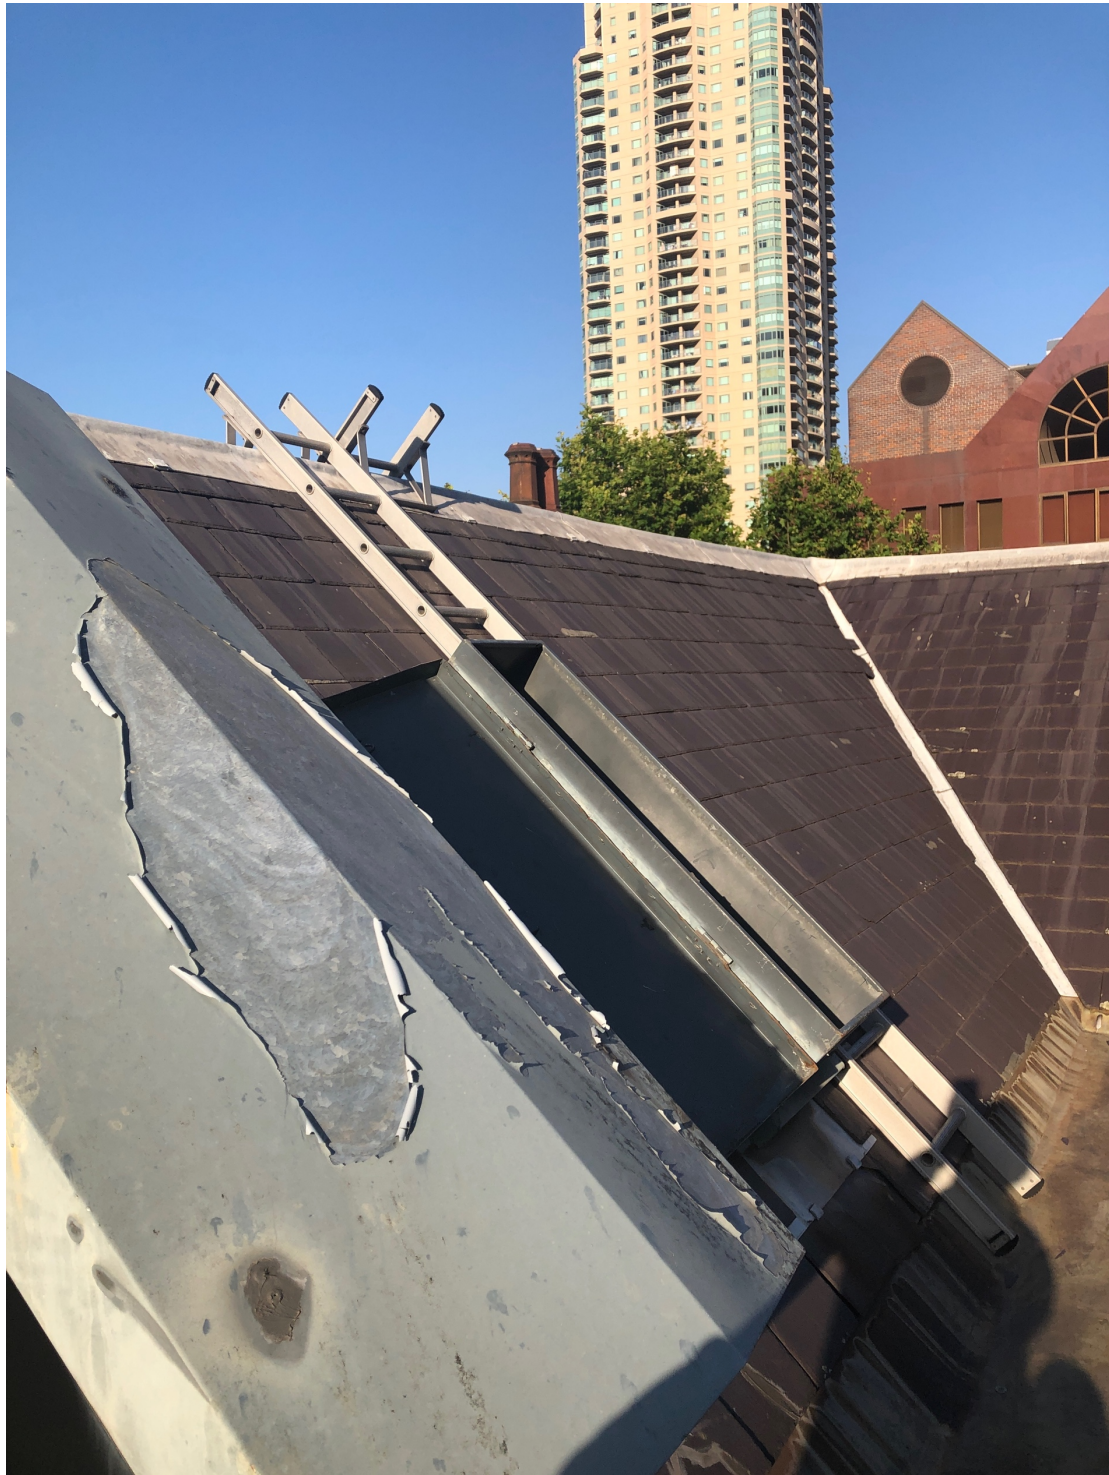
- Photo 3: Once access is gained onto the roof there are 2 x custom made aluminium ladders that take you up and over the roof into the Southern copper box gutter, this is compliant as the parapet wall in the box gutter is 1m high (noted in photo 10) the ladders seem to be in good condition

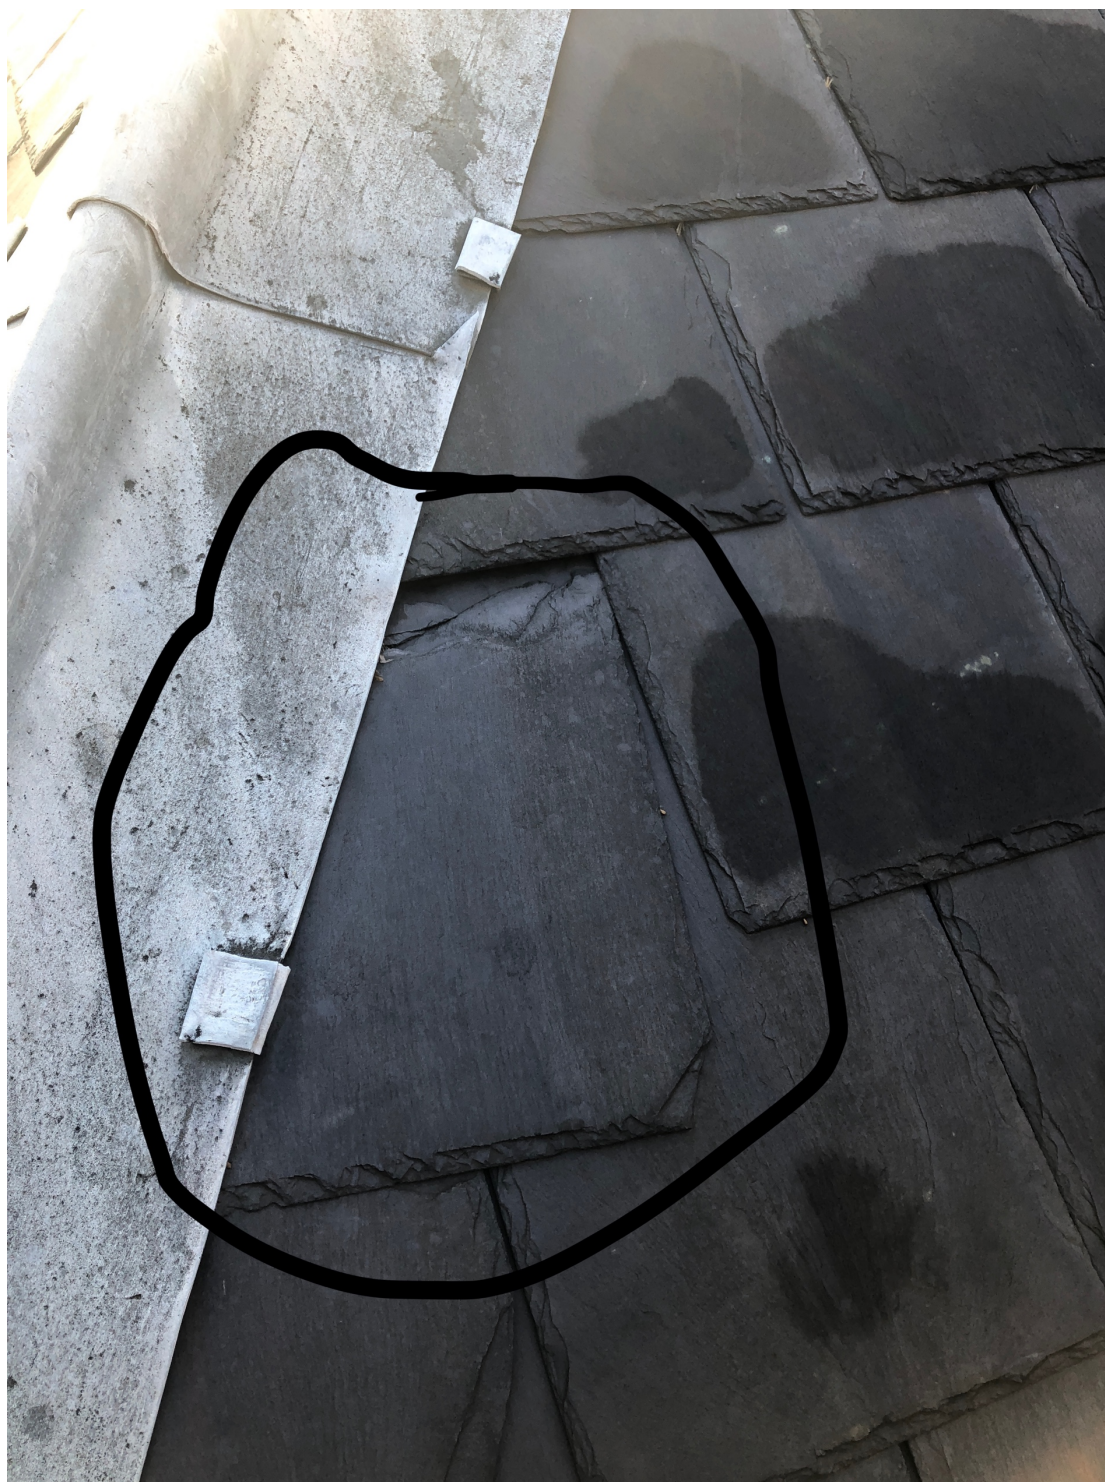
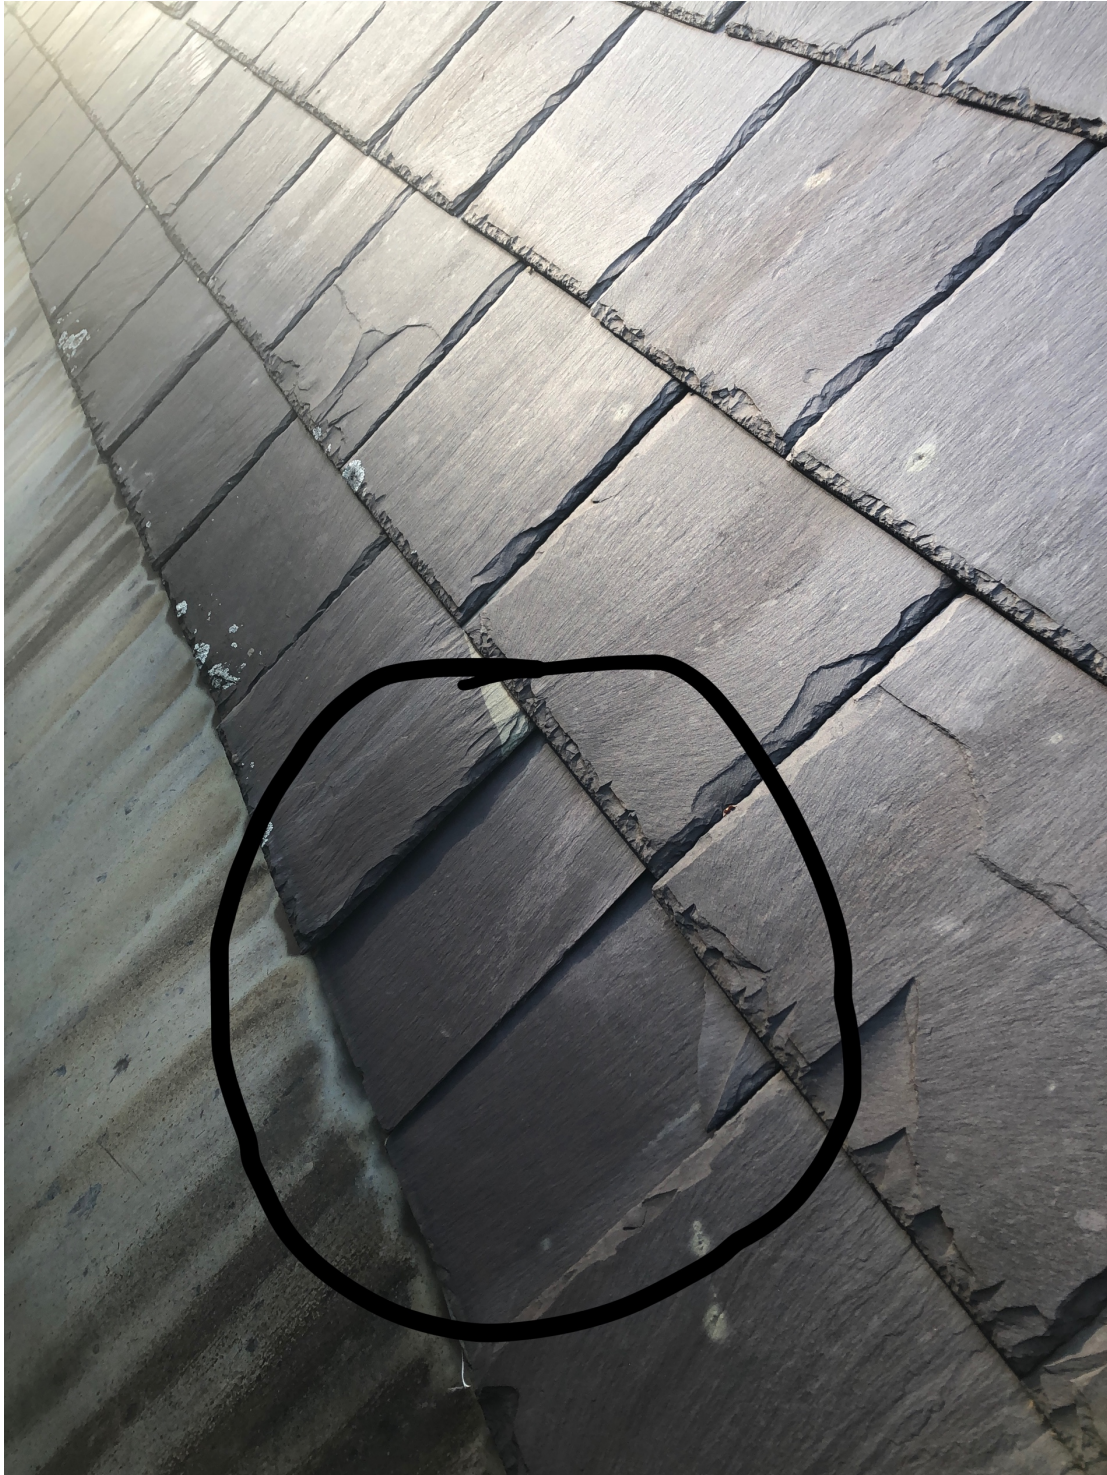
- Photo 4-5: There were a few broken slate noted on the roof, photos were not taken of all but an allowance of 30 pieces would need to be removed and replaced

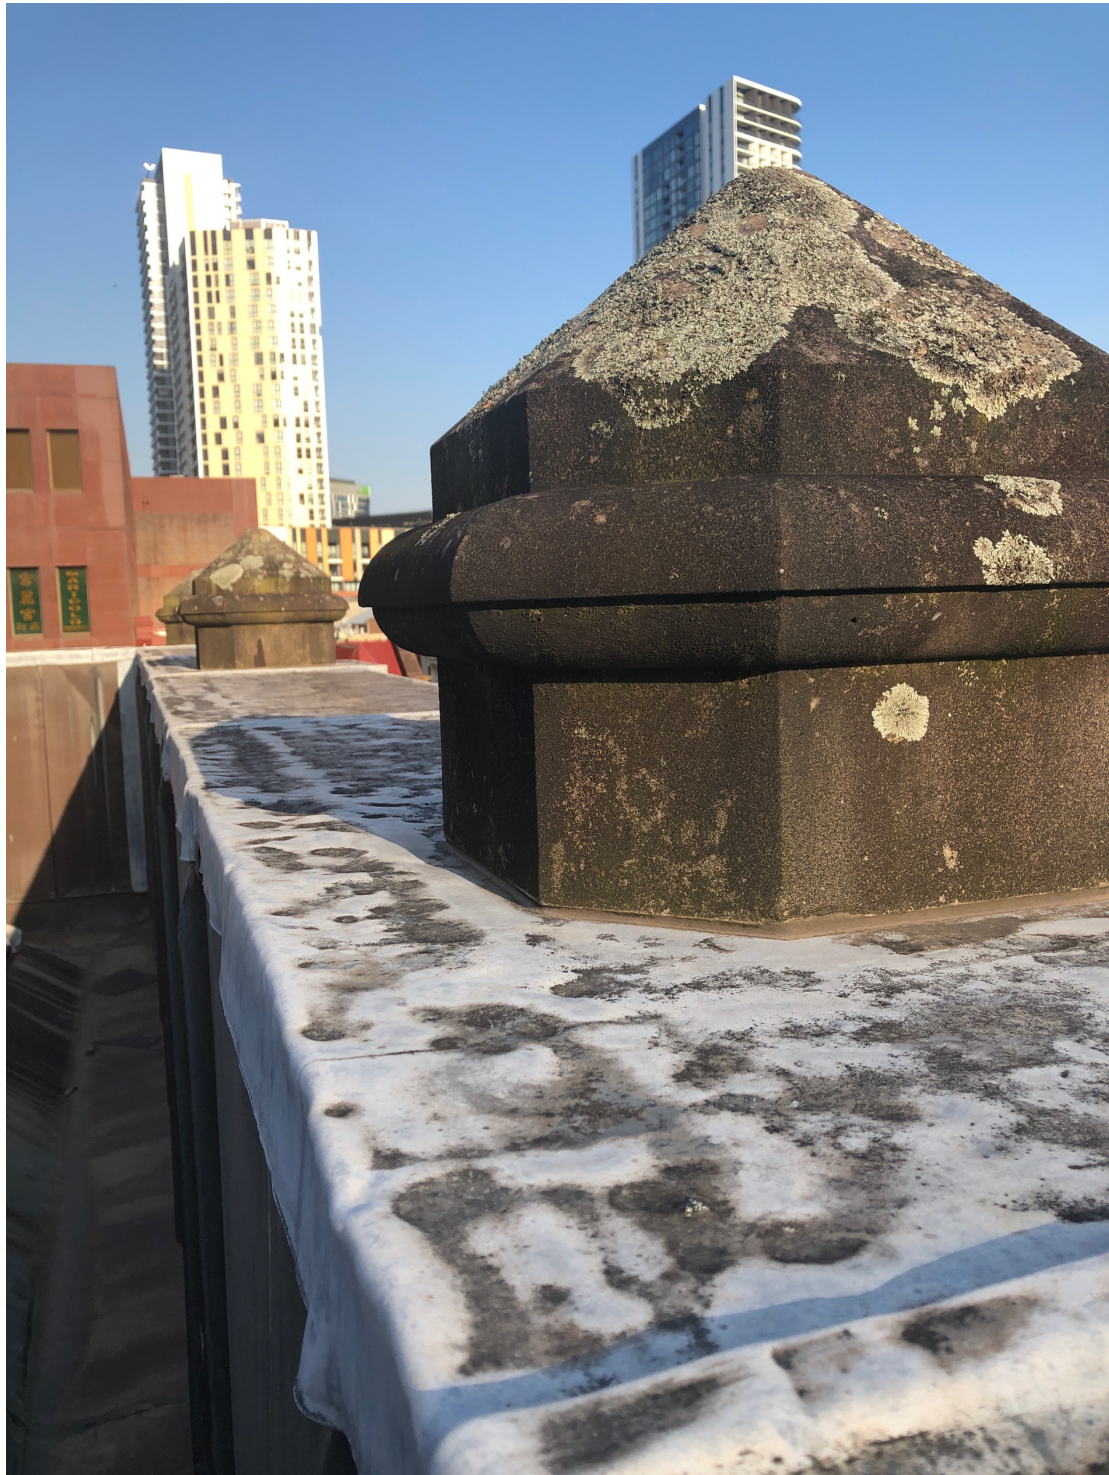
- Photo 6: 30-35 kg lead weathering's were found on all of the parapet walls, the lead was in good condition but dents were noted, presumably from a past hail storm, this wouldn't really effect the life span of the lead as the dents were very minor

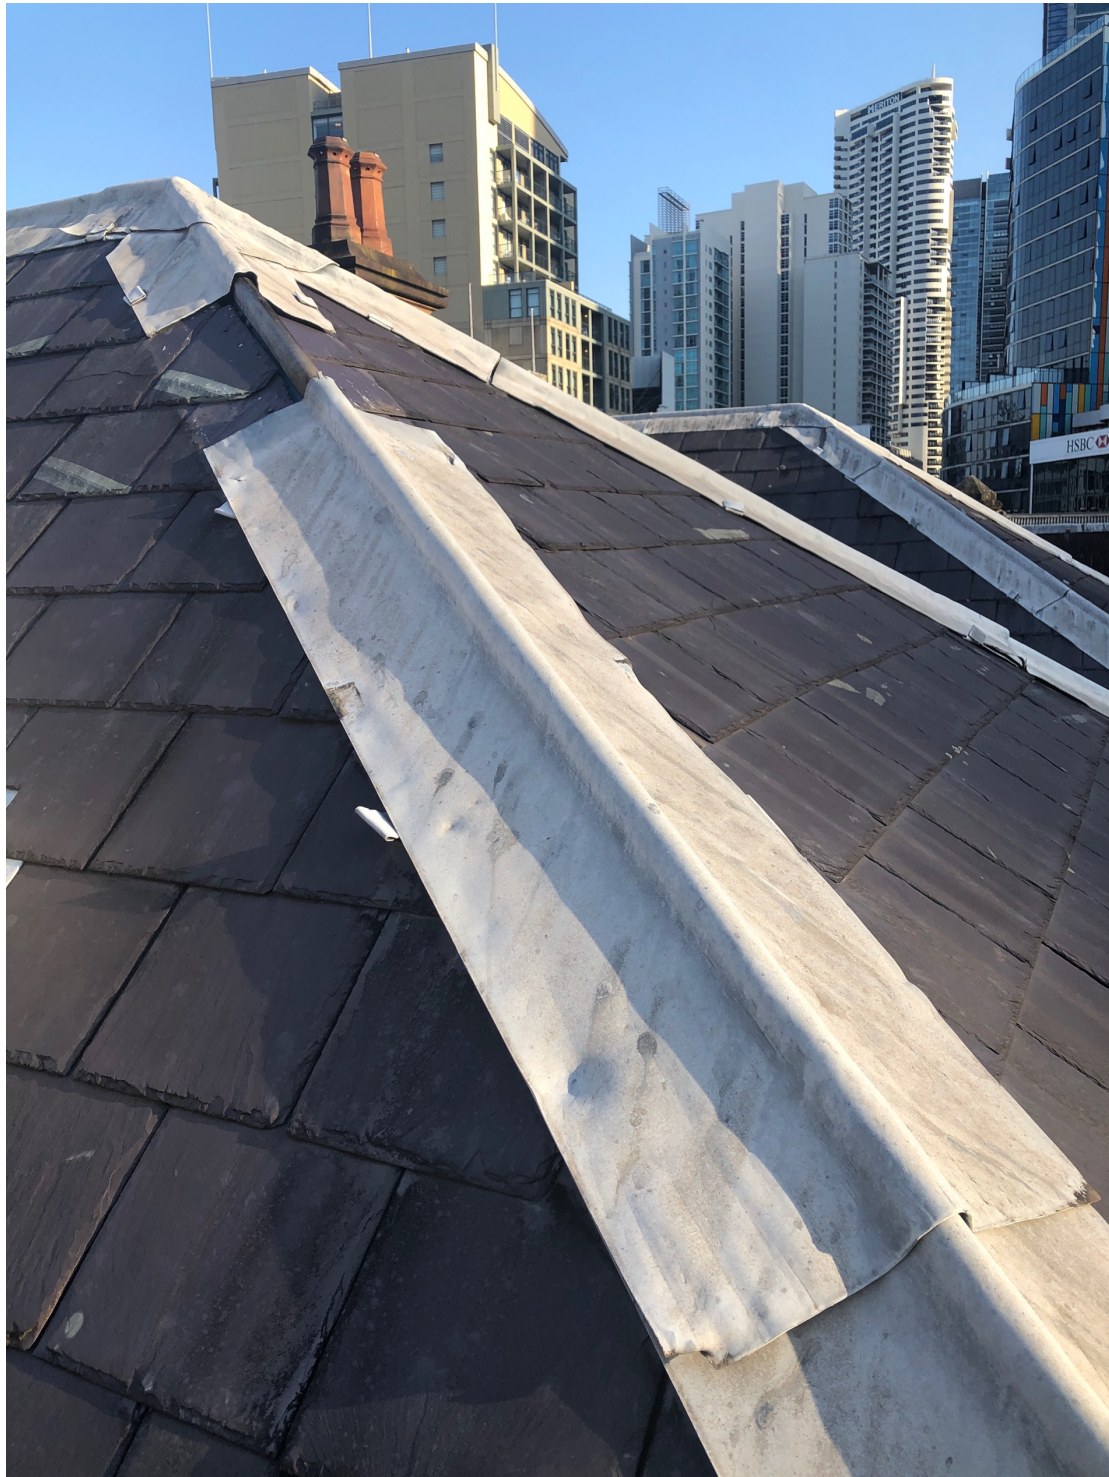
- Photo 7: On the Eastern elevation some lengths of the roll top lead was noted to have slipped down the hip, this is due to the lead not being adequately screw fixed to the timber roll on top of the hip. This would definitely be a point of water ingress but at the moment the sarking (layer of membrane used under the slate) would be shedding most of the water away, the sarking is not designed to be constantly exposed to the environment and will breakdown evidentially.

Unfortunately, the majority of the work needs to be carried out on the Eastern elevation on the hips where the lead capping’s have started to slide due to inadequate fixing methods.

To carry out any works safely on the Eastern elevation at least 2 x safety anchor points will need to be installed by a licensed installer, try RIS safety Pty Ltd. Once this has been installed we can then attach a safety harness with a rope

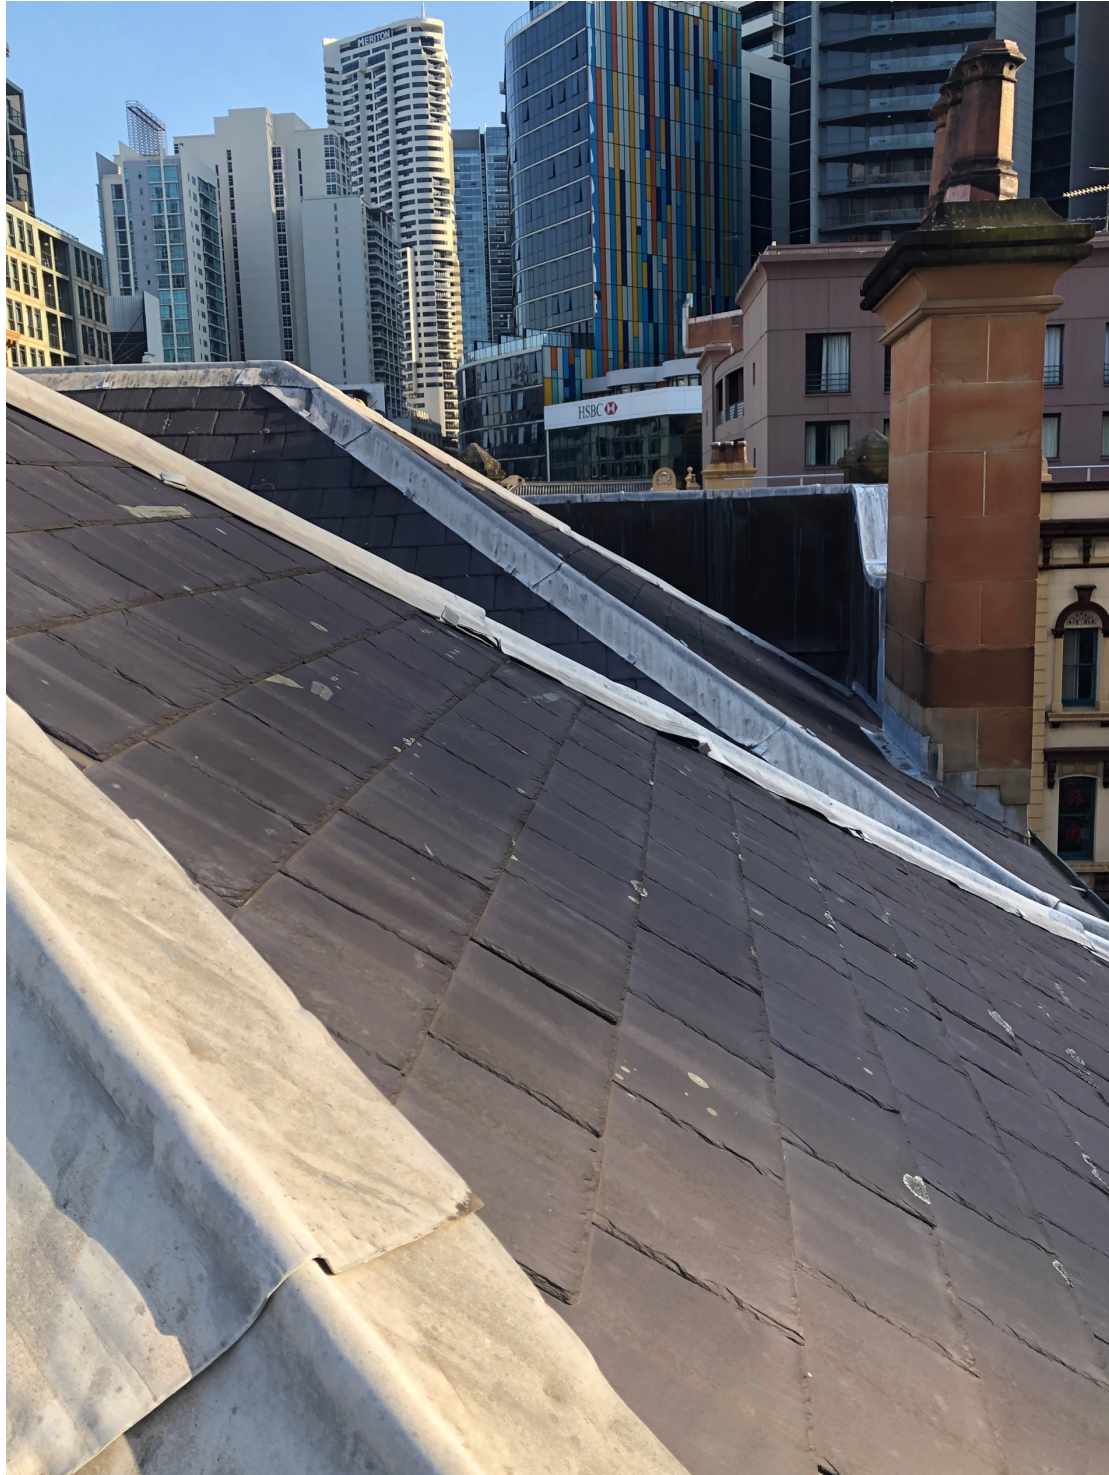
- Photo 8: Looking North East, as above, evidence of the lead roll top on the opposite hip starting to slip and needs to be refixed to prevent water ingress

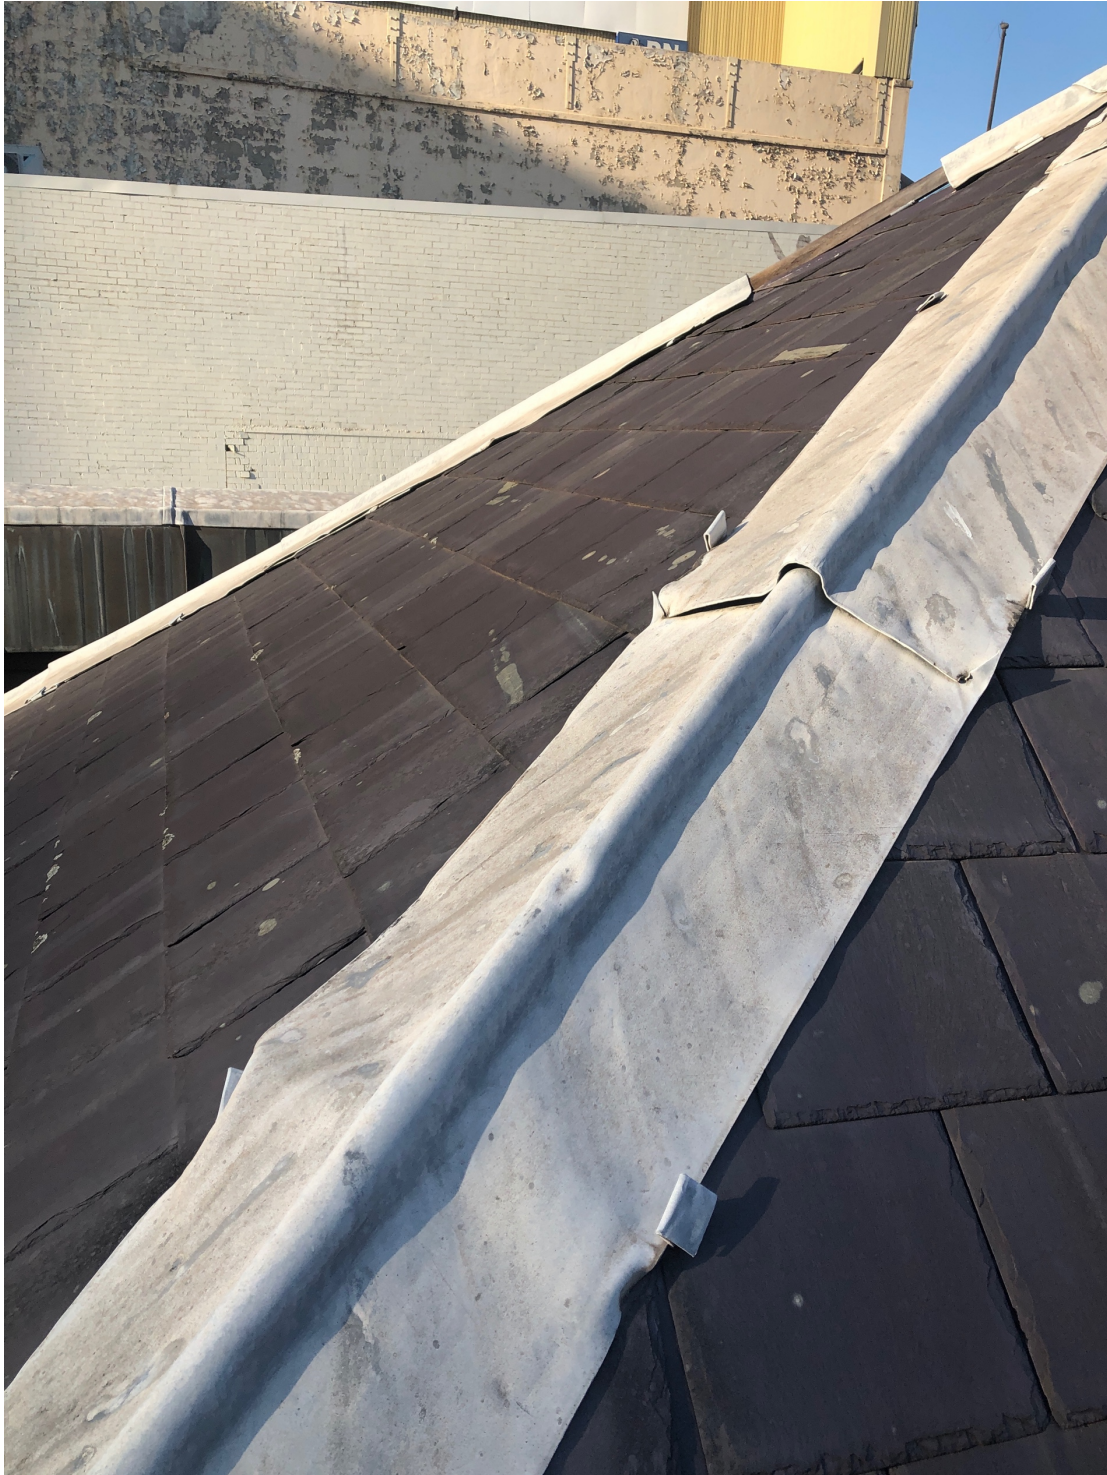
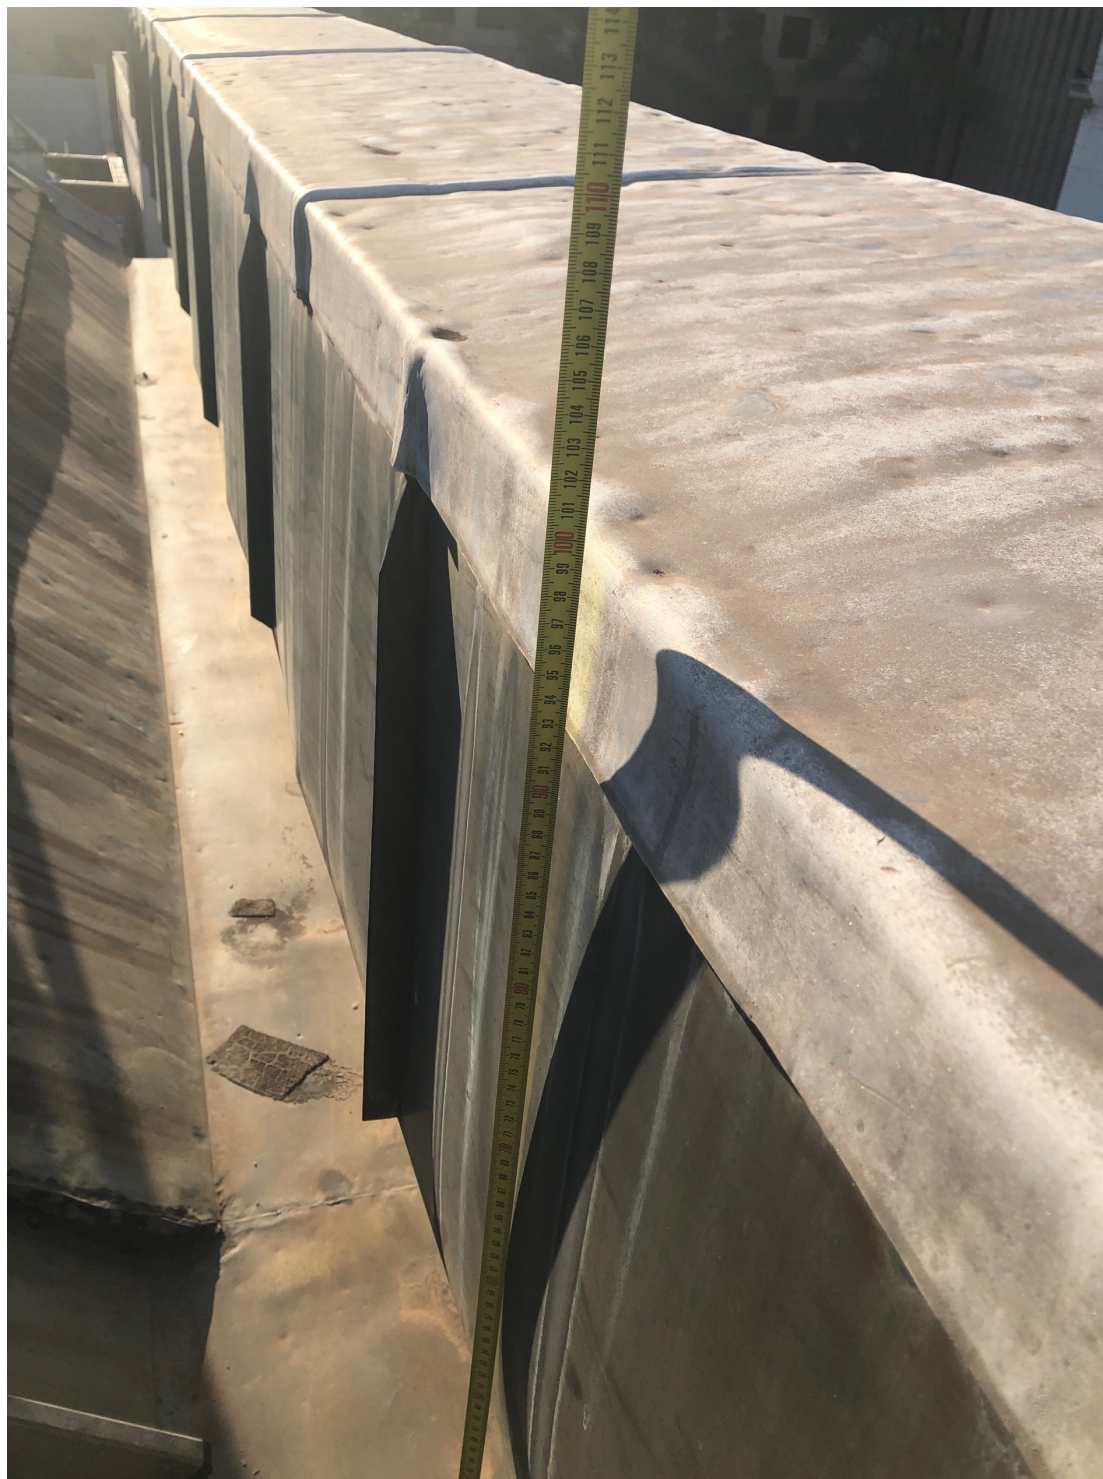
- Photo 9: As above looking South East
- Photo 10: Southern box gutter made of copper sheeting seemed to be in good condition, a little debris needs to be cleaned out but generally the water was free to run. The internal sides of all the parapet walls were made up of copper standing seam sheets which were in a good condition and as noted before 30-35 kg lead weathering's on the top of the parapet walls.

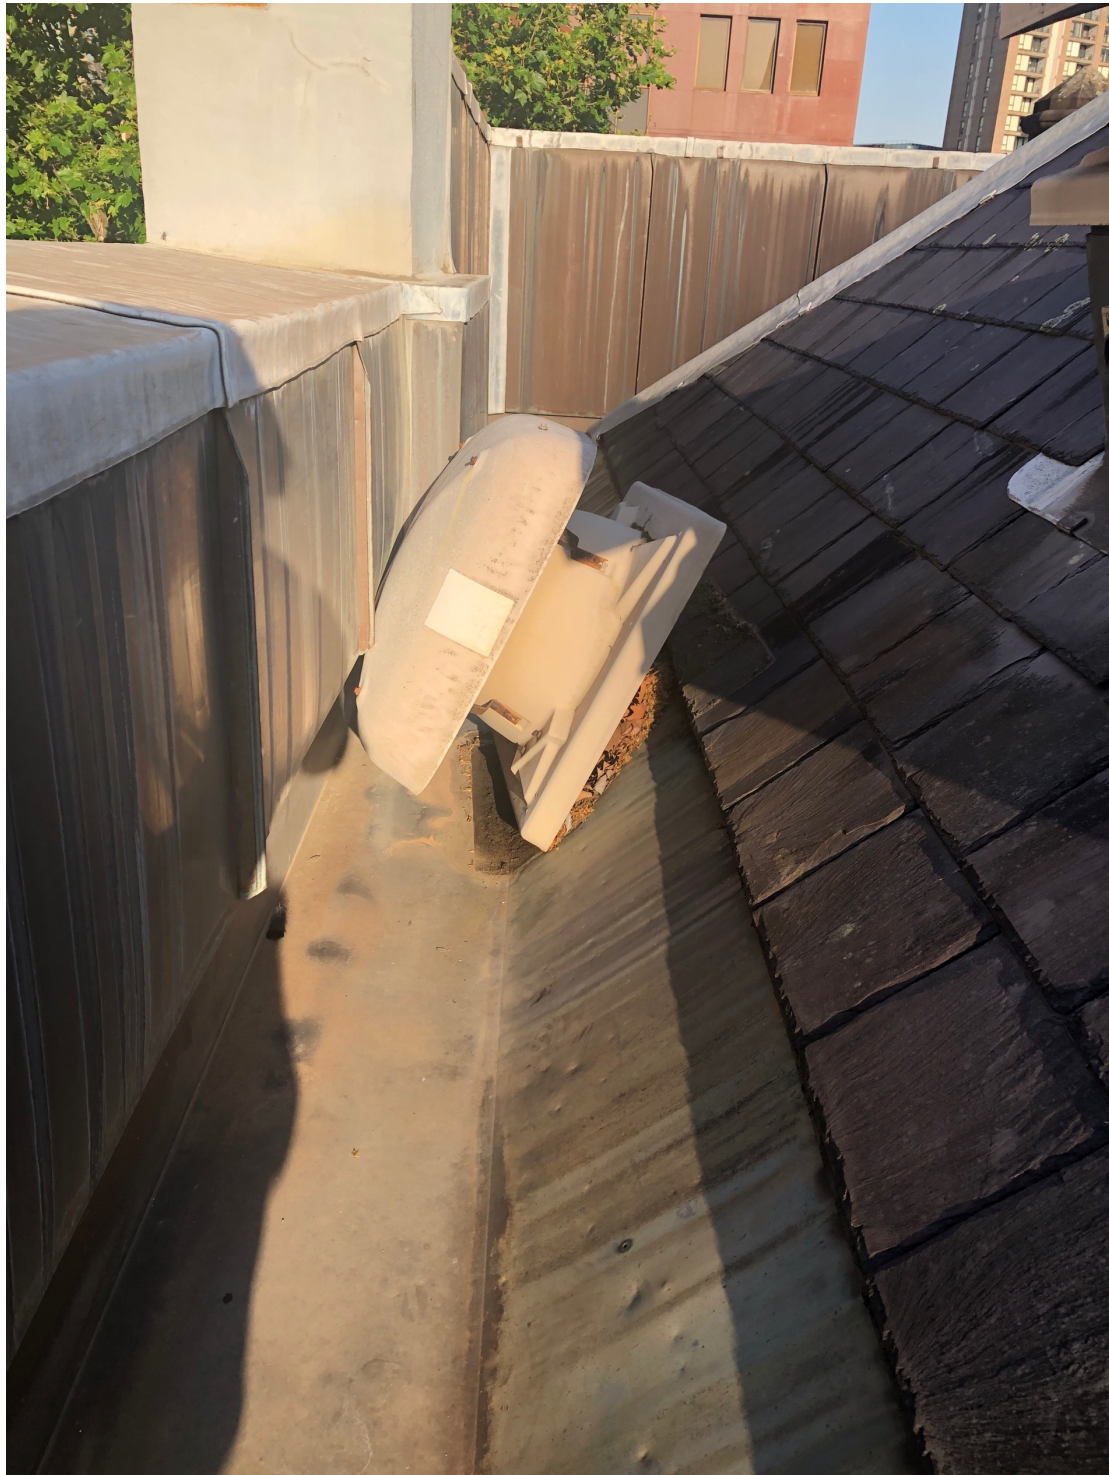
- Photo 11: The Southern box gutter looking West had a redundant Air Con hood left in it which was preventing the water flow in the box gutter. I presume it wasn't removed from the roof when it was replaced as it wouldn't fit through the access hatch, this needs to be cut up and removed from the roof

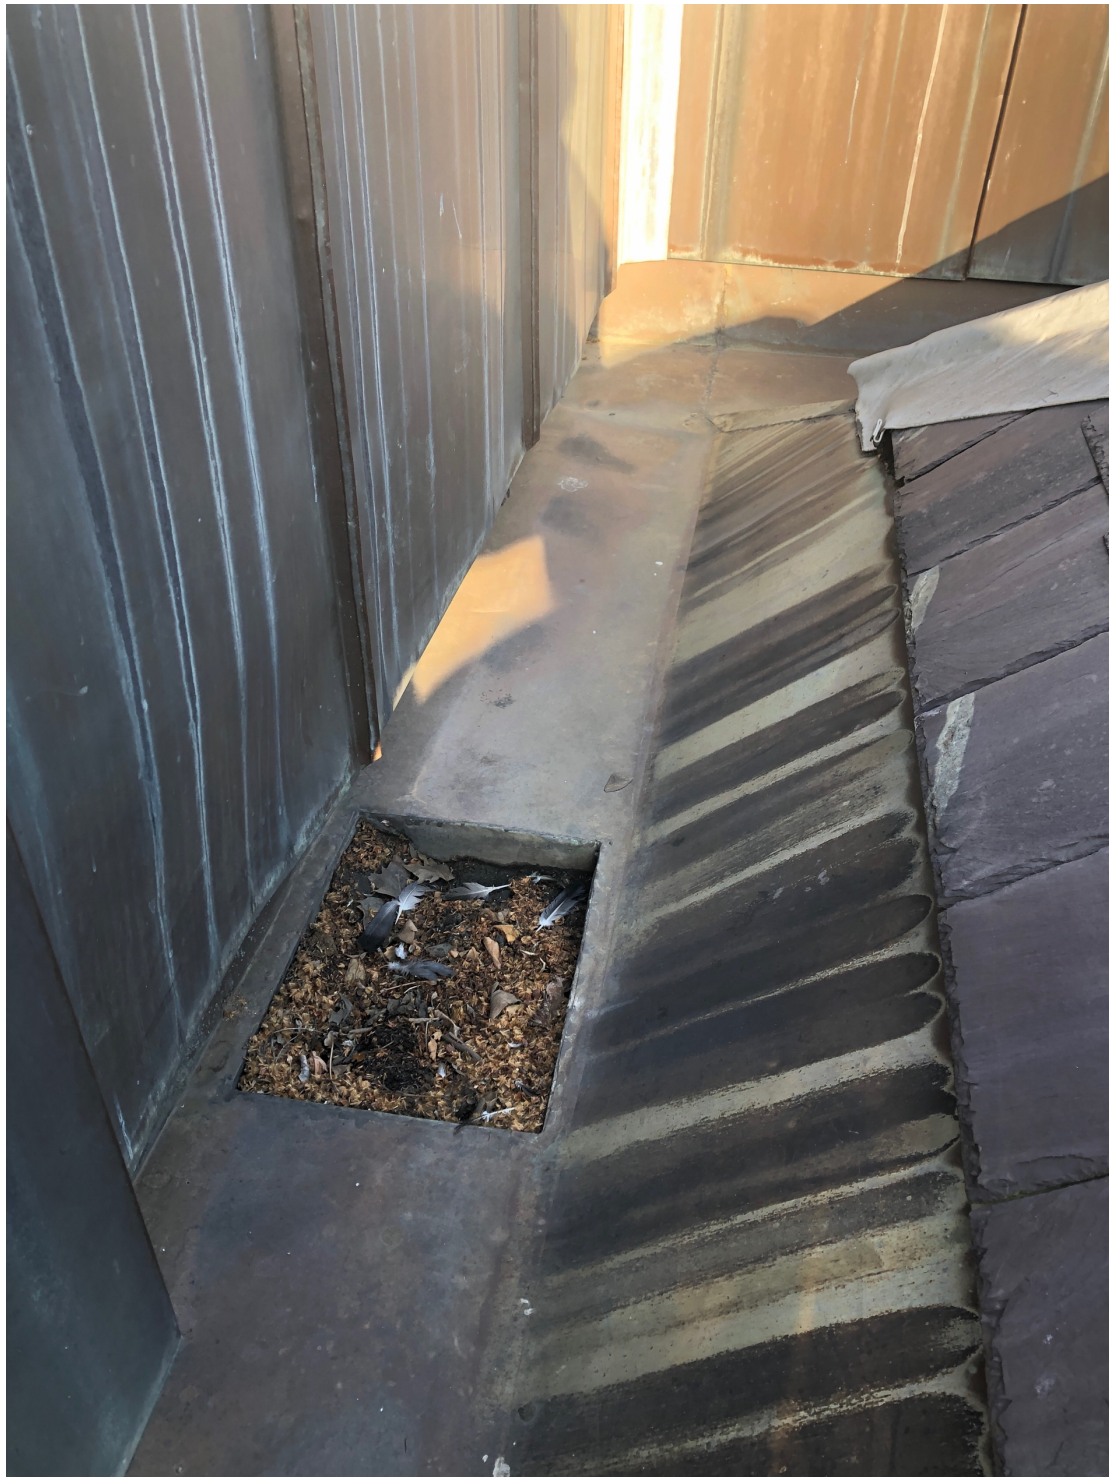
- Photo 12: Also the Southern box gutter looking West has a sump installed in the box gutter which was completely blocked with leaf debris. This needs cleaning out and a copper leaf guard box installed over to prevent leaves and debris from future blockages. The Eastern end also has a Rain Water Head that was blocked with leaves but luckily there was an overflow which prevented the water back flowing into the building

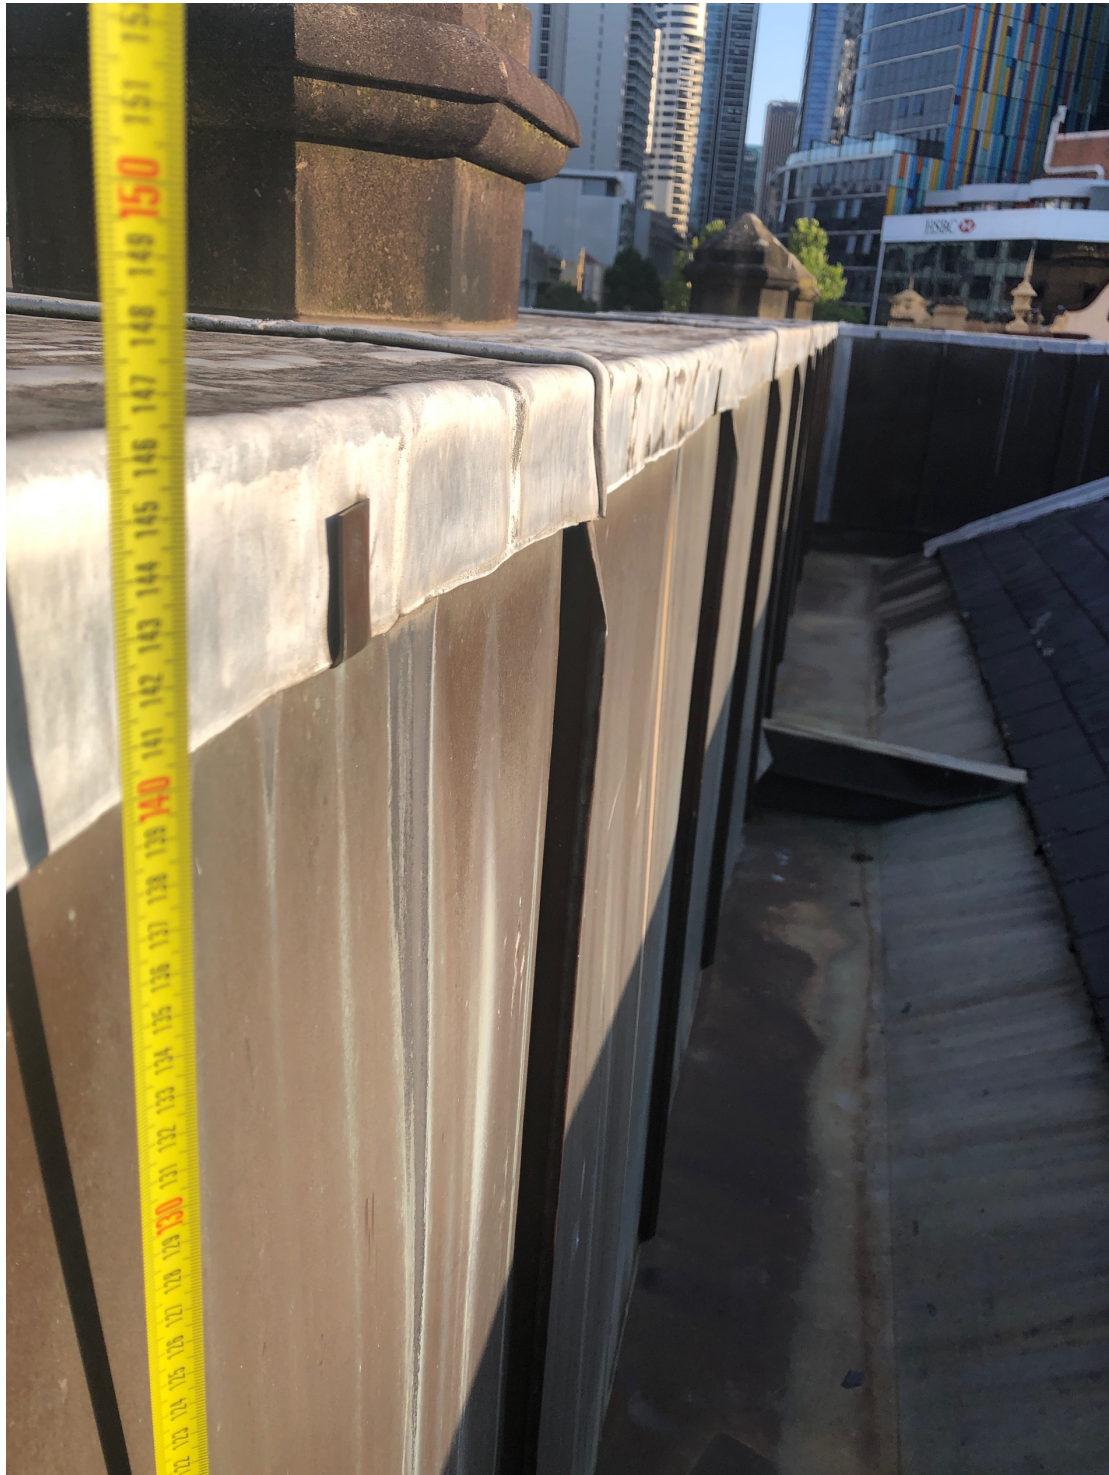
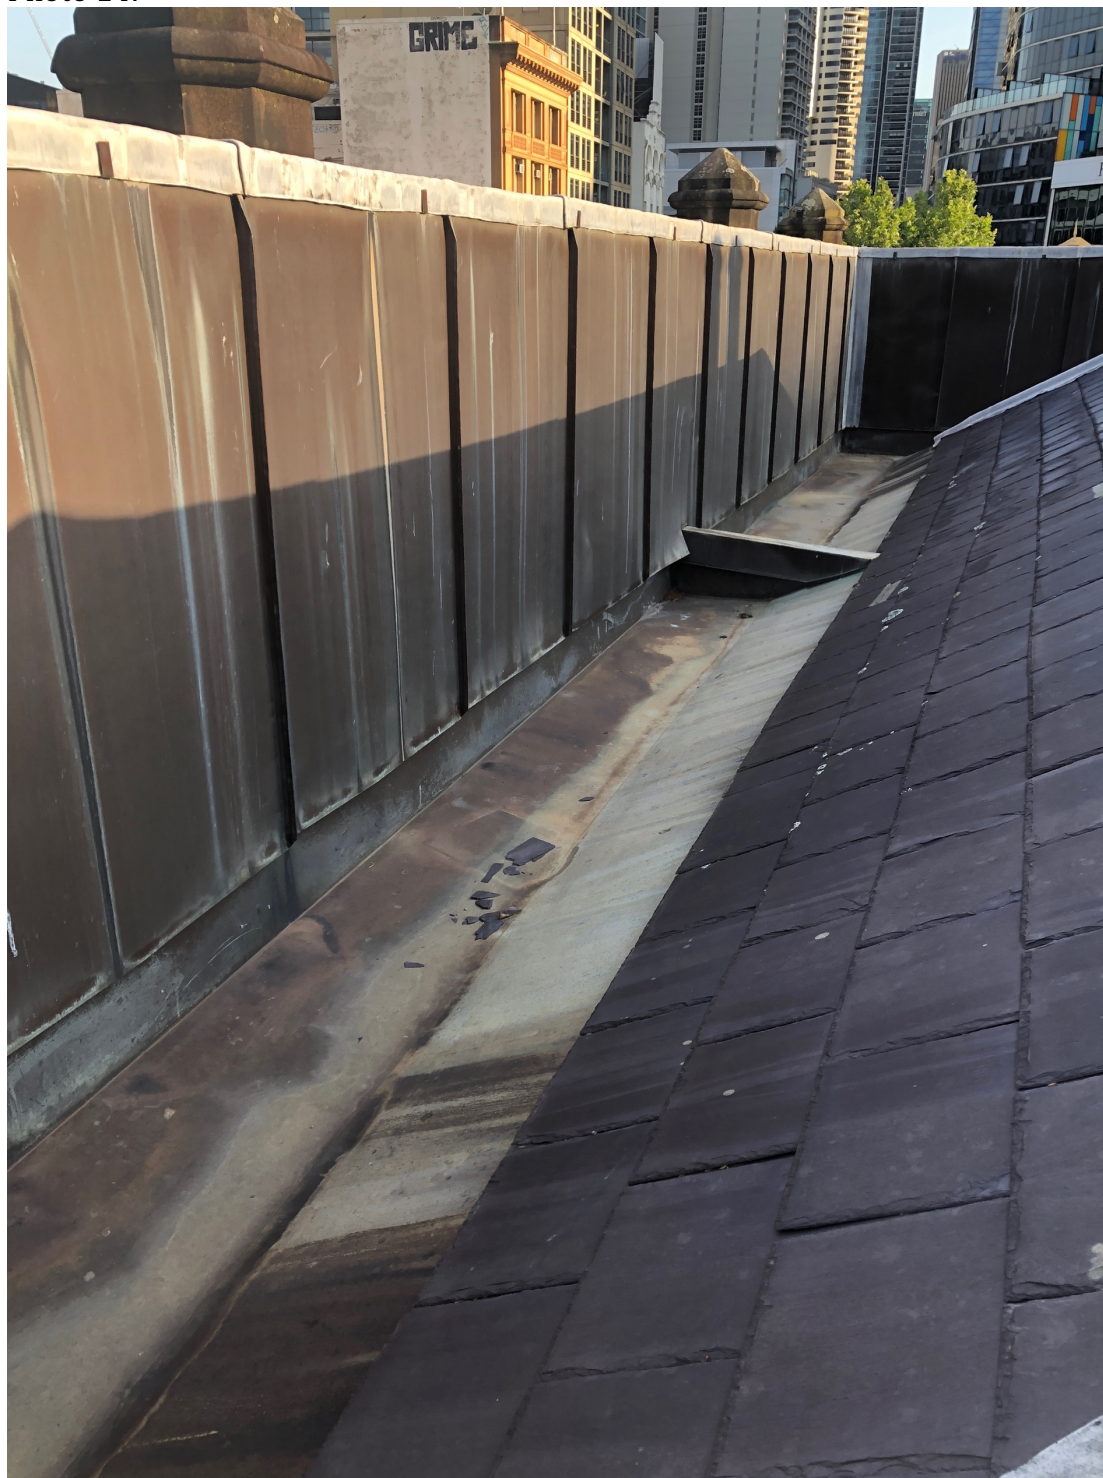
- Photo 13-14: The Western side box gutter seemed to be in good condition, a little debris, mainly off cuts of broken slate needs to be cleaned out but generally the water was free to run. The internal sides of all the parapet walls were made up of copper standing seam sheets which were in a good condition and as noted before 30-35 kg lead weathering's on the top of the parapet walls. The parapet walls were just under 1.5m in height
