Roof Report

Haymarket Library

**744 George Street, Haymarket NSW
2000**

29/10/2019

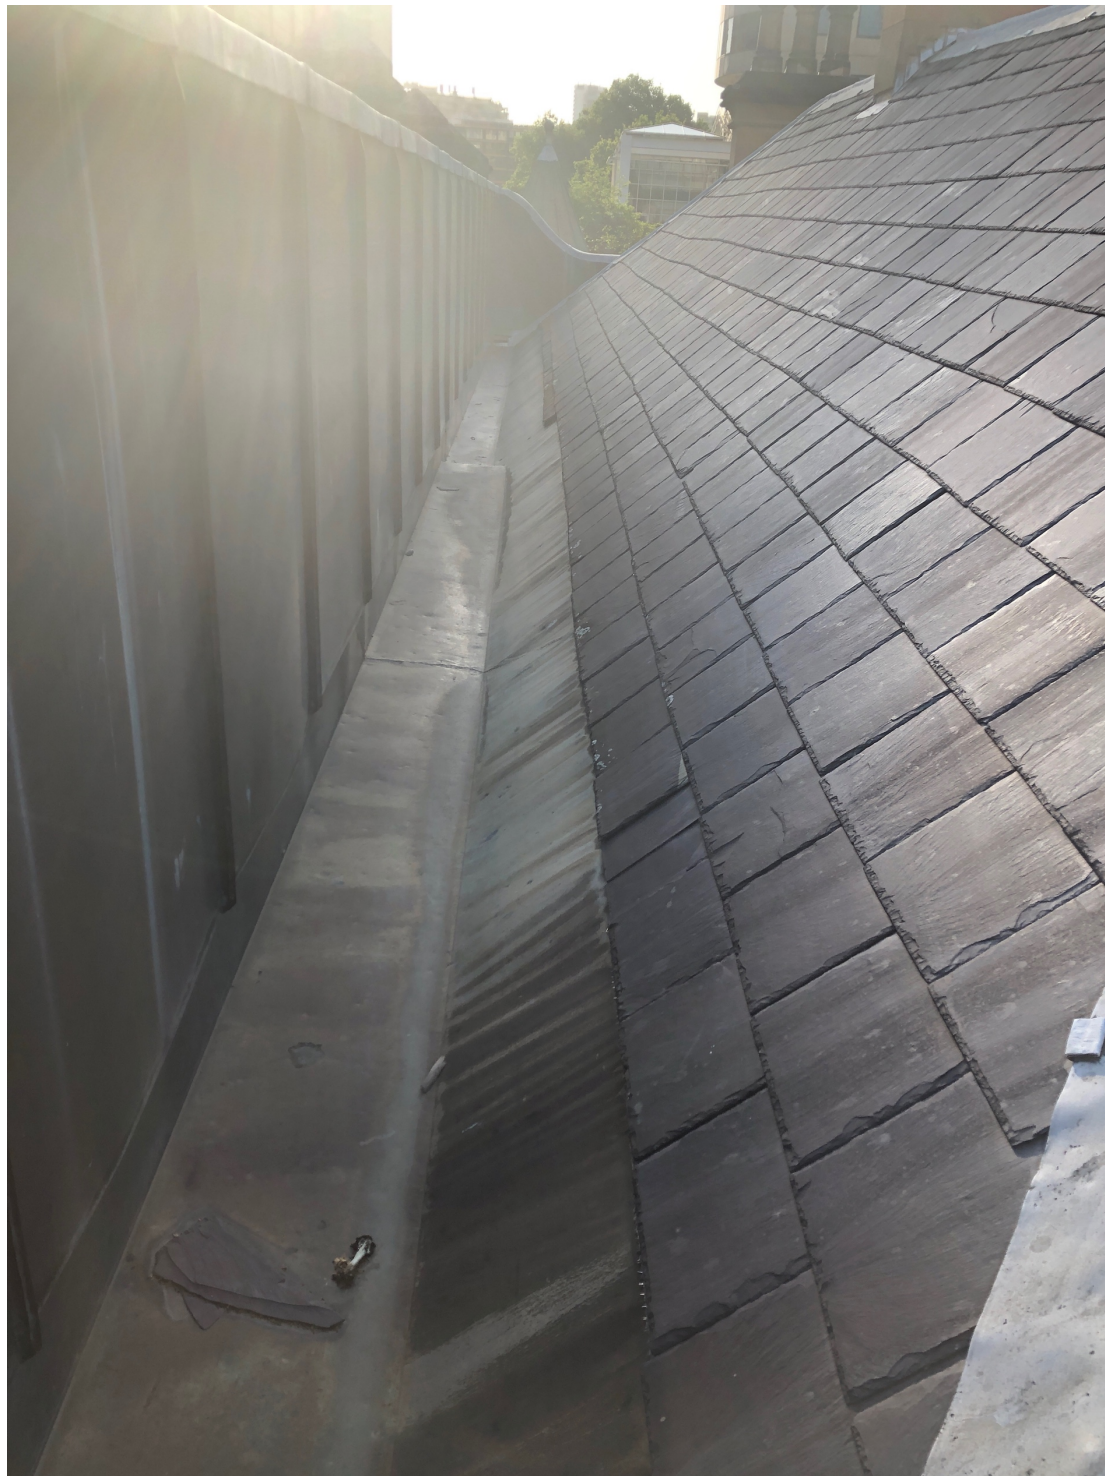
- Photo 15: As the above, the Northern box gutter was identical to the explanation noted on the Western box gutter
