**Capitol Theatre Condition Assessment
prepared by Mott MacDonald Australia Pty Ltd**

Capitol Theatre Condition Assessment

11 March 2019

Document reference: 399302 | 1 | A

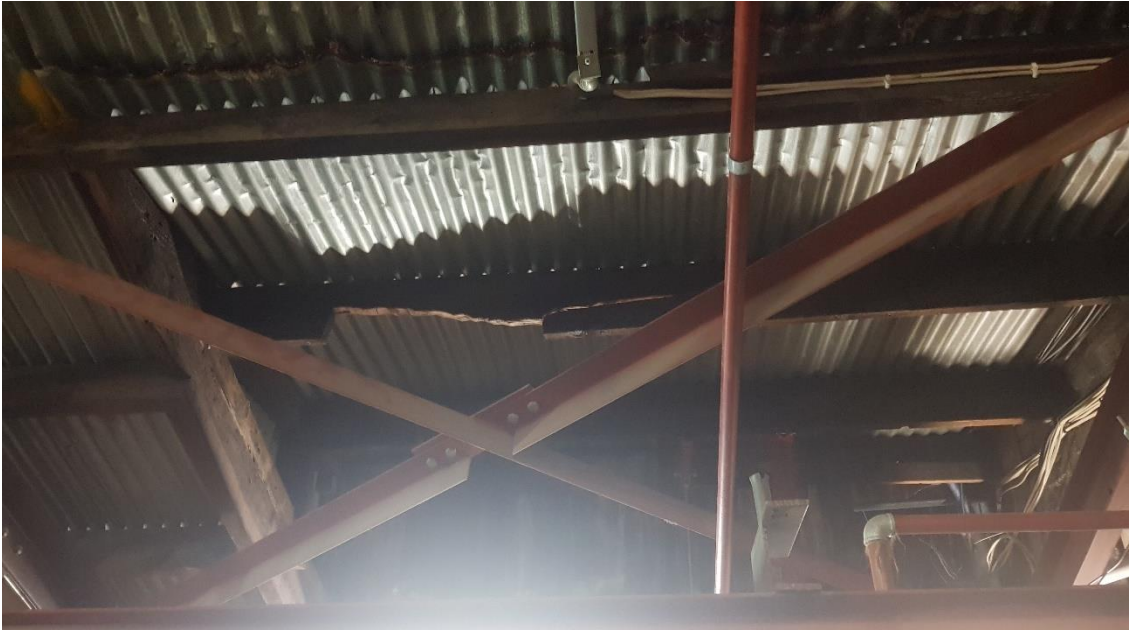
- Timber purlin damage (Figure 1, Figure 2). These defects are low risk as the timber roofing is only supporting weight of the corrugated sheeting and services above, however, should be monitored periodically for any further deterioration.
- Buckled flat truss chord members (Figure 7 and Figure 9). It is uncertain when this failure occurred and could be caused by the cutting and rewelding of the truss members. These members should be assessed when performing the desktop study and the structural check recommended above.

Figure 1: Original Theatre Roof – Existing Timber Purlins, Sheeting and New Steel Bracing

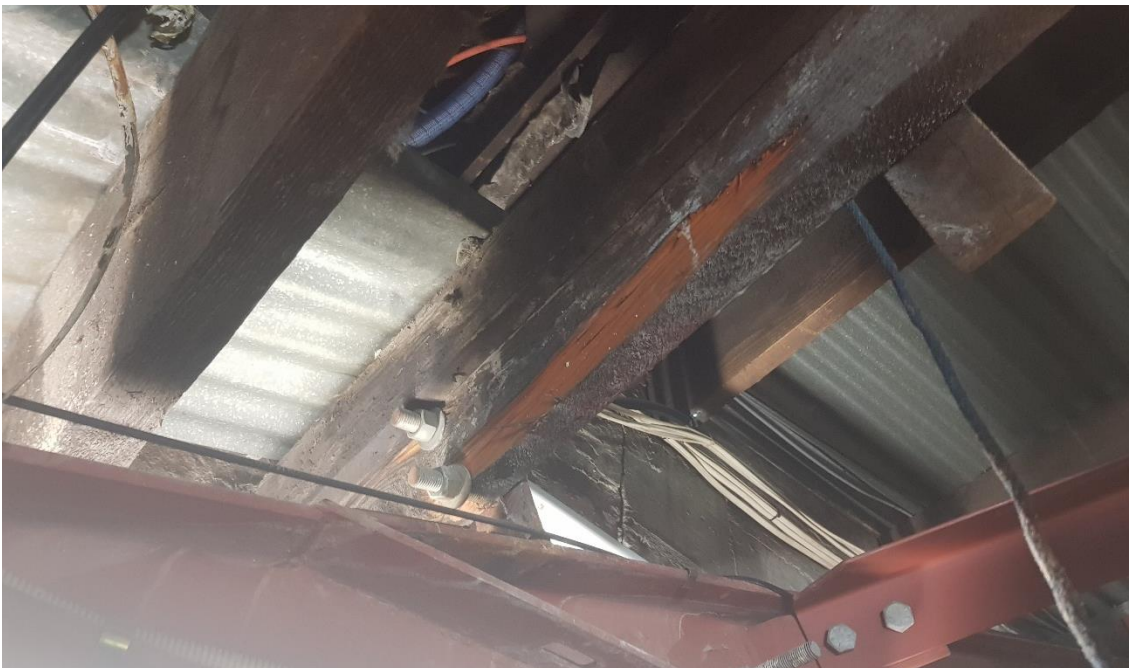
Figure 2: Original Theatre Roof – Timber Purlin Damage

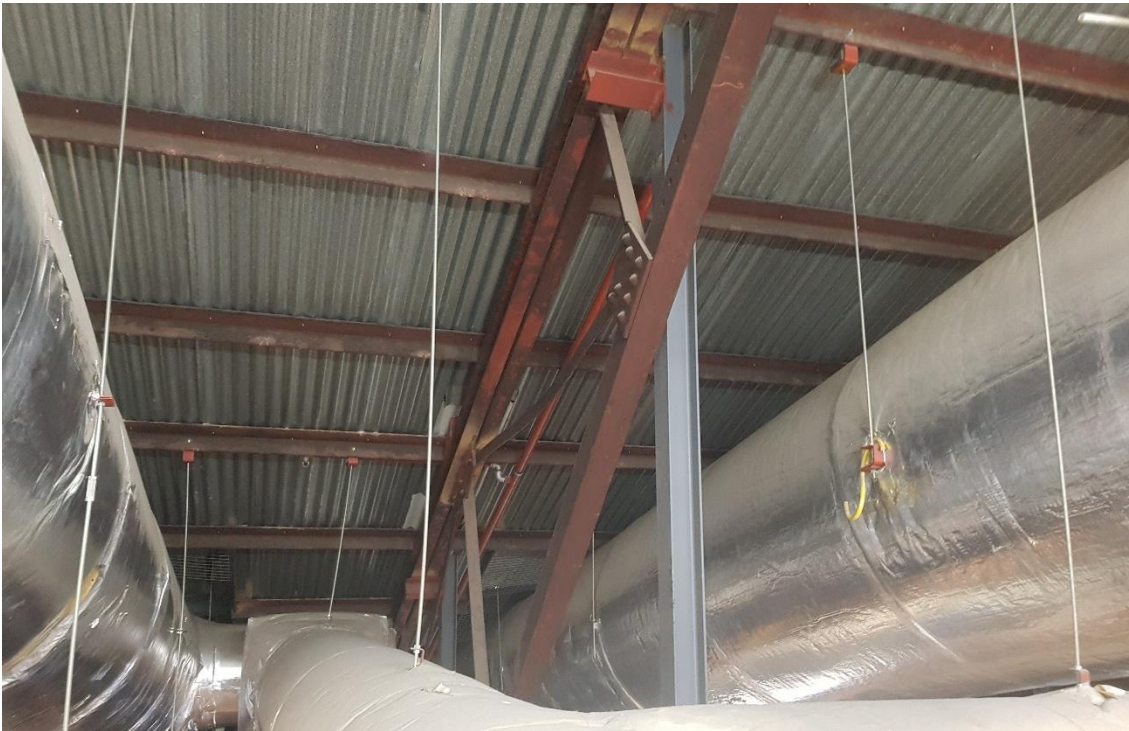
Figure 7: Original Theatre Roof – Buckled Truss Chord

- A desktop check is performed to ensure records are kept of each structural change and that these have been checked by an engineer. If no records are found, a structural check should be performed to determine the load paths through the ceiling and roof structures.

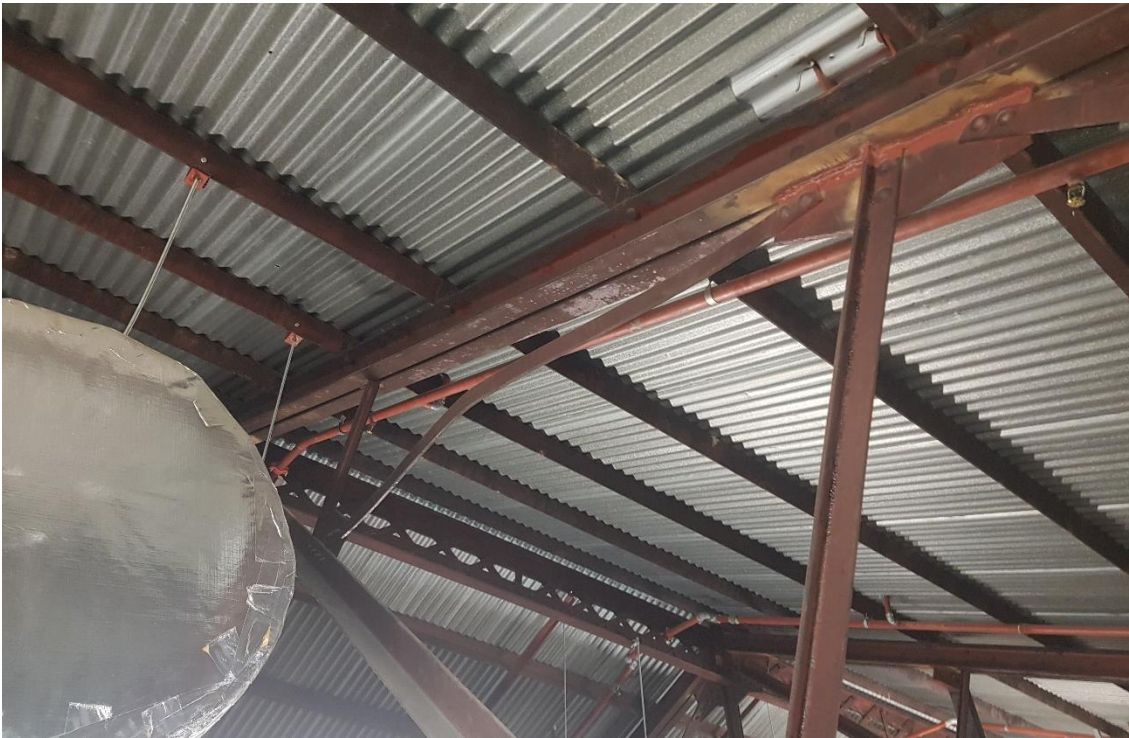
Figure 9: Original Theatre Roof – Bucked Truss Chord

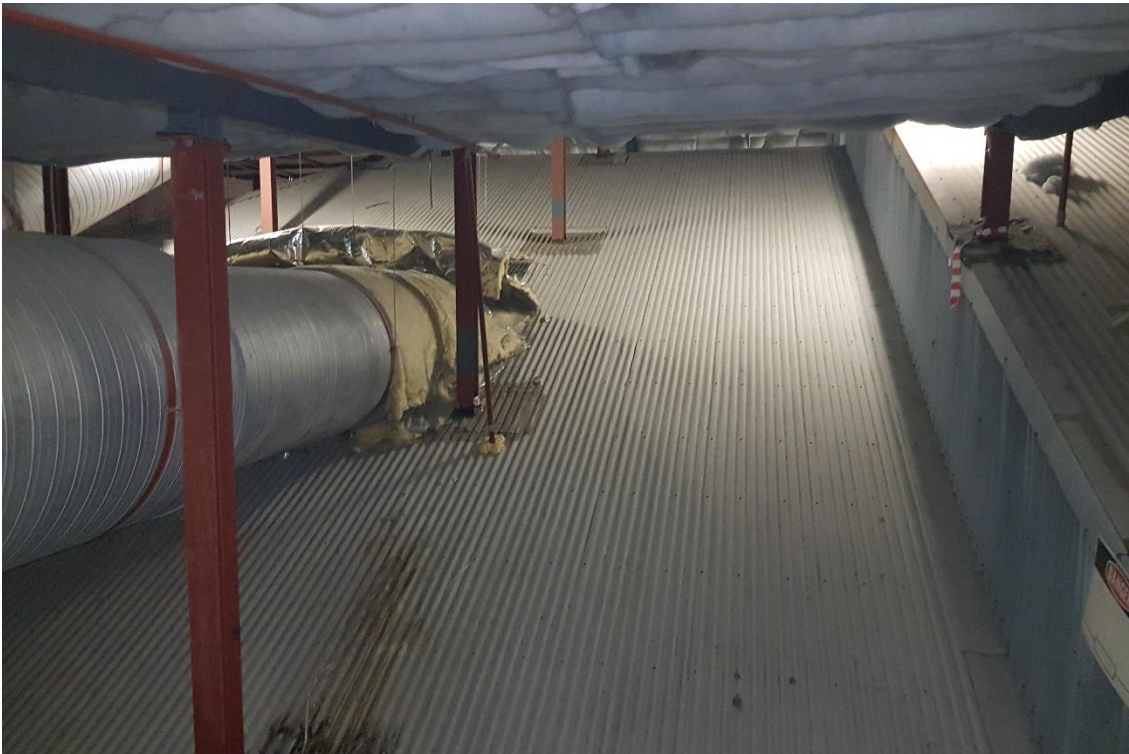
During one of the renovations of the Capitol theatre, a second roof was installed above the original. As shown in Figure 11, the new theatre roof is a steel framed structure supported from posts landing on the original roof trusses. The new roof protects the theatre from weather penetration, particularly preventing water from landing on the original roof structure, as a result, protecting the steel from further corrosion and timber from degradation. The new roof also has the added benefit of eliminating the wind load on the timber purlins of the original roof structure.

Despite the aforementioned benefits, the additional roof has created new load paths along the original trusses. Further load path changes include apparent alterations to the original roof trusses, evidence of cut and re-welded sections, the new steel bracing, and any changes to the access structures and services. With this in mind, it is recommended that:

Figure 11: Original Theatre Roof – New Roof Built Above the Original Roof

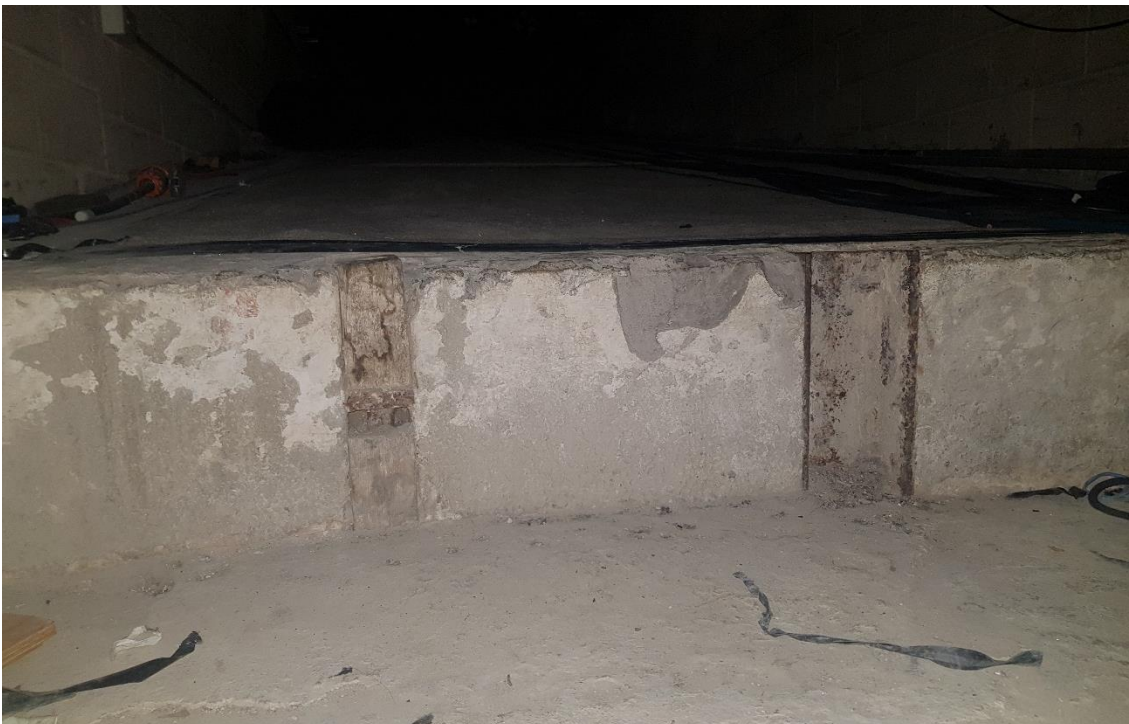
Although the majority of the tank walls was painted (Figure 13), the top of the tank was visible through an access hatch (Figure 14). No major defects were visible at the time of inspection and the elements are not in a particularly exposed location, however, due to its historic significance the walls should be monitored periodically for signs of cracking or spalling.

Figure 14: Original Walls – Top of Tank Wall

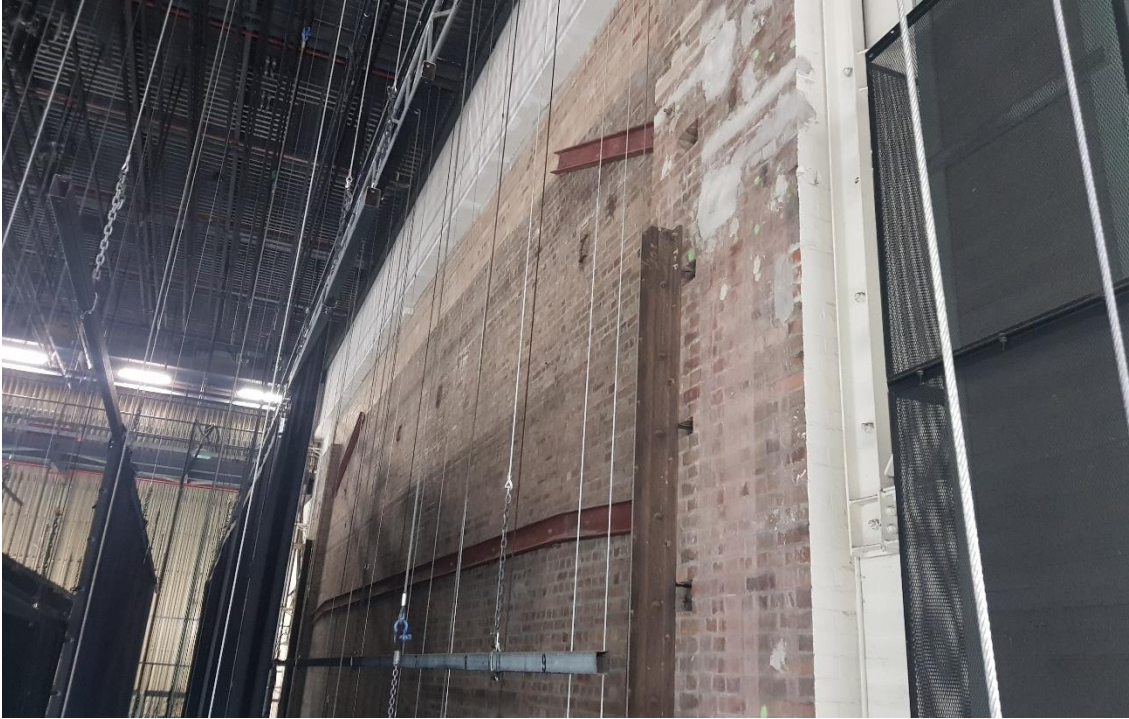
The southern wall (Figure 17), which divides the back-stage area from the theatre seats appears to be a single skin masonry wall that has long spans between supports in both the vertical and horizontal directions. Due to the size and age of this wall, it is suggested that an engineer be engaged to carry out a desktop analysis to check its structural stability.

Figure 17: Original Walls – Large Wall Dividing Back Stage and the Theatre

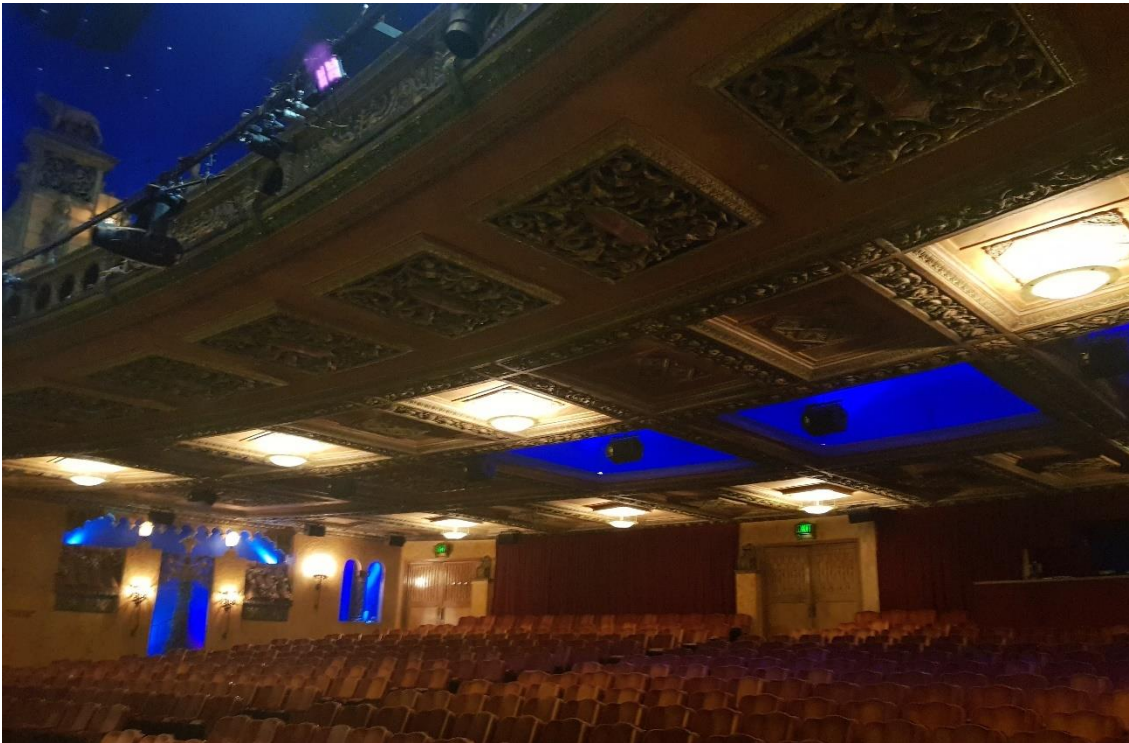
The large cantilevered balcony of the dress circle pictured in Figure 27, presents the highest point of stress and was inaccessible at the time of inspection. Maintenance staff at the Capitol theatre were unaware of any access panels or doors to inspect and maintain this large area. It is recommended that access be provided to this large area and that a maintenance and monitoring scheme of the dress circle trusses is instituted.

Figure 27: Dress Circle Structure – Balcony from below

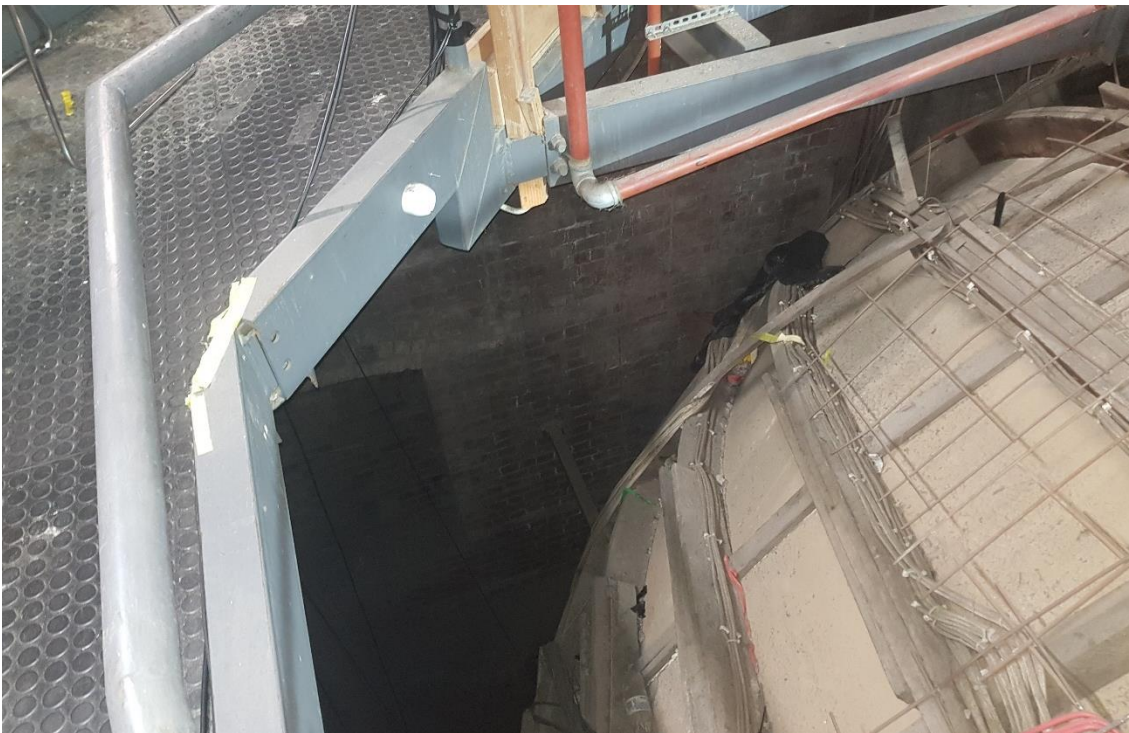
Access routes, such as the catwalk above the original roof as well as ladders and stairs between levels are another area of high risk. Missing bolts (Figure 28) and wobbly railings (Figure 29) were noticed throughout the inspection. It is recommended that the fixings in the aforementioned areas, as indicated on the plan in Appendix B, be addressed and the rest of the elevated access structures be periodically monitored for defects and repaired/ strengthened accordingly.

Figure 28: Roof Access Structure – Missing Bolts

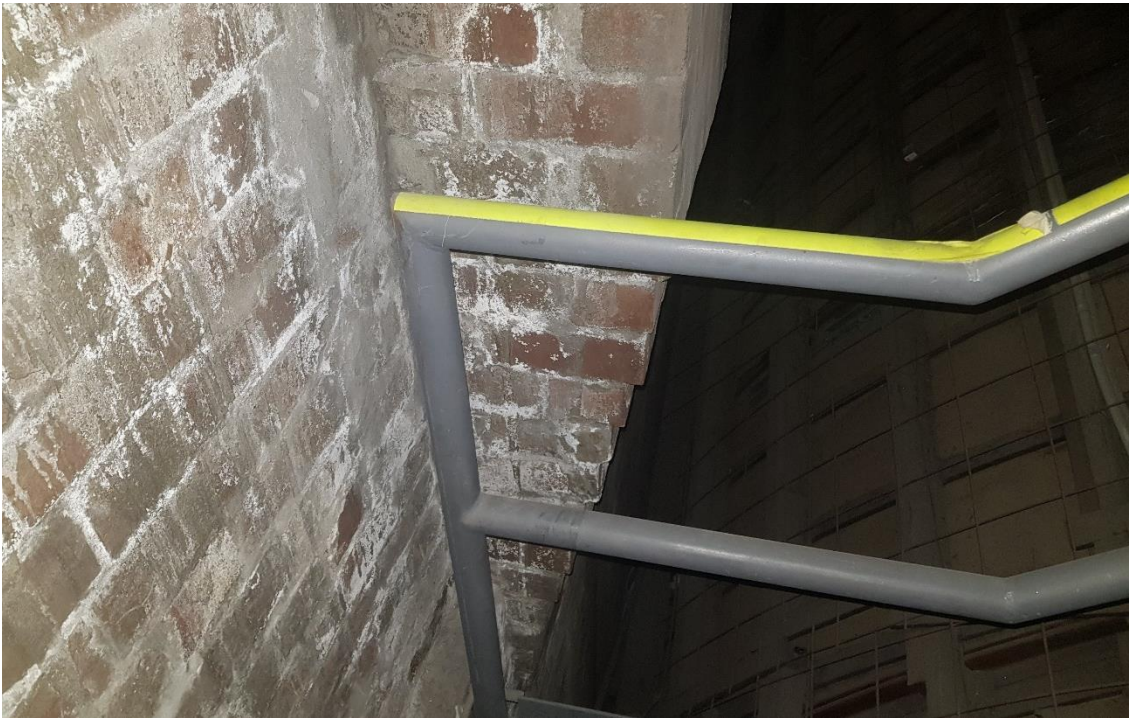
Figure 29: Roof Access Structure – Wobbly Balustrade

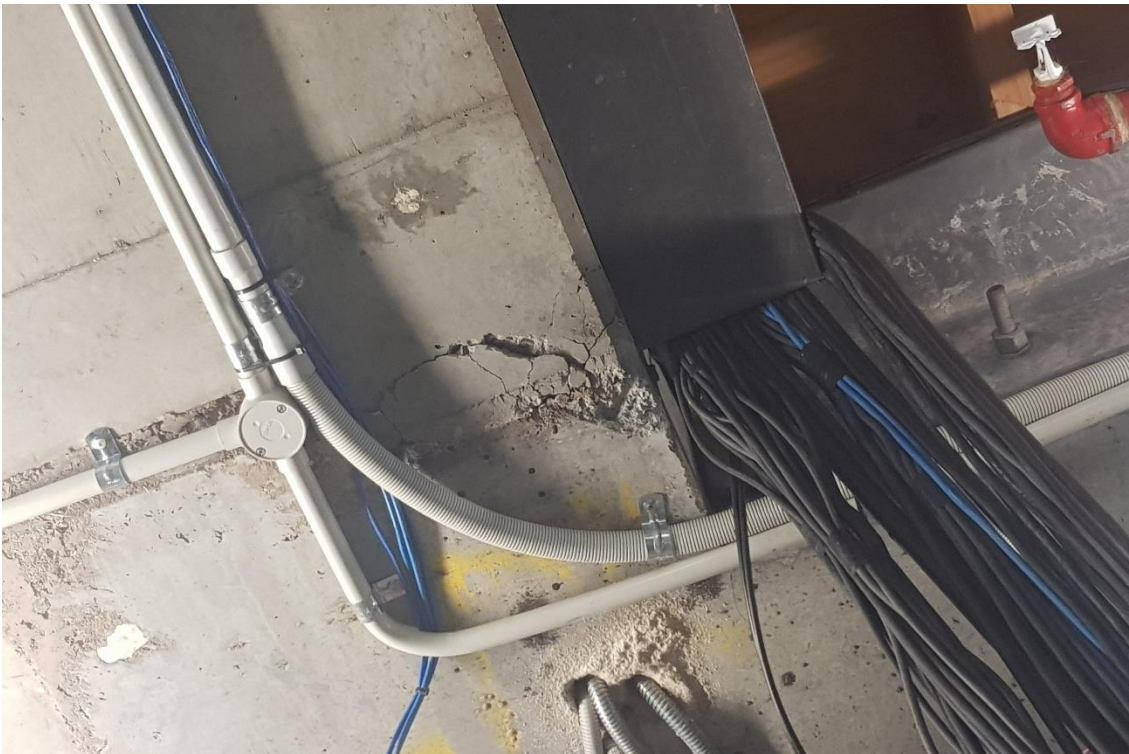
- Cracking due to embedded steel sections in the ground floor slab below the stage (Figure 30)
- Minor crushing of concrete pre-cast panel due to a steel member above (Figure 34)

Figure 30: Minor Cracking – Underside of New Concrete Slab

- Cracks throughout the building should be documented and monitored to determine if further movement is occurring. Cracks continuing to grow should be assessed and repaired if necessary.

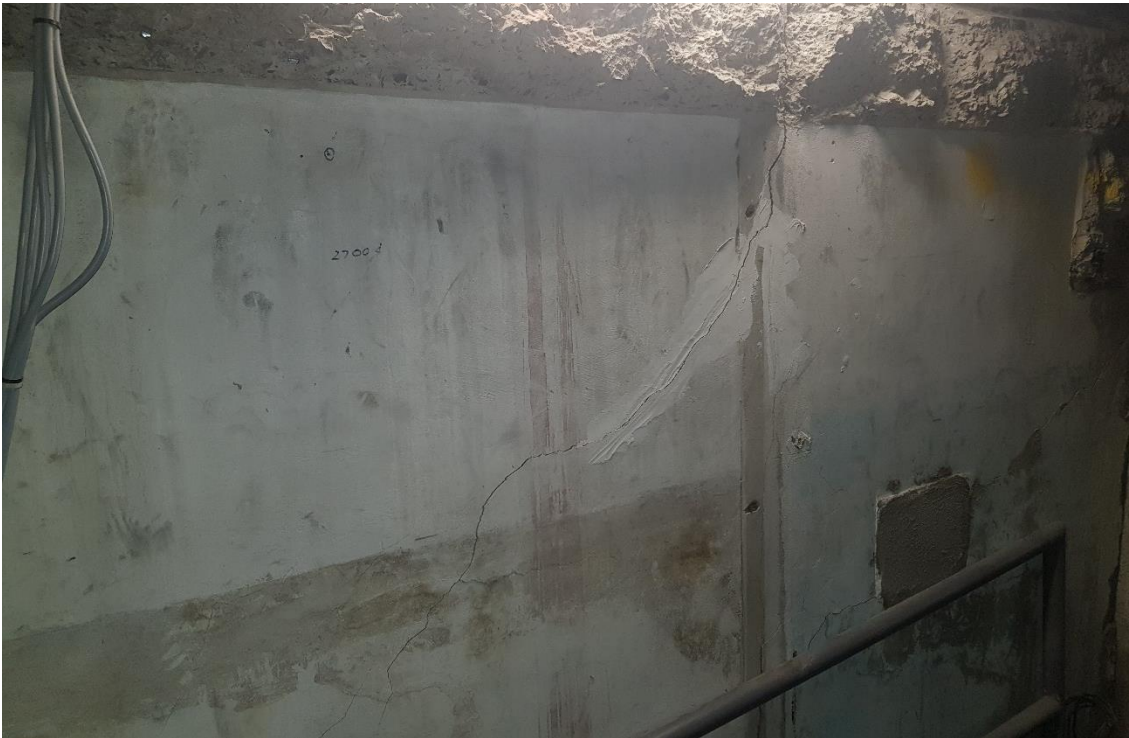
- Cracking most likely due to minor building movement (Figure 31 - Figure 33, Figure 35 - Figure 37)

Figure 31: Minor Cracking – Diagonal Crack in the Cement Rendered Masonry Wall

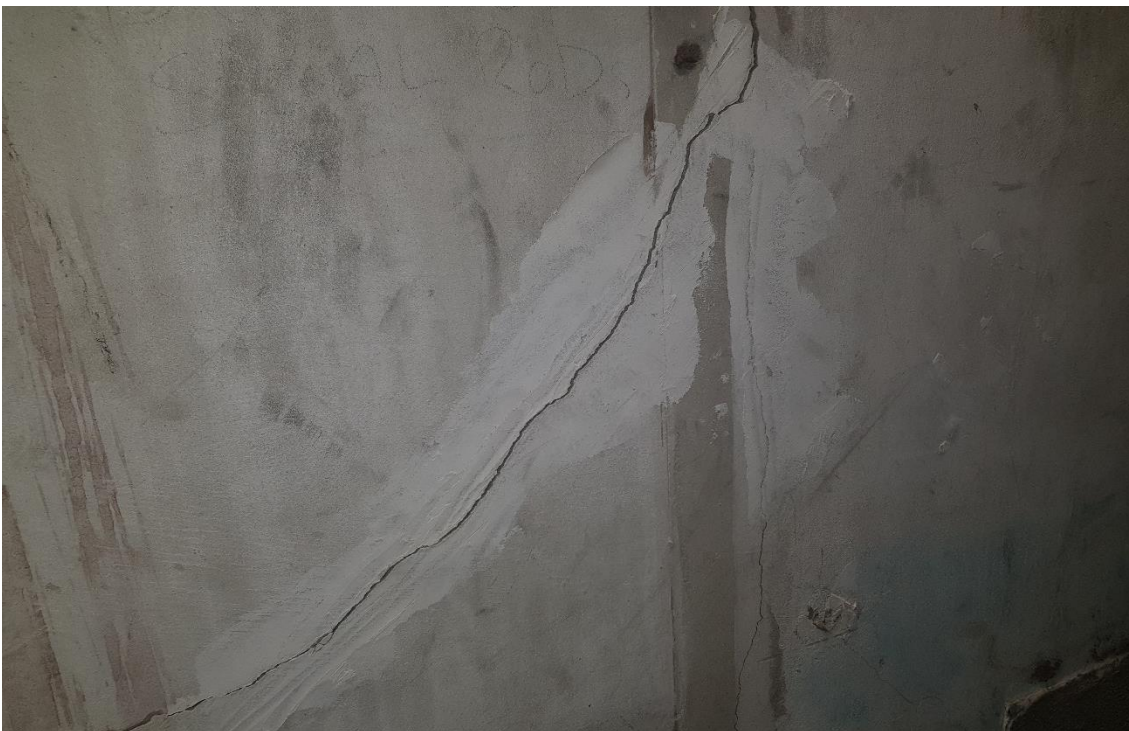
Figure 32: Minor Cracking – Close up of Cement Rendered Masonry Wall Crack

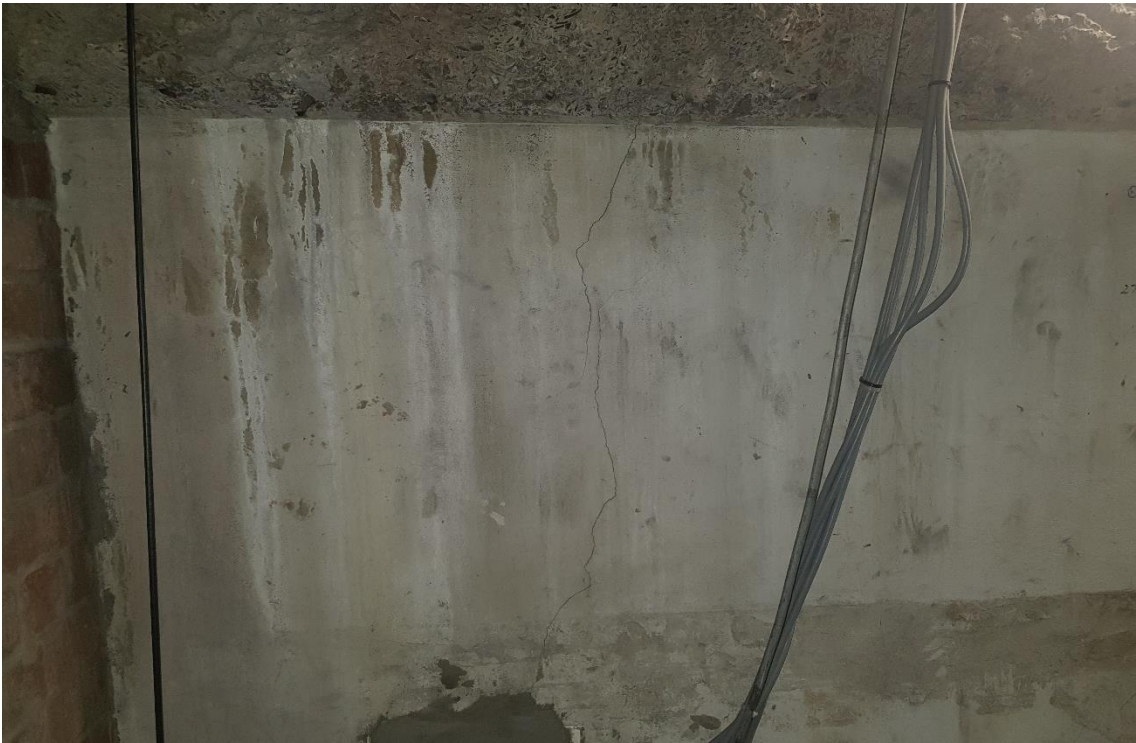
Figure 33: Minor Cracking – Cement Rendered Masonry Wall Crack

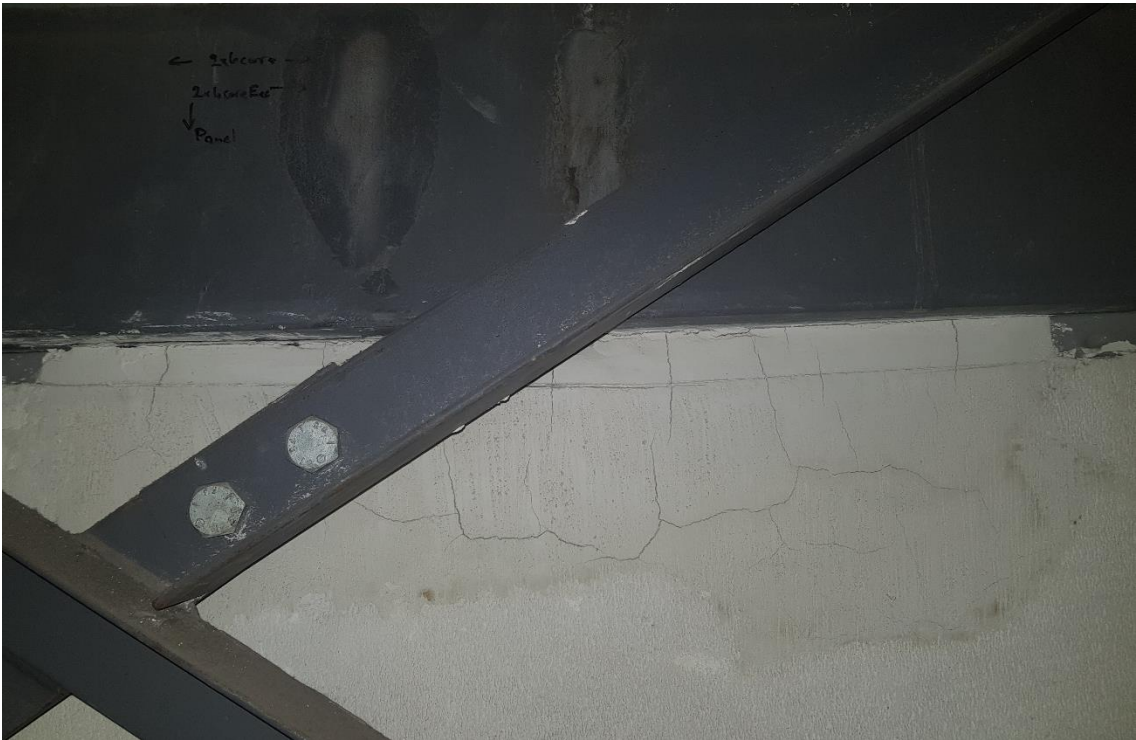
Figure 34: Minor Cracking – Crushing of Pre-Cast Panel below Steel Member

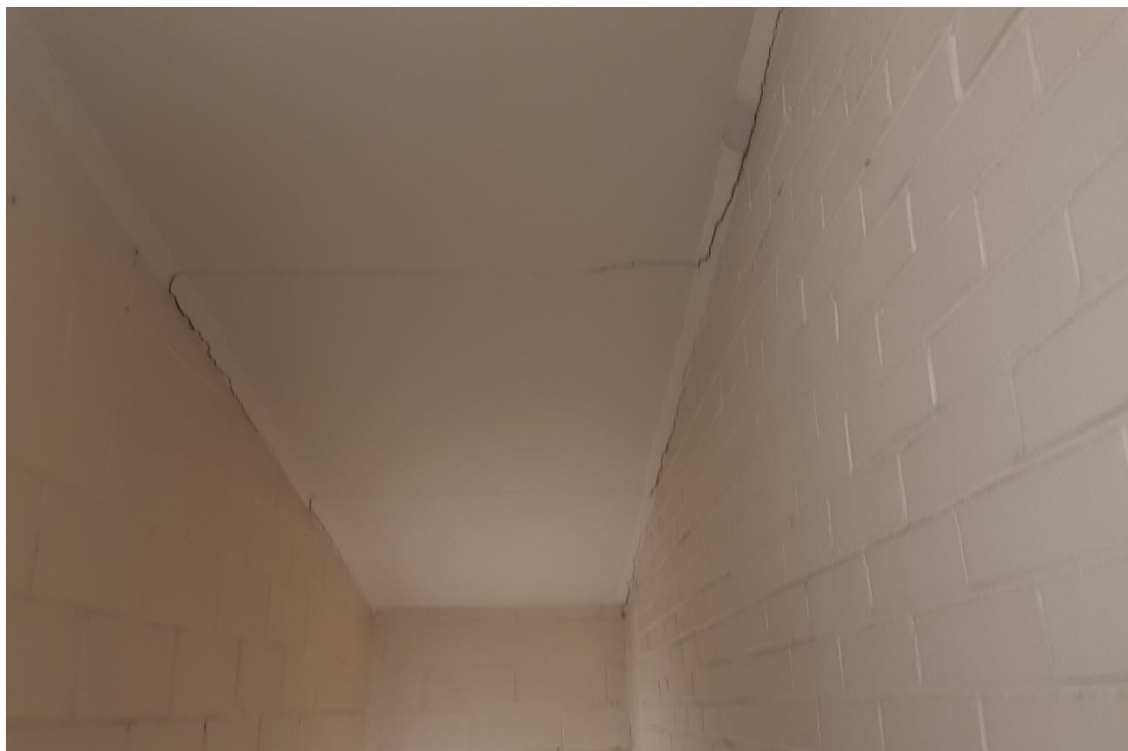
Figure 35: Minor Cracking – Stairwell Roof

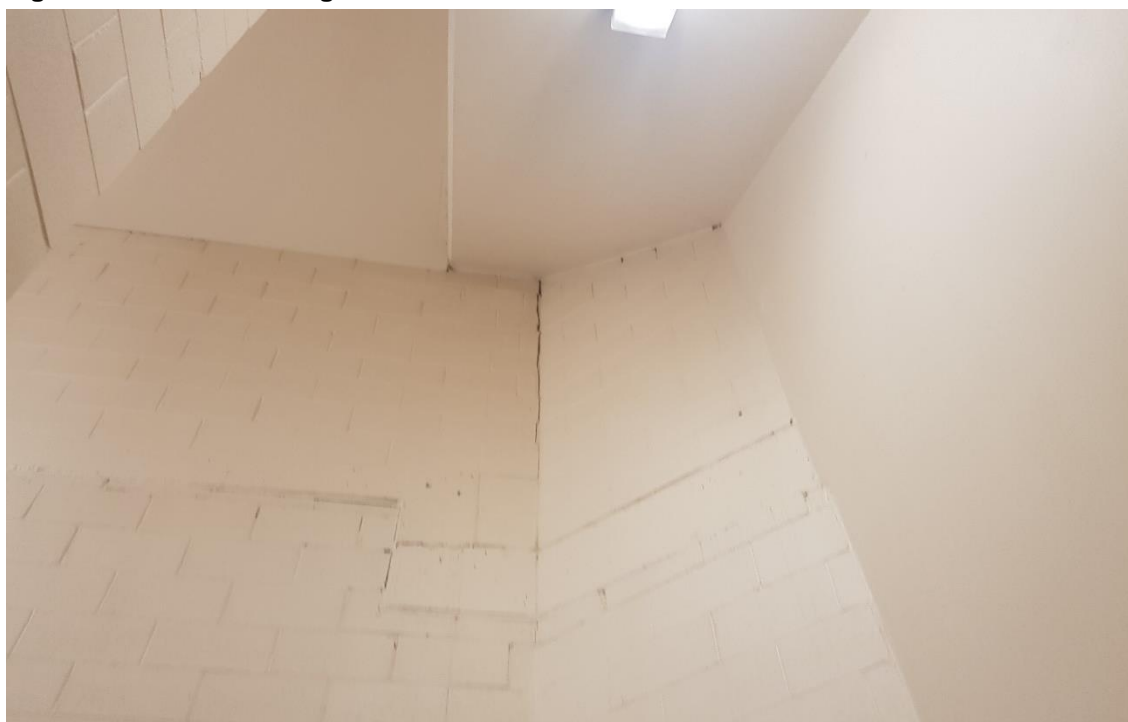
Figure 36: Minor Cracking – Stairwell Wall

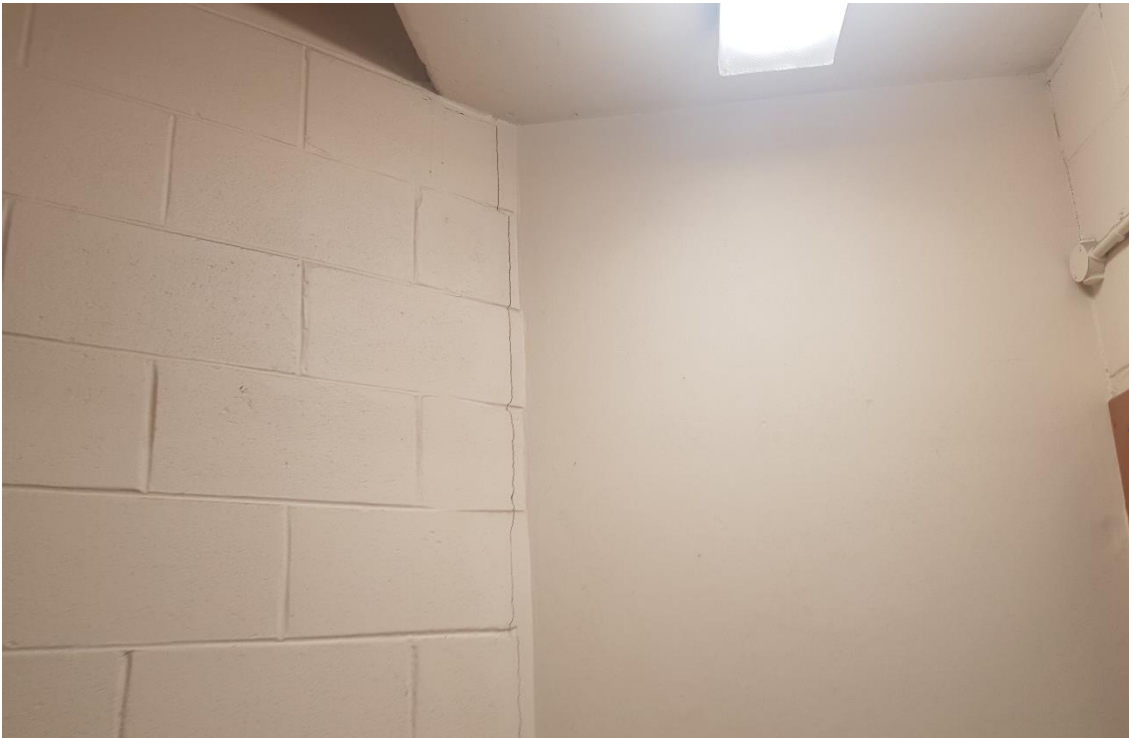
Figure 37: Minor Cracking – Stairwell Wall
