**Mirvac Office Developments Pty Ltd
Preliminary Contamination Assessment**

55 Pitt Street, Sydney NSW

12 December 2019

754-SYDEN221350-R01-Rev2

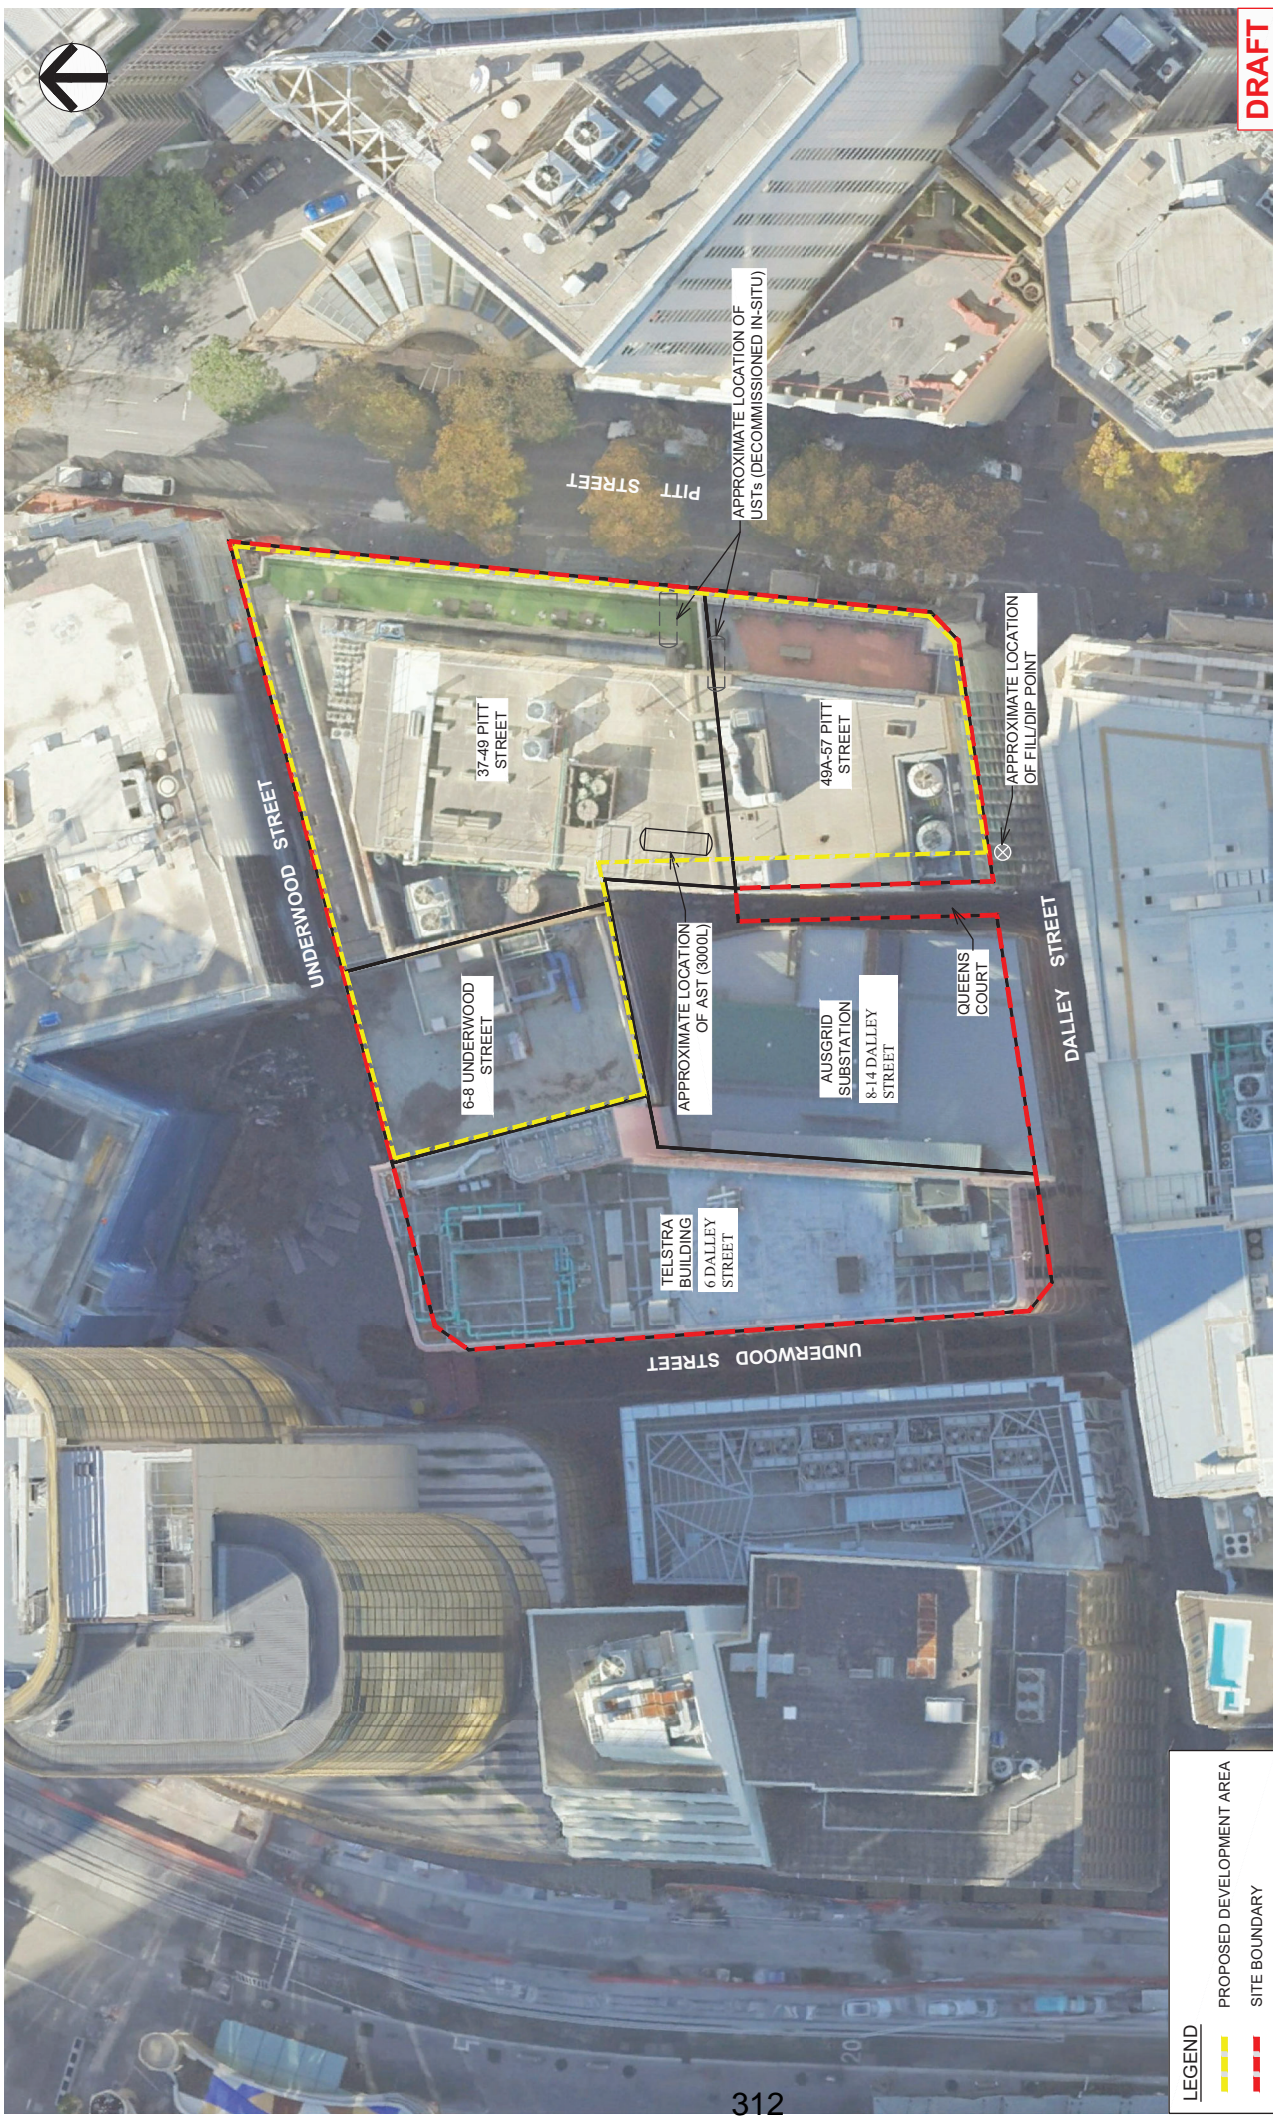
client:	MIRVAC OFFICE DEVELOPMENTS PTY LTD
project:	PRELIMINARY CONTAMINATION REVIEW 55 PITT STREET, SYDNEY, NSW
title:	SITE LAYOUT PLAN
project no:	754-SYDEN221350
figure no:	FIGURE 2
rev:	A

- The concrete surface of both car parks appears to be in generally good condition with some minor cracks observed.
- The 3,000L AST (used to contain diesel) was observed on the upper level of the basement car park beneath 37-49 Pitt Street. The AST was empty and appeared to be in generally good condition with no rust or holes observed on the tank. There was no indication of spills or leaks observed on the concrete beneath the tank. The transfer pipes from the AST appear to lead to fire extinguisher pumps that are no longer in use. The location of the AST is shown in Figure 2.

- The UST on the 37-49 Pitt Street was not sighted, but the location is shown in Figure 2, as documented in previous report.
- A fuel fill / dip point was observed in the northern footpath on Dalley Street (approximate location is shown in Figure 2).

- Potential fuel fill / dip point observed in the northern footpath on Dalley Street (approximate location is shown in Figure 2)
- Fill of unknown origin within the general site surface

A number of the ASTs and the UST at 37-49 Pitt St were not sighted during site walkover. It is recommended that the presence of these be confirmed prior to demolition work. It is considered that potential impact from ASTs is considered to be low as ASTs and the areas surrounding them appear to be in condition. It is recommended that AST removal is undertaken appropriately to minimise impact to surrounding area.

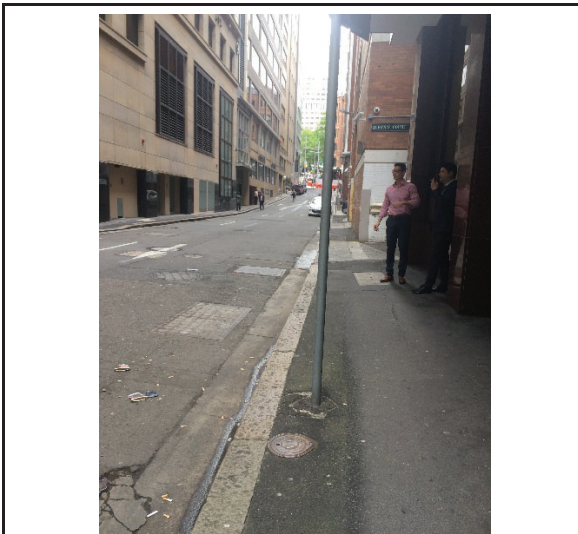
- A fuel fill / dip point observed in the northern footpath on Dalley Street (approximate location is shown in Figure 2)
- Fill of unknown origin within the site boundaries.

Photo 5: Potential dip/fill point on northern footpath of Dalley Street

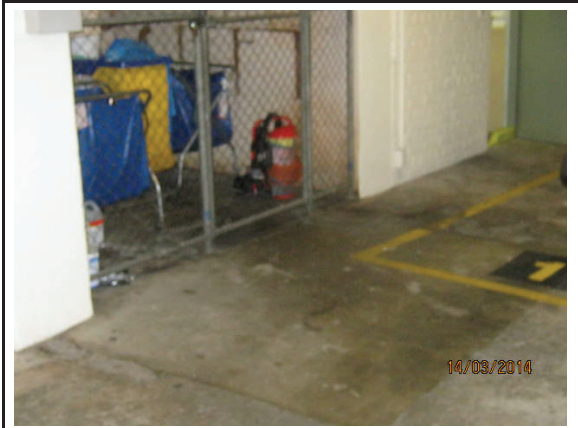
- A decommissioned 5,000L UST within the basement of 49A-51 Pitt St (approximate location is shown in Figure 2)
- A 10L diesel tank located in the plant room of 49A-51 Pitt St associated with the hydrant pump (not sighted during the site walkover)

Photo 7: Location of UST in basement car park at 51 Pitt Street

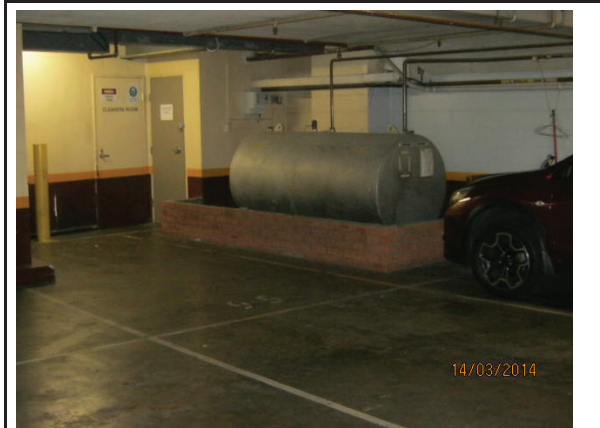
Photo 8: AST location on upper basement car park at 37 Pitt Street

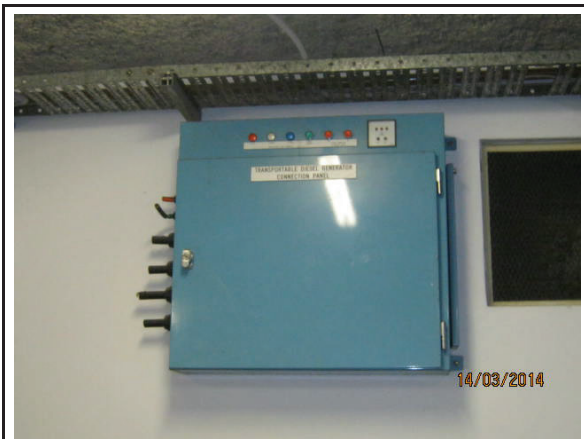
- A diesel databox was observed on the western wall at the entrance to the car park beneath 37-49 Pitt Street, which appeared to no longer be in use as the wiring had been cut.

Photo 9: Disconnected power box to diesel AST

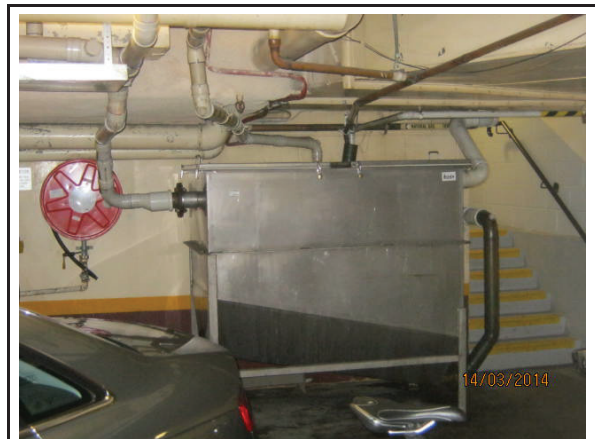
- The building manager's office is located on the upper level of the basement car park at 37-49 Pitt Street.
- An AST associated with the grease trap (size is unknown) was located adjacent to the building manager's office at 37-49 Pitt Street. The AST was made of steel and minor staining was observed around the base of the grease trap. The location of this is not shown in Figure 2.

Photo 10: Grease trap AST located on lower basement level car park at 37 Pitt Street

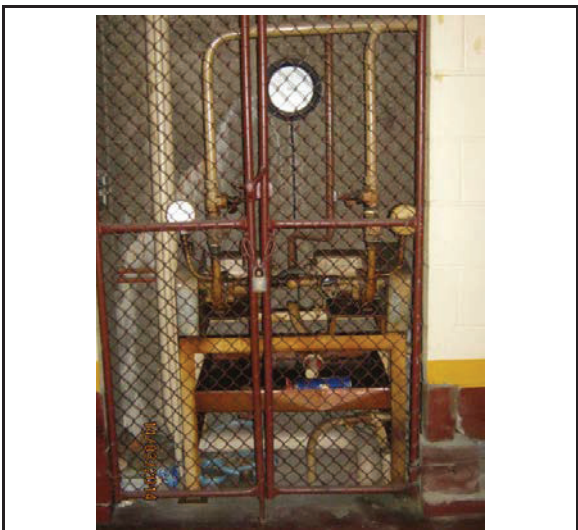
Photo 11: Decommissioned fire hydrant pumps located on lower level car park at 37 Pitt Street
