**Condition Assessment
Queen Victoria Building**

Queen Victoria Building Condition Assessment

23 July 2018

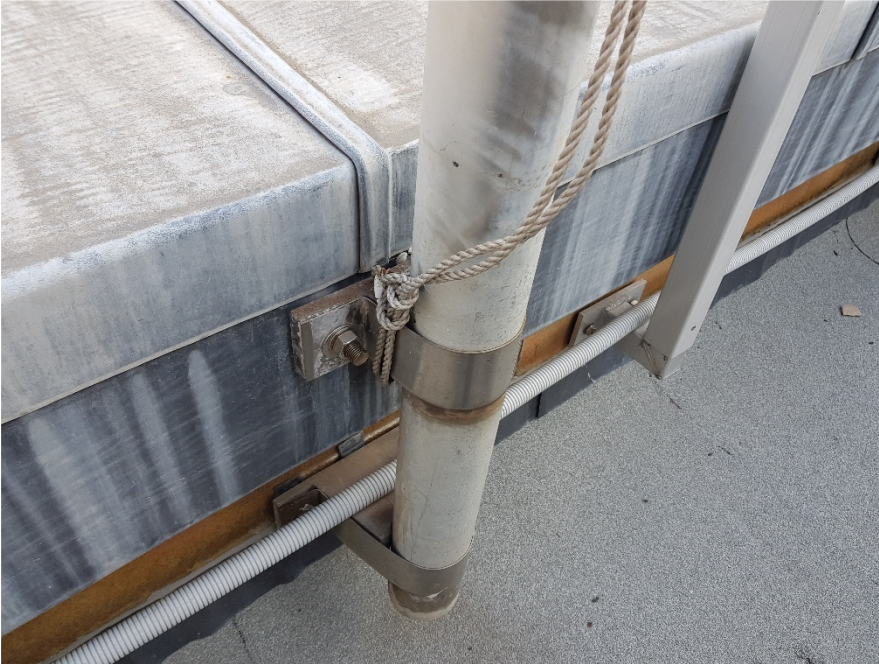
- The side connection to the flag pole in Figure 1 was found to be loose.
- The flag poles at the southern end looked to have potentially corroded bolts with insufficient threads.

Figure 1: Typical Connection for East and West Flag Poles

- All flag poles to be inspected and checked on a regular basis.
- Where defective fixings are identified they should be rectified as soon as possible.

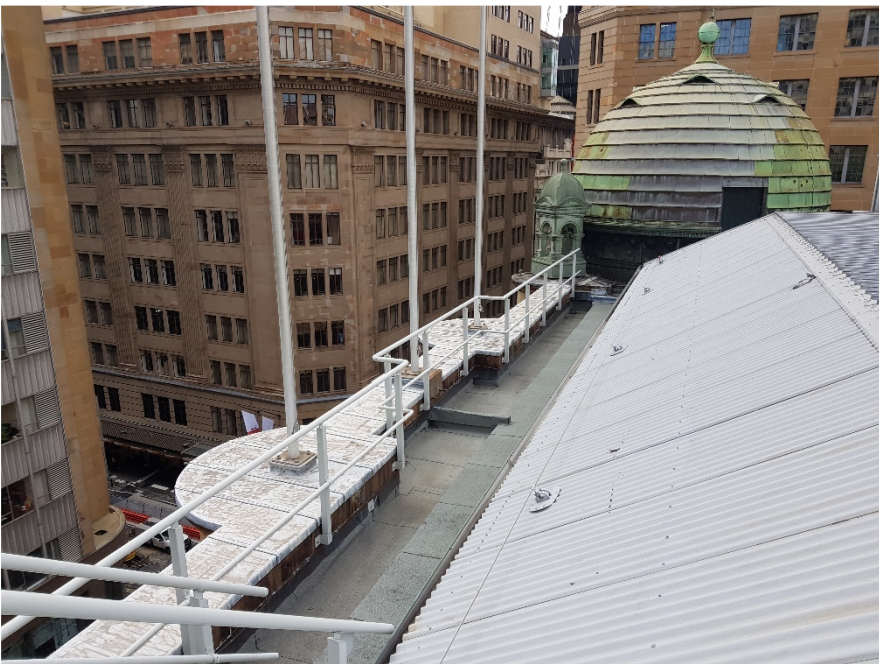
Figure 2: Flag Poles North End

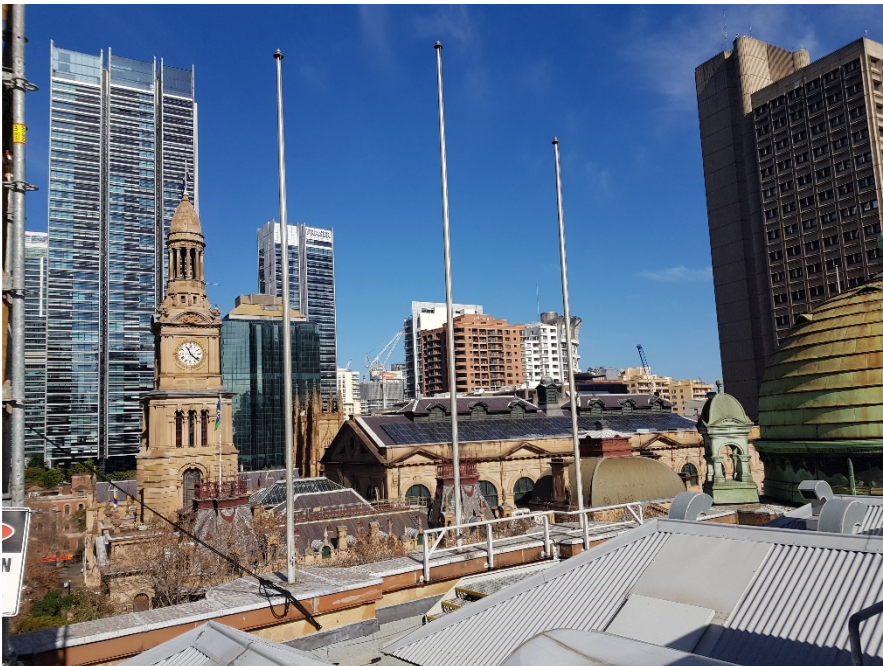
Figure 3: Flag Poles South End

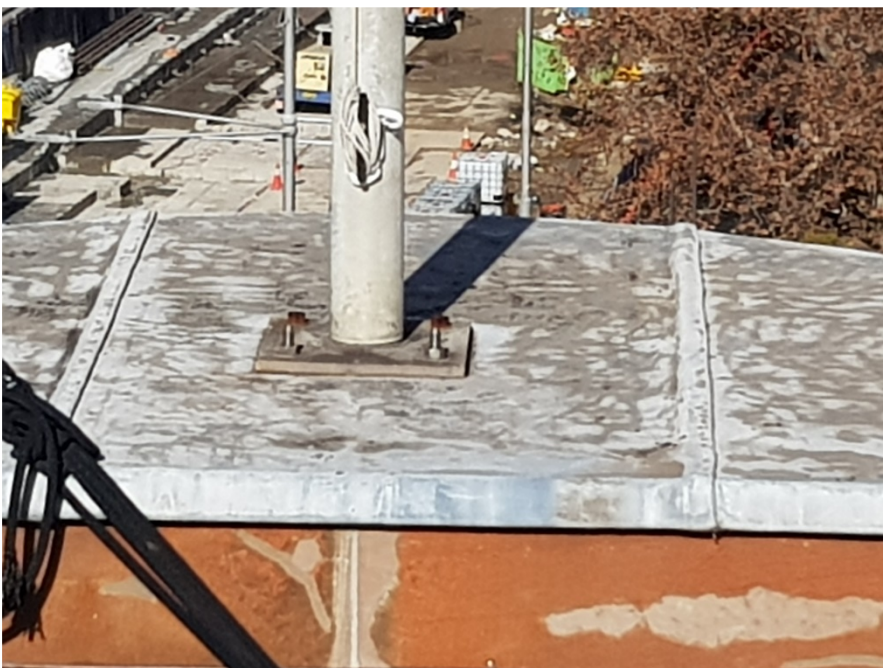
Figure 4: Corroded Flag Pole Connections South End

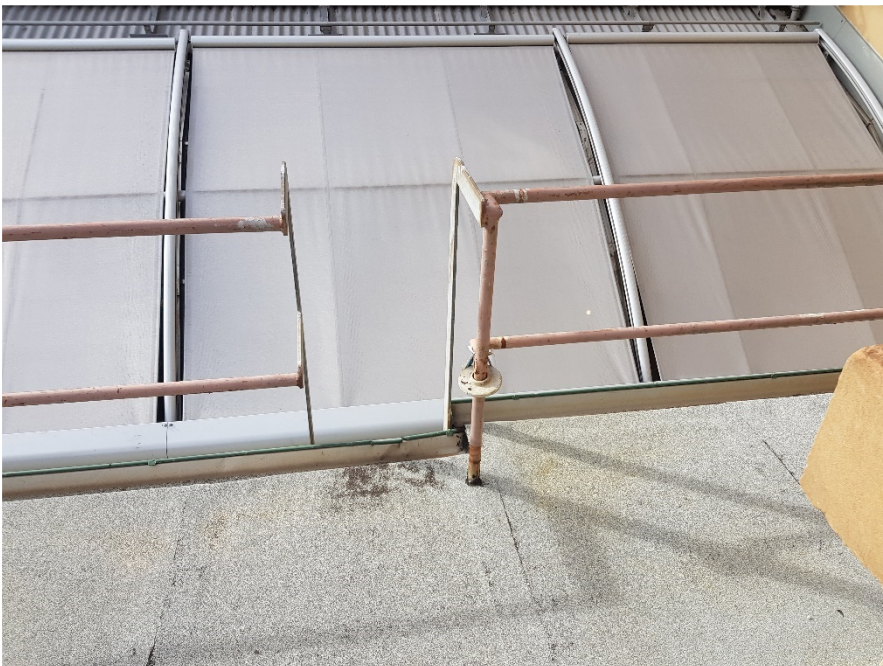
Figure 6: Balustrade North West

- A survey of roof access structures be made and a risk assessment carried out. And where necessary access should be upgraded to meet new codes.
- All fixings be checked during routine maintenance and replaced if necessary.

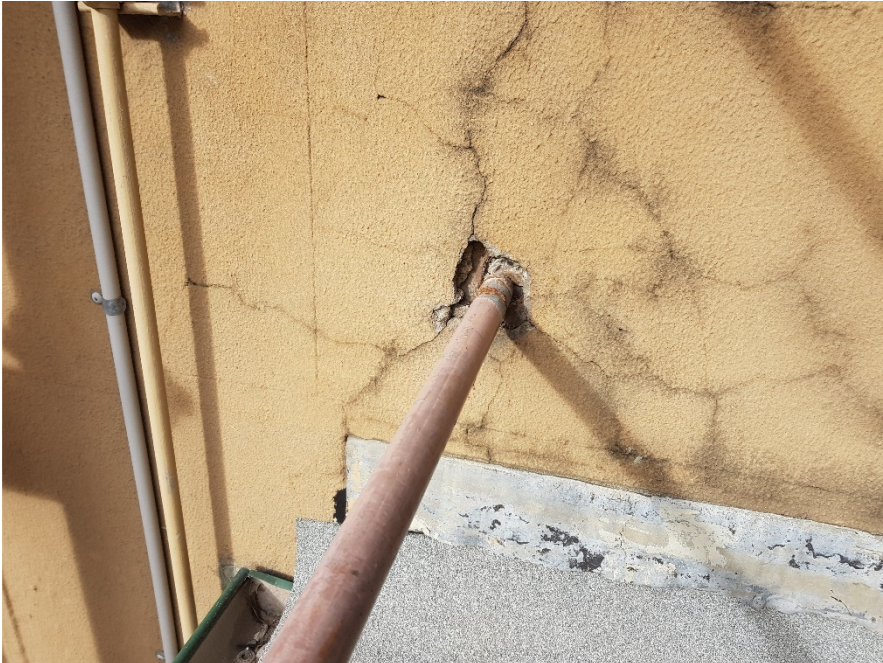
Figures 6-12 show example photos of the access structures found on the building's roof. Figures 7 and 8 show an original railing having broken off from the embedded end. Figure 12 shows an unbolted end to a railing on one of the new lightweight walkways.

Figure 7: North West Balustrade Closest to Central Dome Fixing

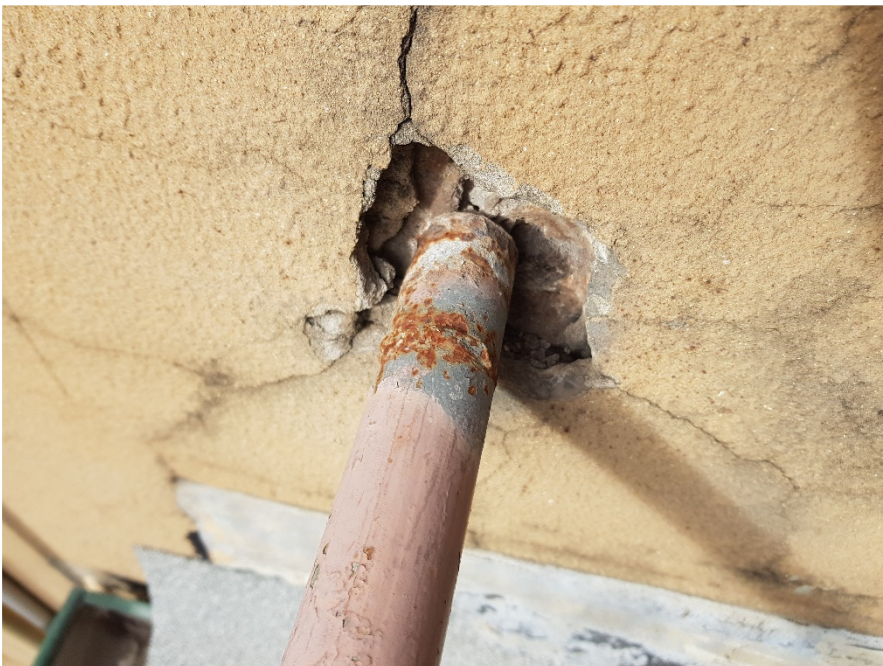
Figure 8: Original Railing Broken Off from Wall

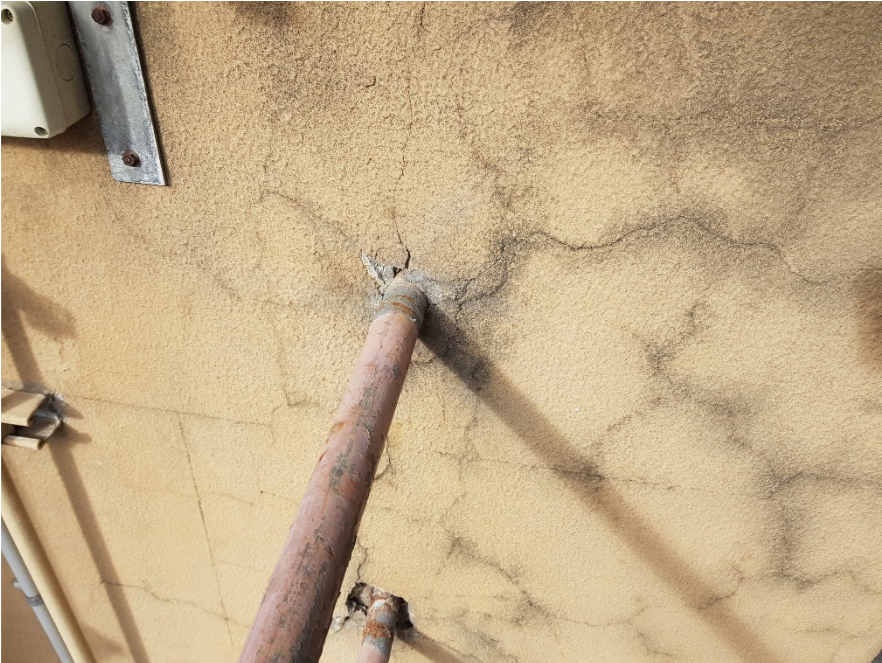
Figure 9: Cracking Around Embedded Railing

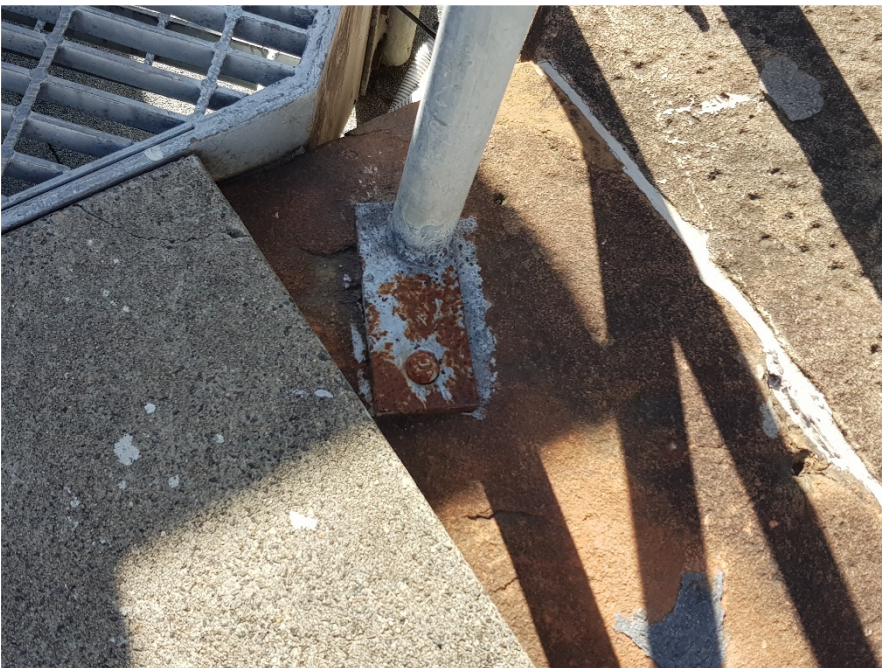
Figure 10: Corroded Connection of Access Structure South End
