Attachment G2

**Condition Assessment
Queen Victoria Building**

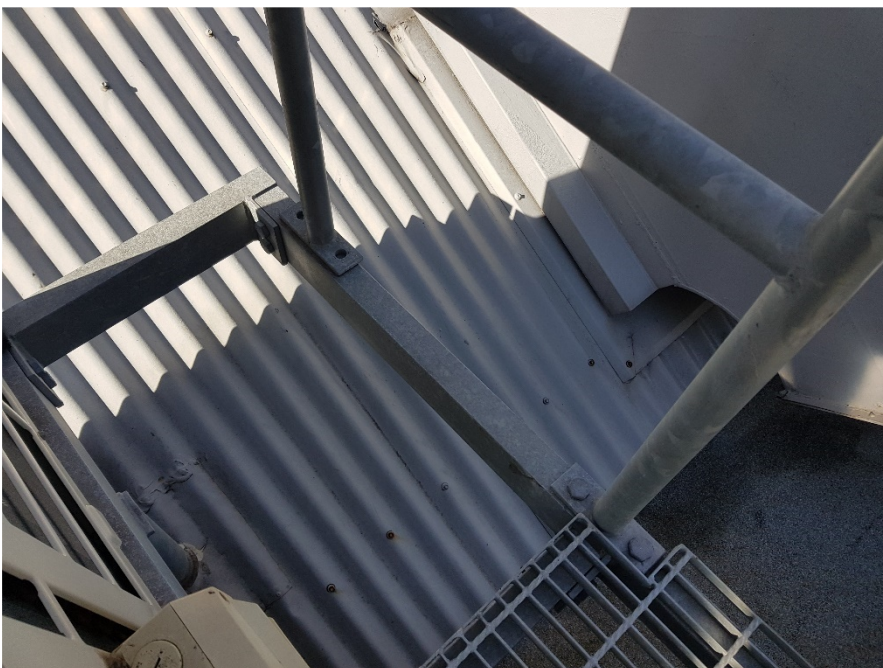
Figure 12: Missing Bolts on Balustrade South End

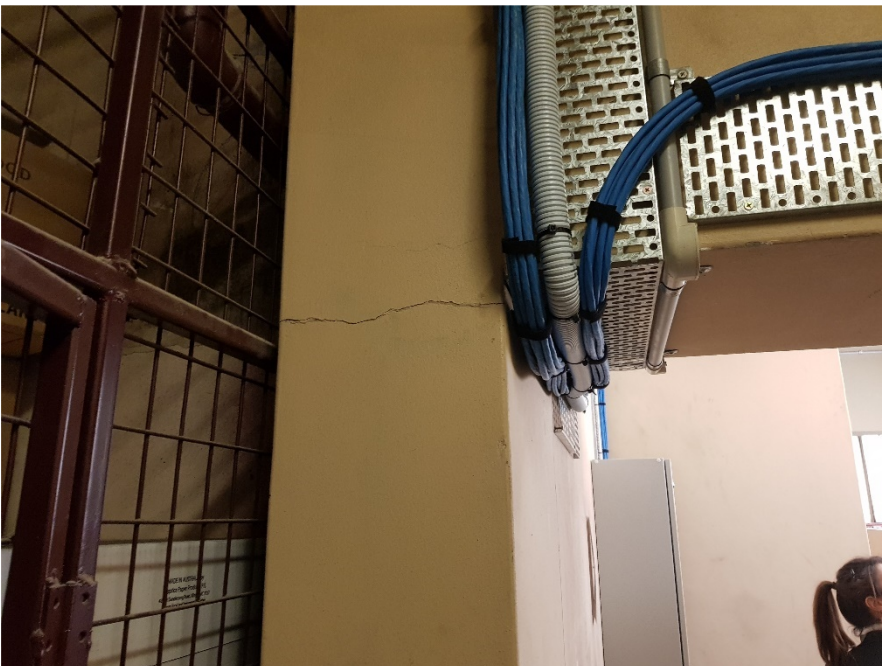
Figure 24: Horizontal Crack in Column

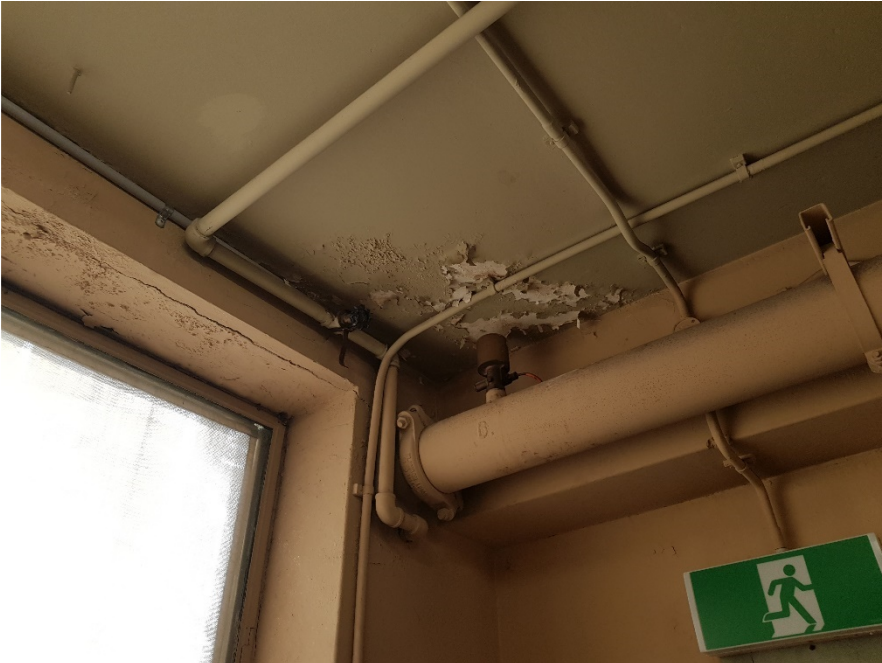
Figure 25: Cracking in Lintel

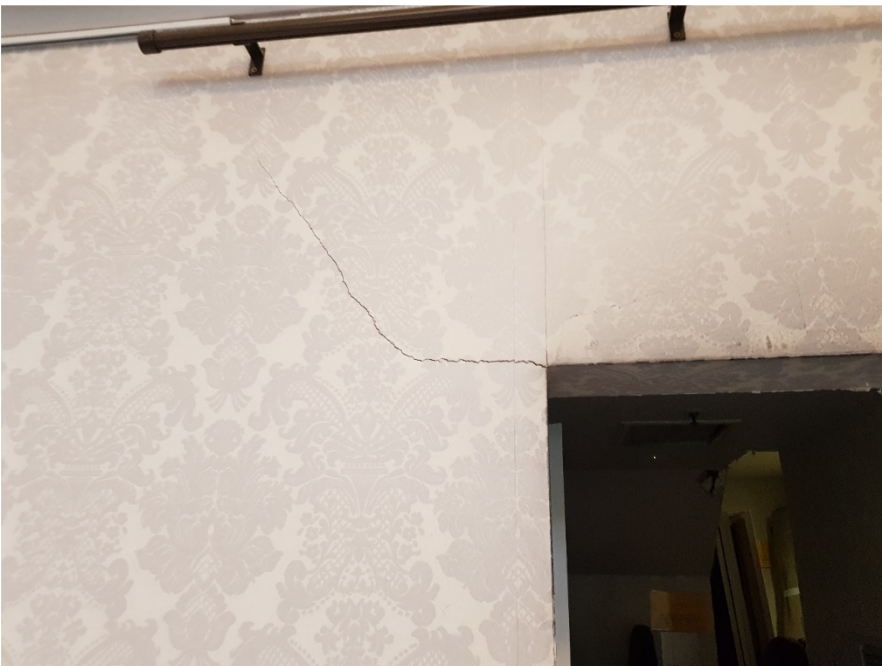
Figure 26: Diagonal Cracking in Tea Room Lintel

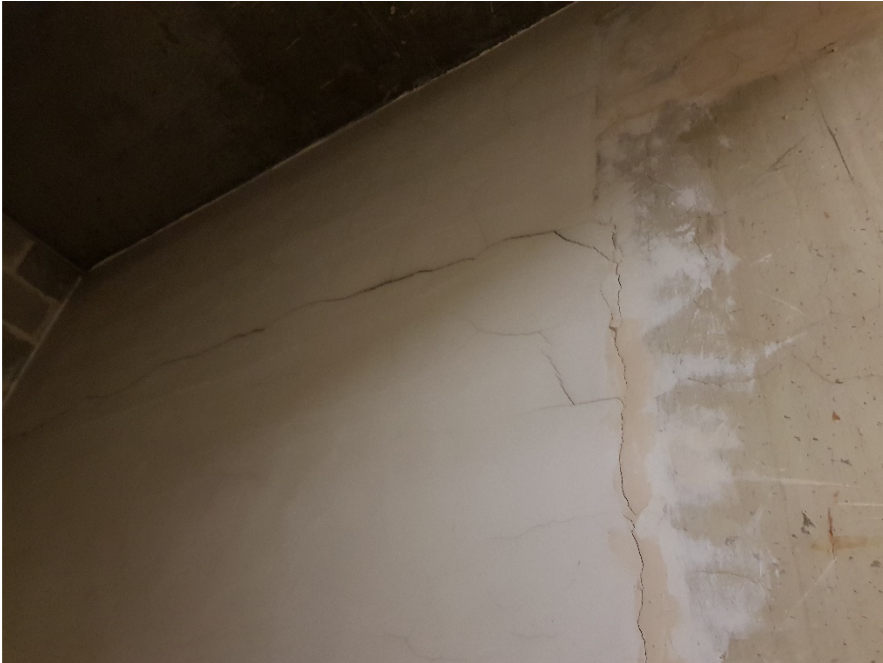
Figure 27: Fire Escape Cracking

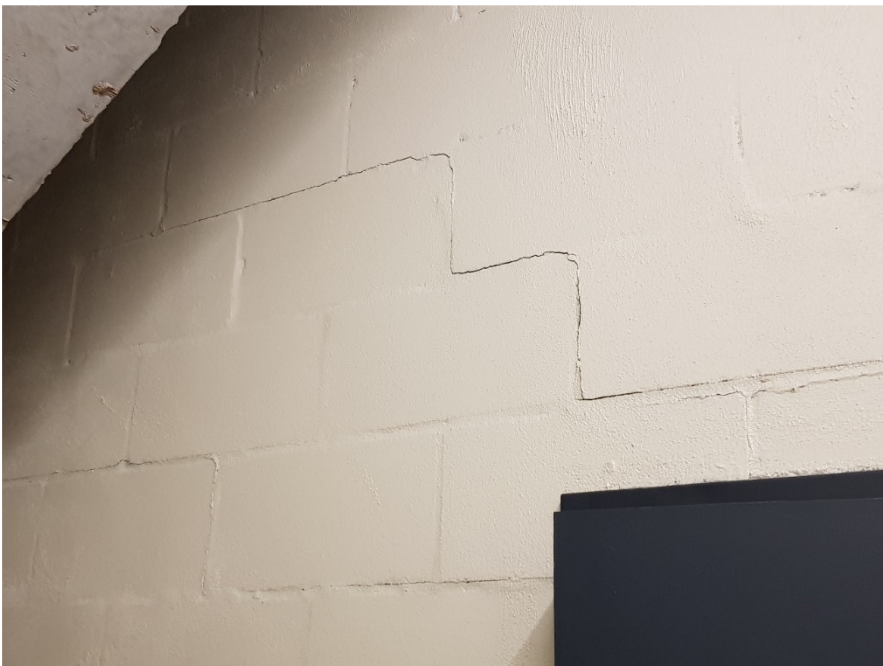
Figure 28: Diagonal Cracking Above Fire Escape Door Opening

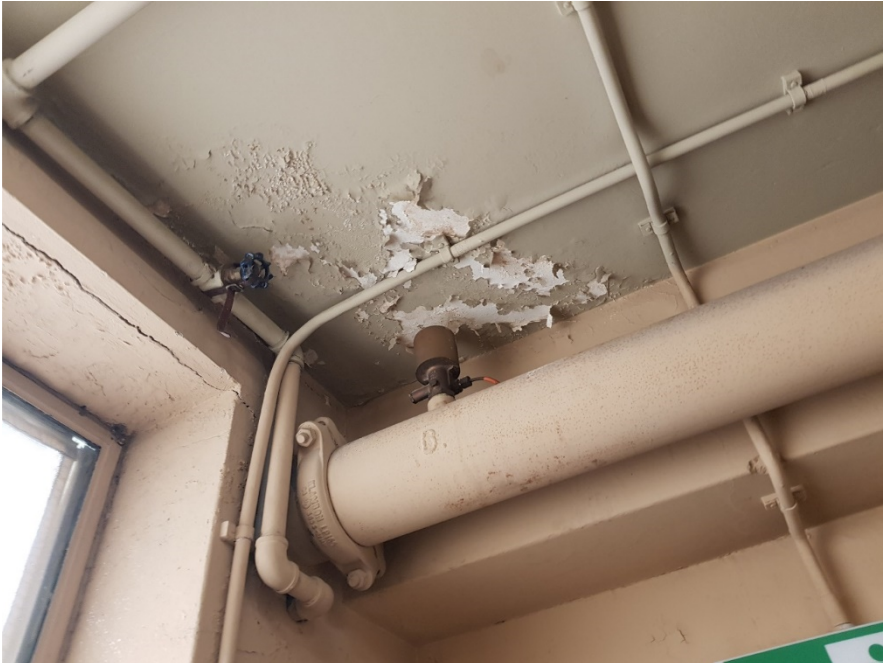
Figure 29: Spalling Concrete

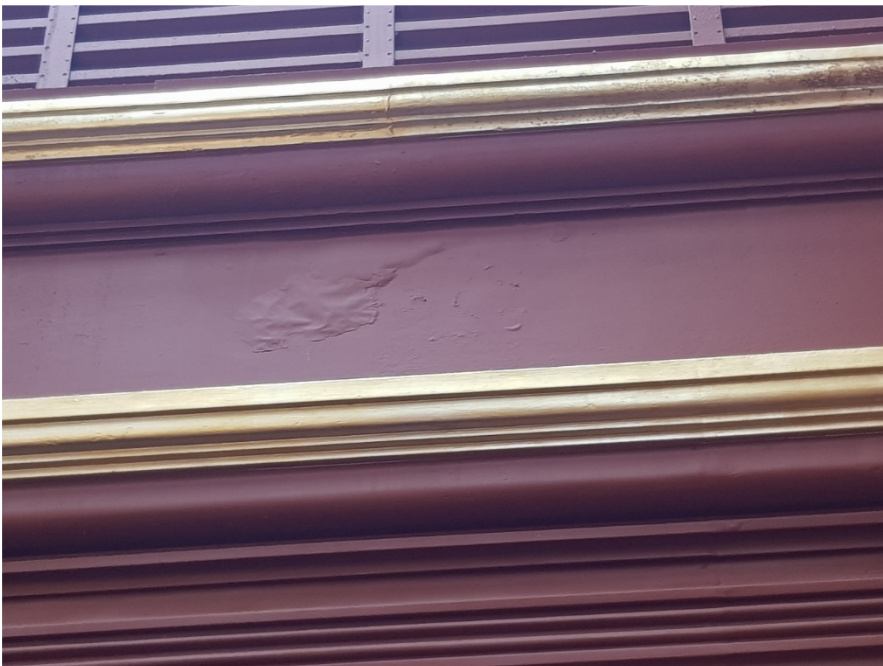
Figure 30: Signs of Water Ingress On Tea Room Entrance Roof
