Attachment G3

**Condition Assessment
Queen Victoria Building**

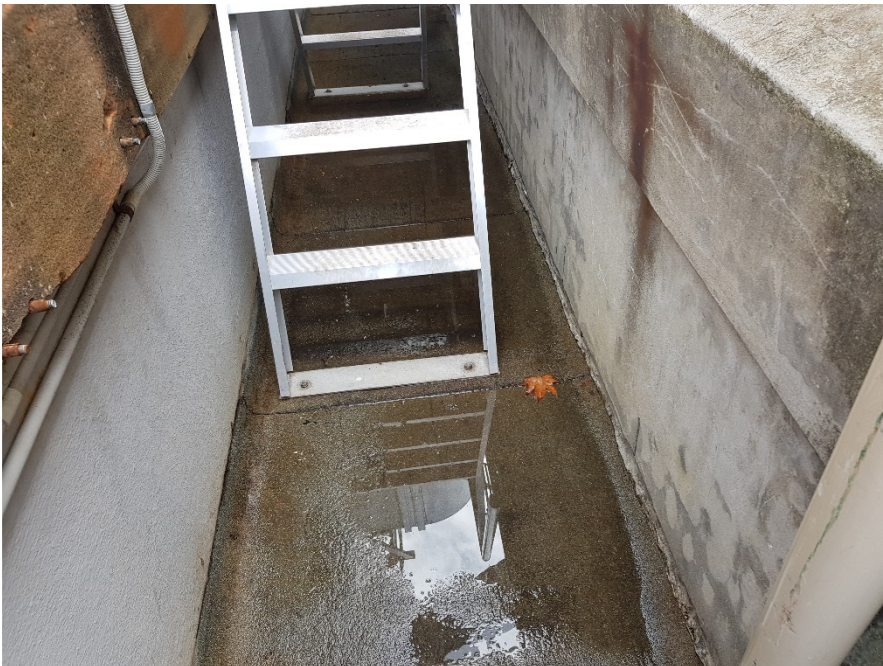
Figure 33: Ponding Water on North East Flat Roof

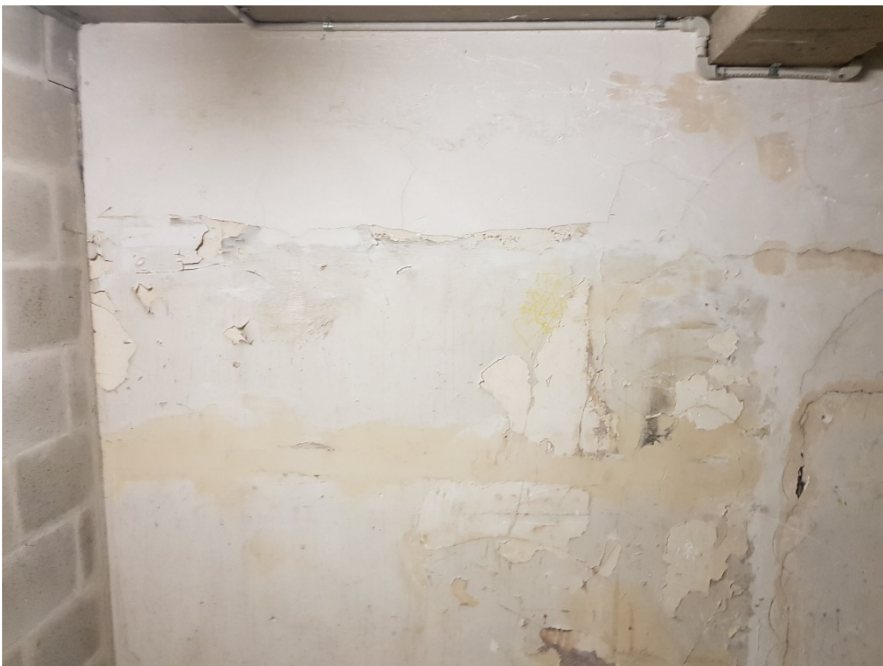
Figure 34: Damp Fire Escape Walls Under North West Flat Roof

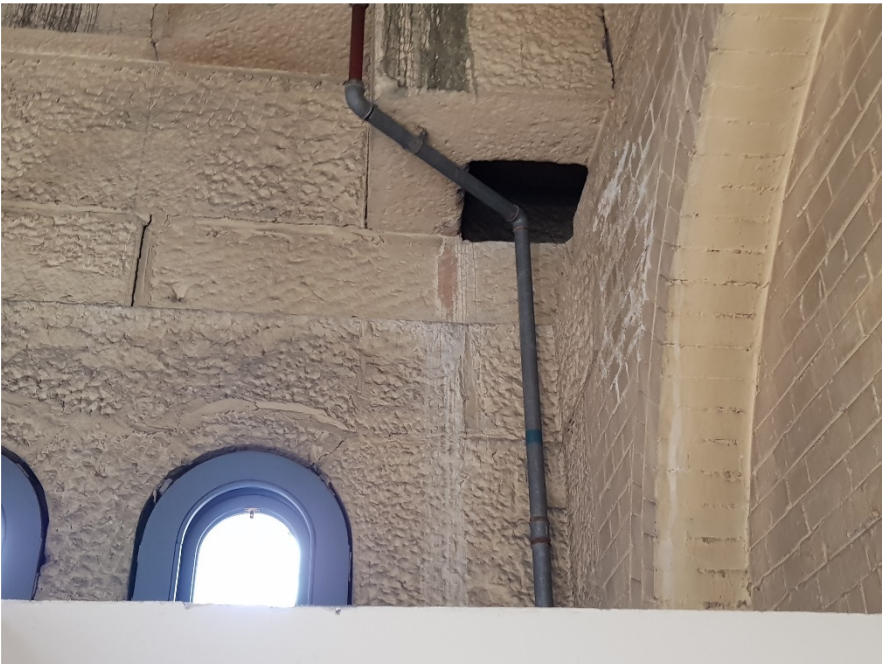
Figure 36: Water Staining From Dome Roof

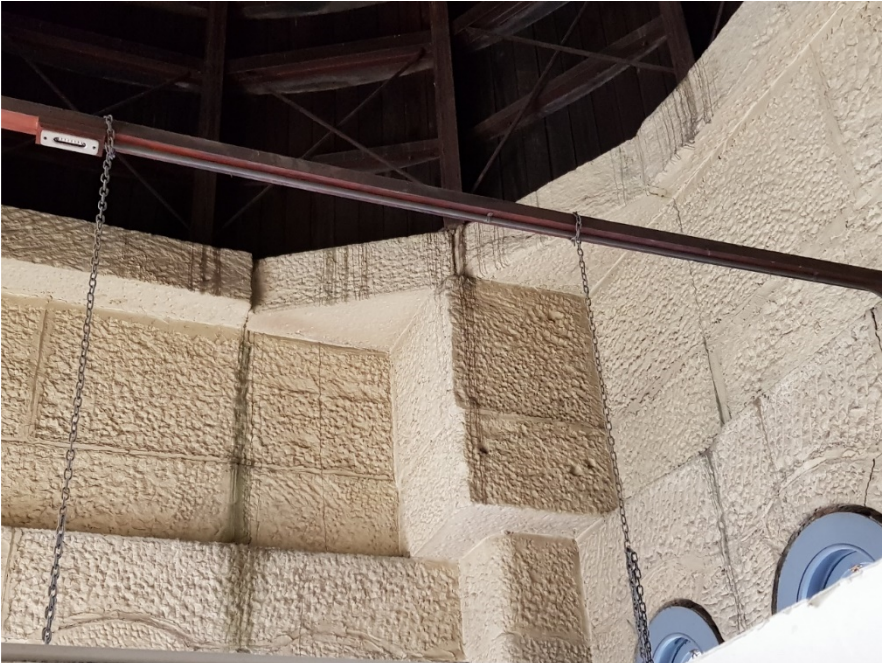
Figure 37: Water Staining From Dome Roof

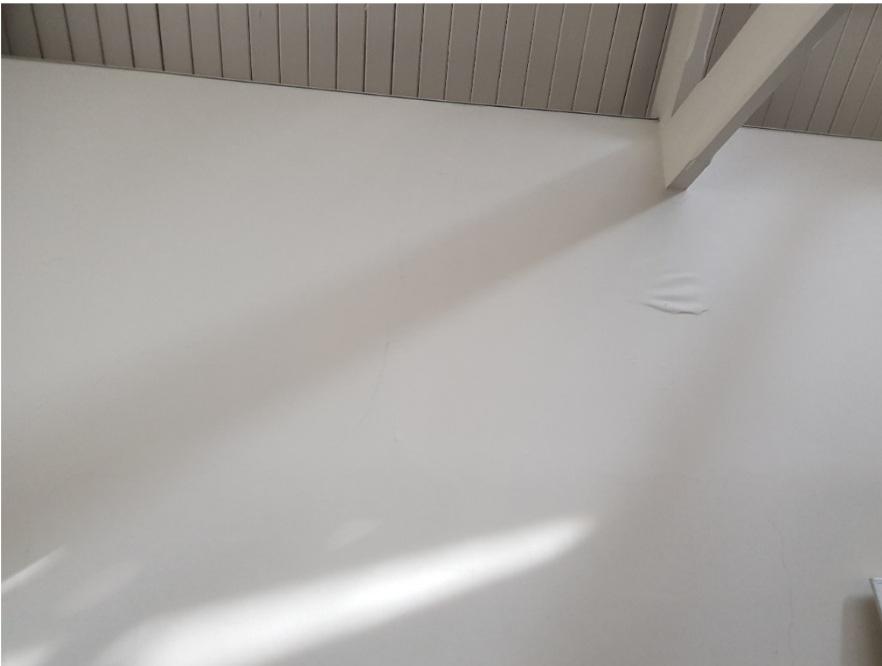
Figure 38: Signs of Water Ingress From The Victoria Room Roof

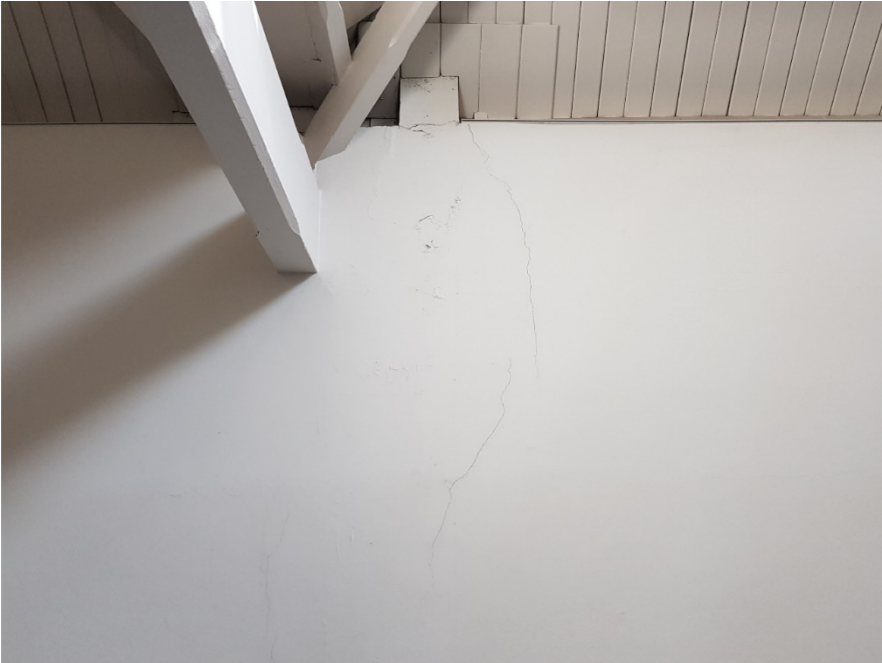
Figure 39: Signs of Water Ingress From The Victoria Room Roof

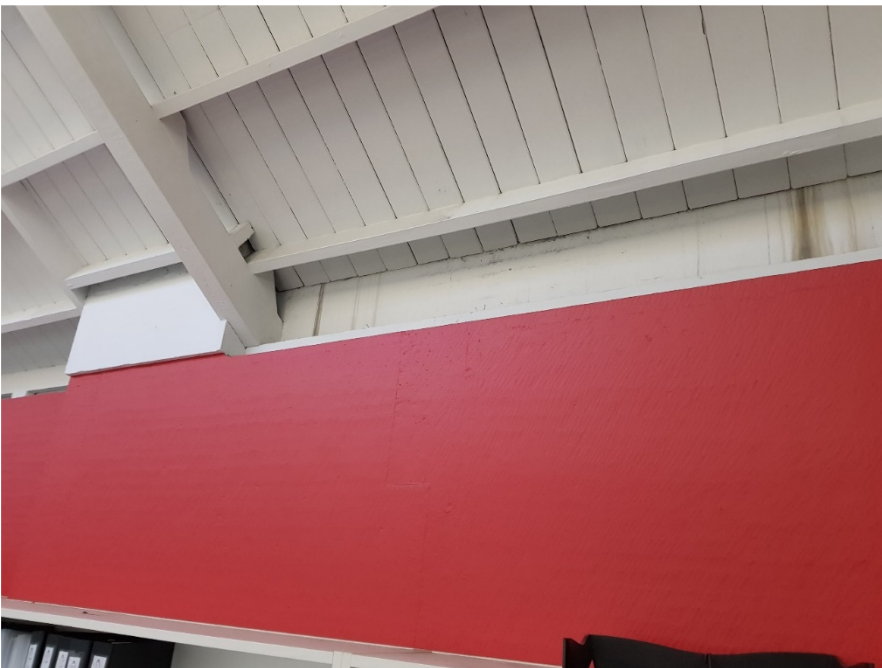
Figure 40: South East Meeting Room Water Staining

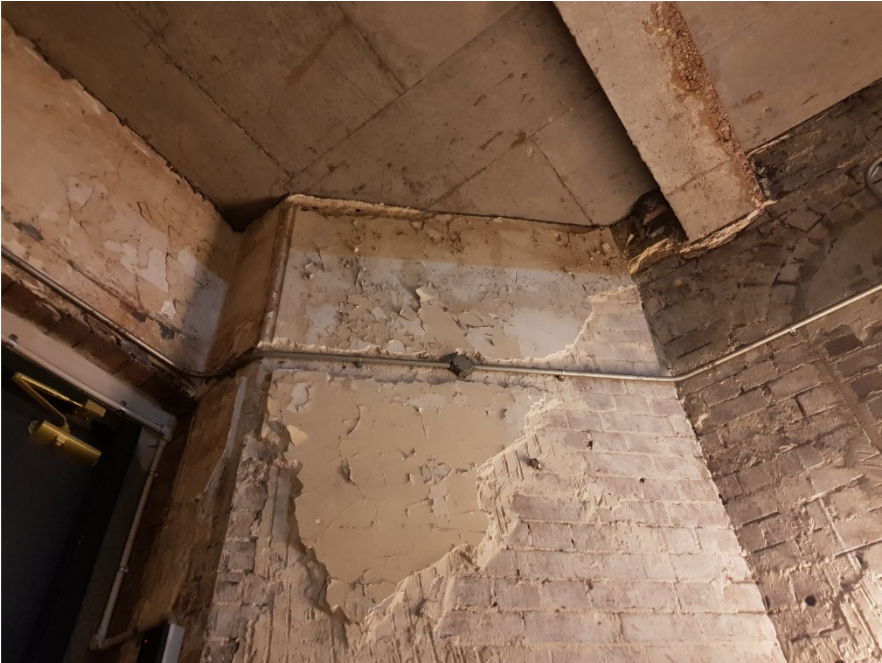
Figure 41: South Fire Escape Damp and Spalling Concrete

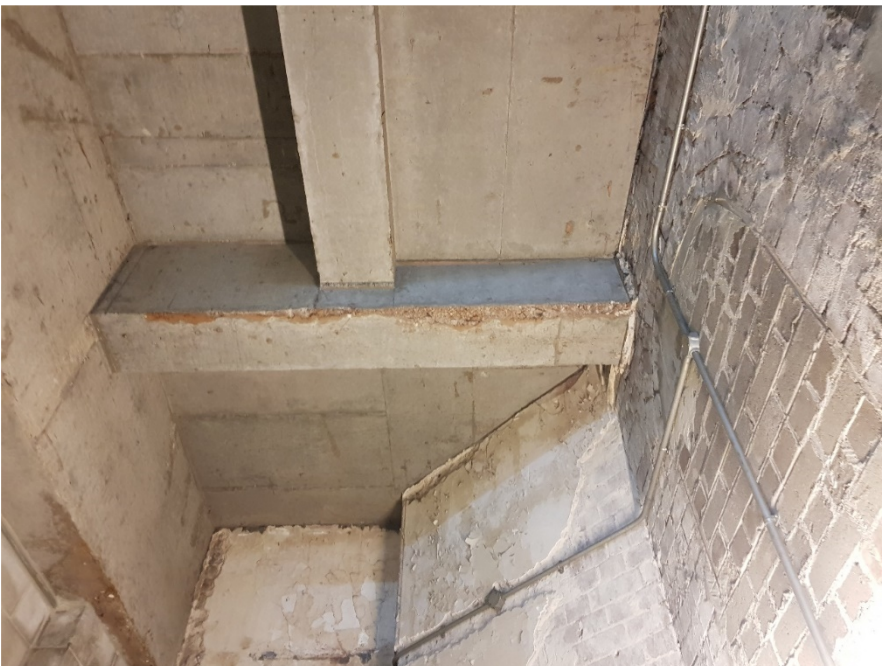
Figure 42: South Fire Escape Damp and Spalling Concrete

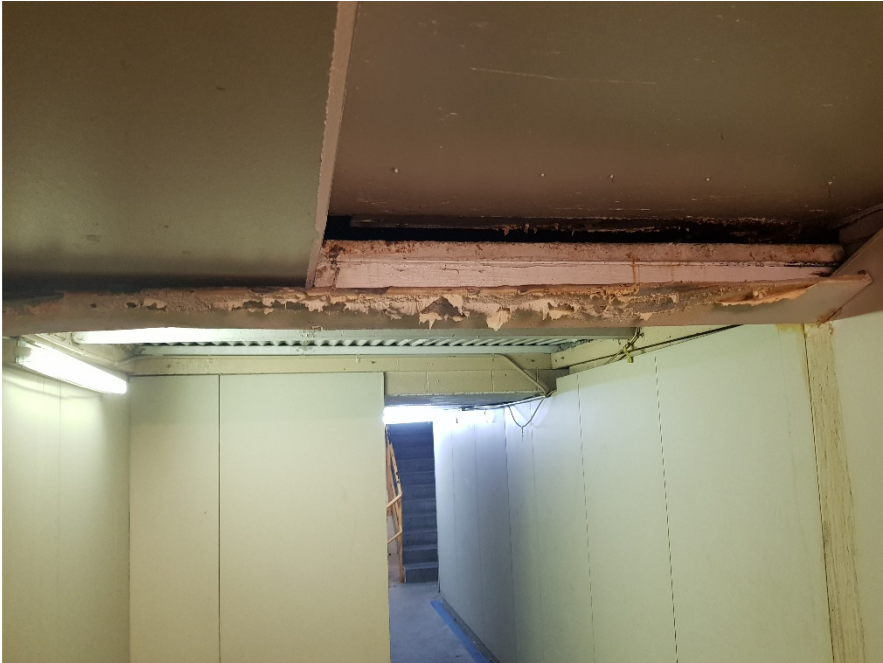
Figure 43: Water Staining Around Lower Ground Gutter in Service Corridor

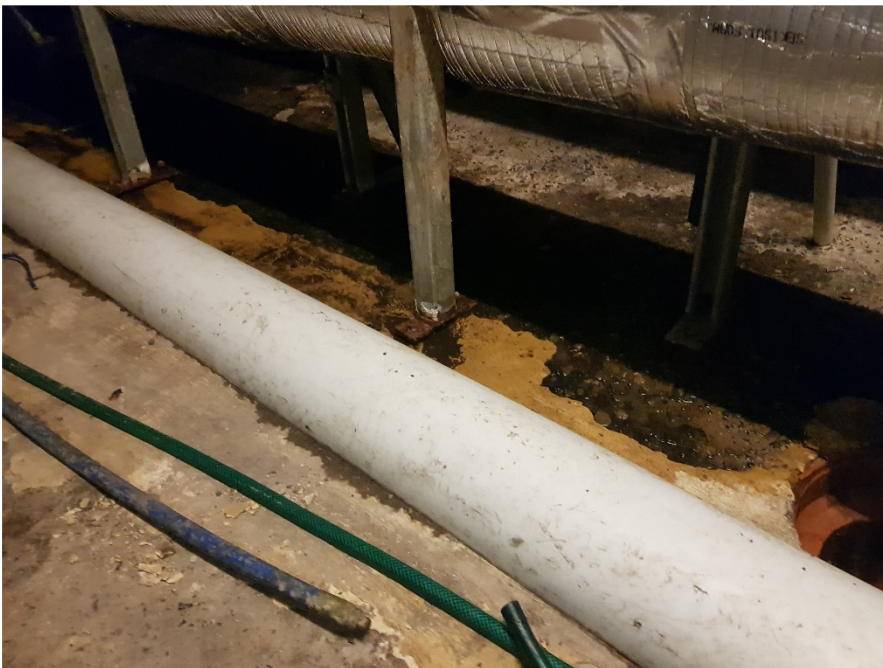
Figure 44: Ponding Water in Lower Ground Service Corridor

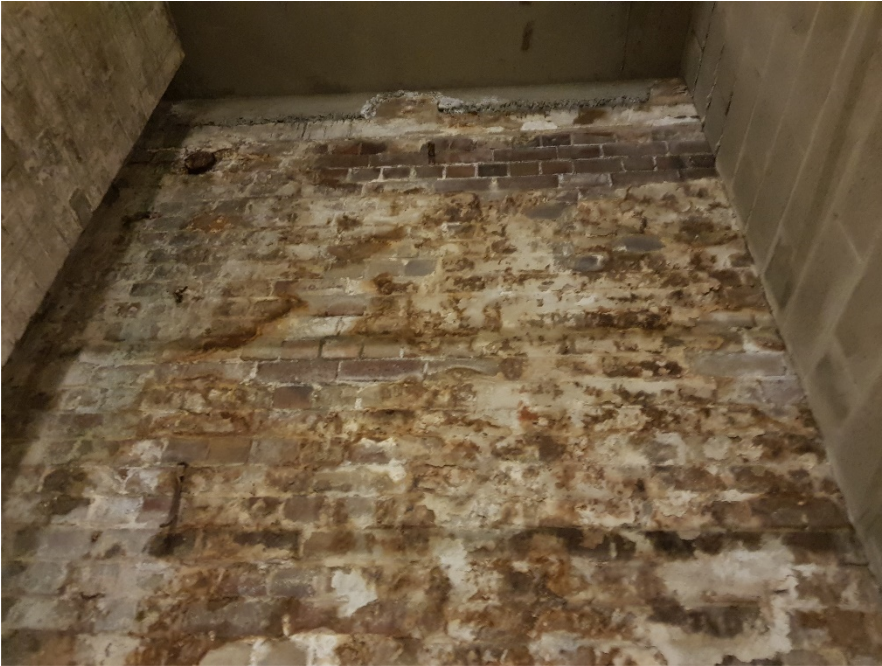
Figure 45: Damp Wall in Lower Ground Fire Escape

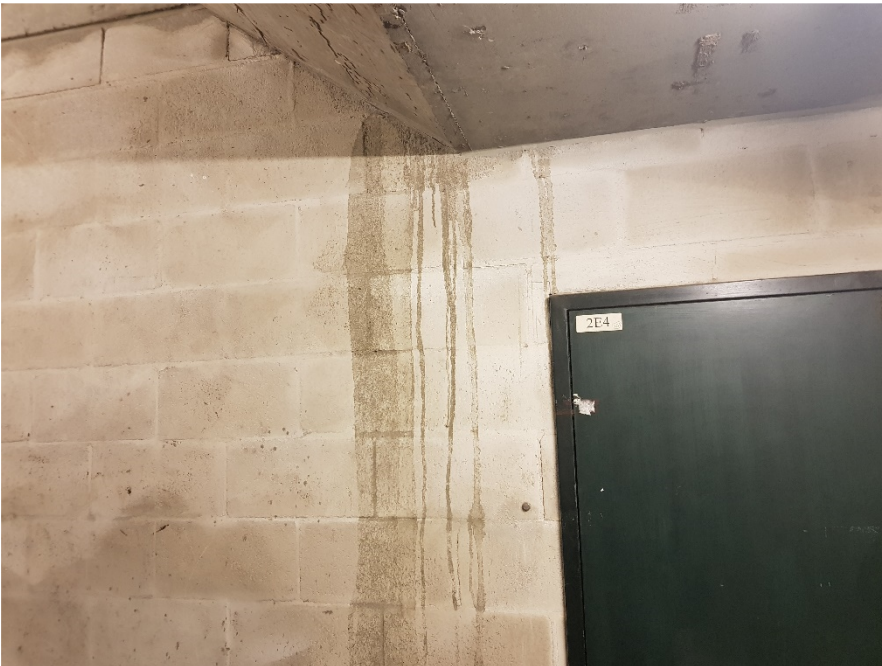
Figure 46: Signs of Water Ingress in Lower Ground Fire Escape

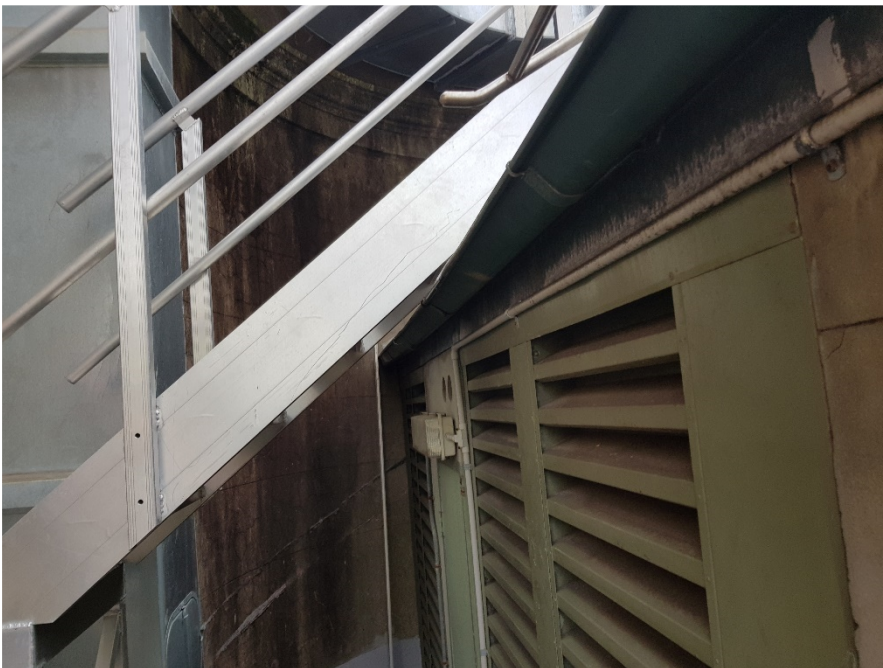
Figure 50: Bowing Gutter Above North West Flat Roof

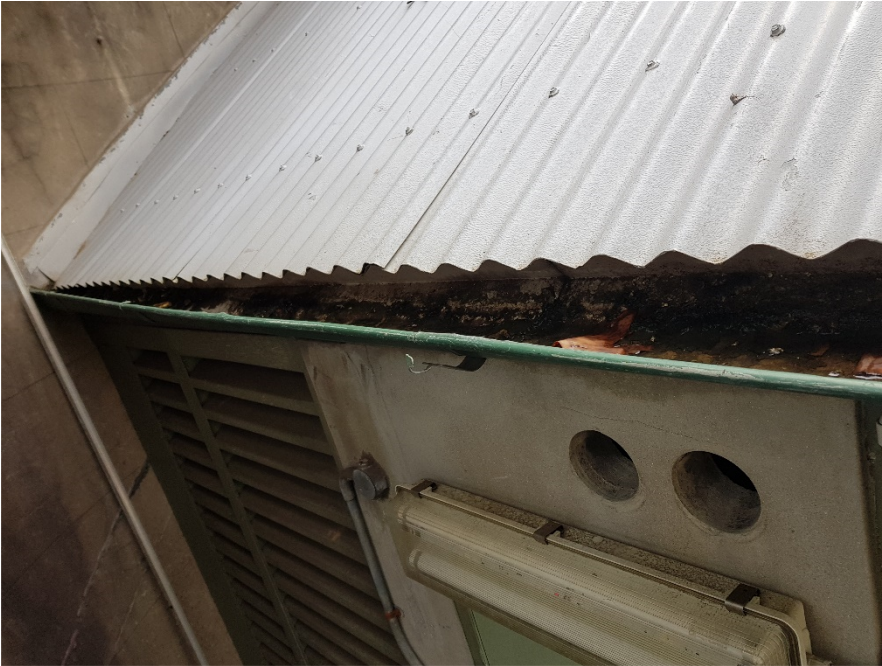
Figure 51: Broken Fixing on Gutter Above North West Flat Roof
