Preliminary Contamination Review

**Mirvac Office Developments Pty Ltd
Preliminary Contamination Assessment**

55 Pitt Street, Sydney NSW

12 December 2019

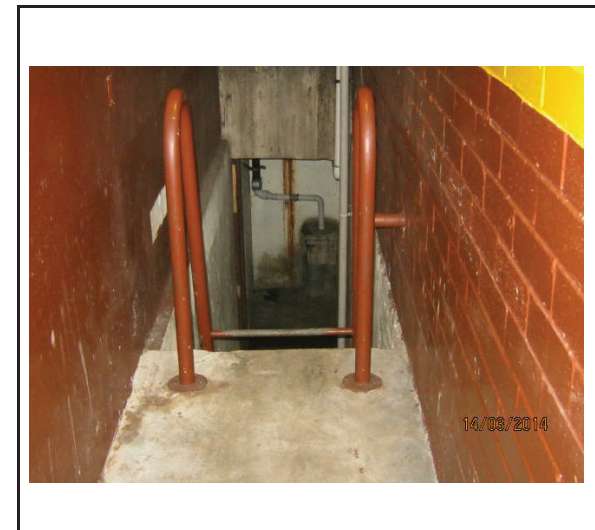
Photo 12: Sump pump room located on lower basement car park at 37 Pitt Street
