**Condition Assessment
Queen Victoria Building**

Queen Victoria Building Condition Assessment

23 July 2018

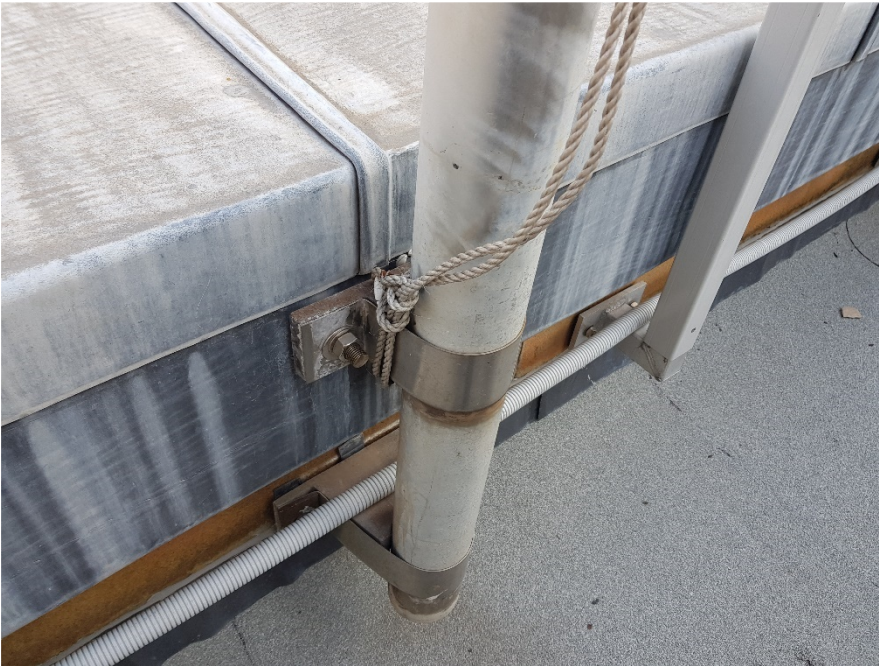
- The side connection to the flag pole in Figure 1 was found to be loose.
- The flag poles at the southern end looked to have potentially corroded bolts with insufficient threads.

Figure 1: Typical Connection for East and West Flag Poles

- All flag poles to be inspected and checked on a regular basis.
- Where defective fixings are identified they should be rectified as soon as possible.

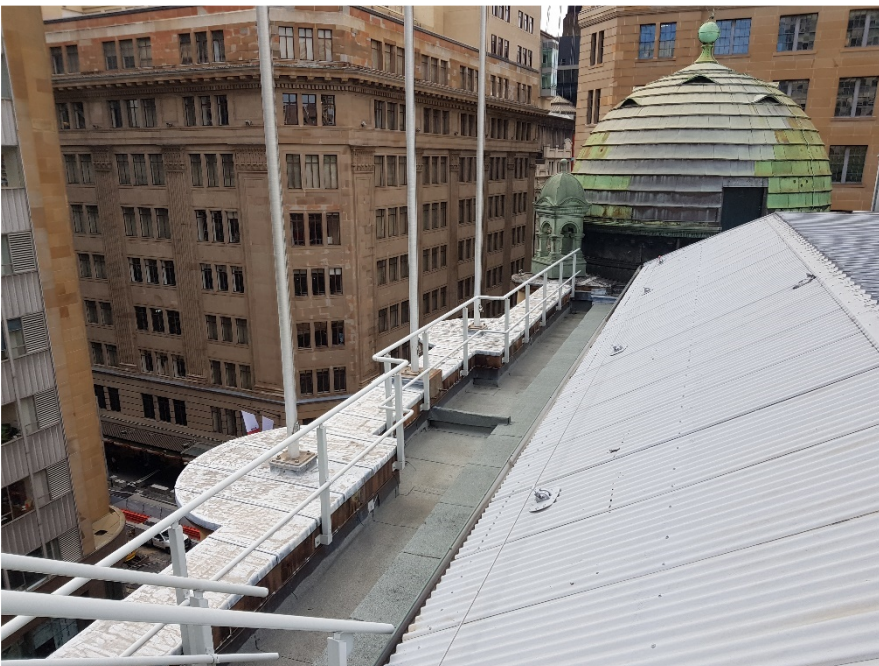
Figure 2: Flag Poles North End

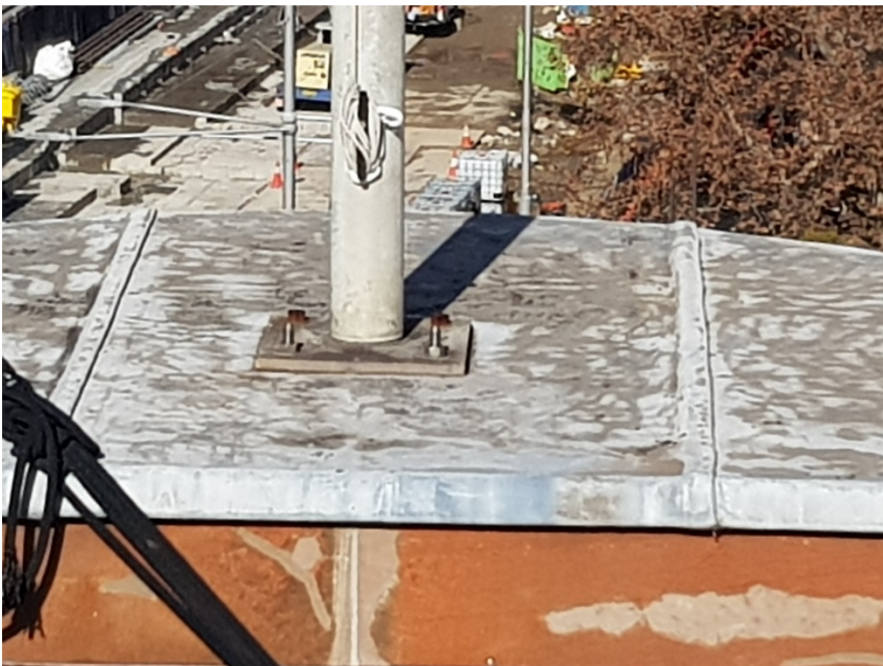
Figure 4: Corroded Flag Pole Connections South End

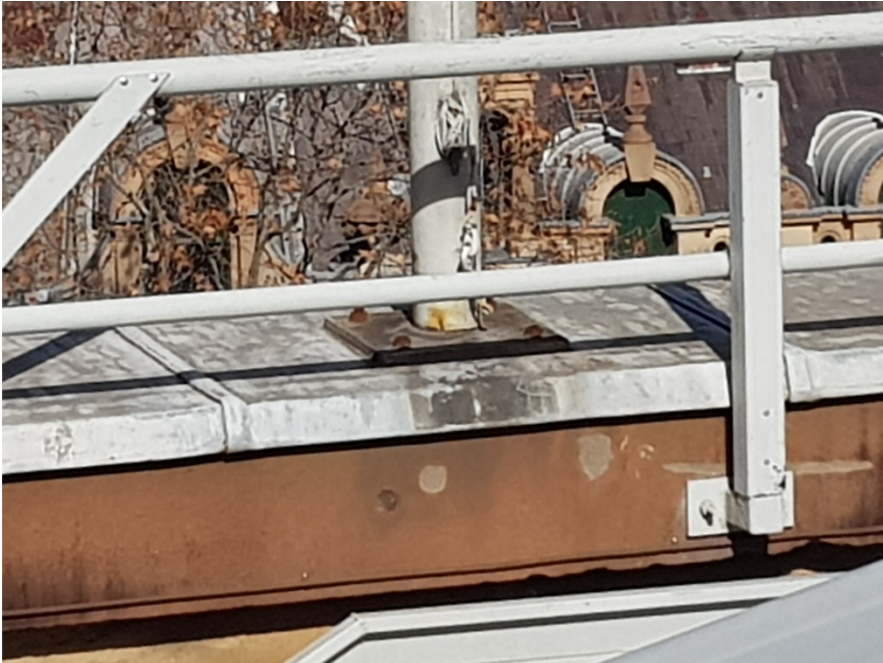
Figure 5: Corroded Flag Pole Connections South End

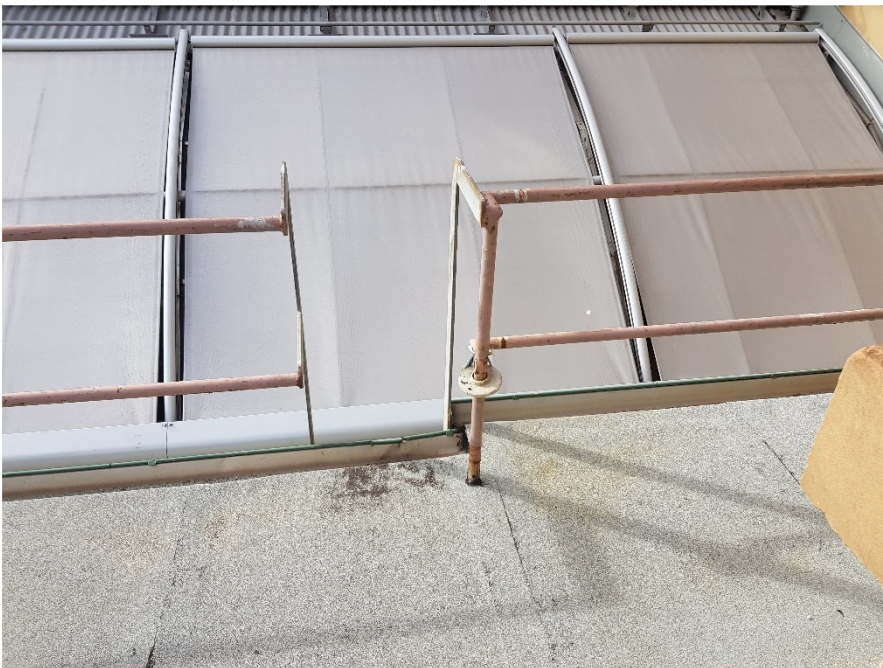
Figure 6: Balustrade North West

- A survey of roof access structures be made and a risk assessment carried out. And where necessary access should be upgraded to meet new codes.
- All fixings be checked during routine maintenance and replaced if necessary.

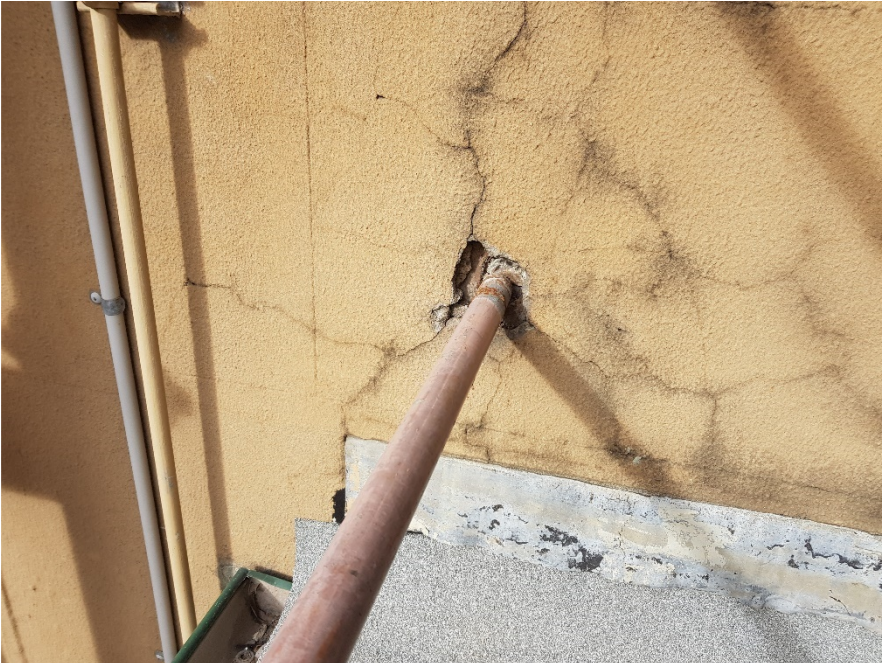
Figures 6-12 show example photos of the access structures found on the building's roof. Figures 7 and 8 show an original railing having broken off from the embedded end. Figure 12 shows an unbolted end to a railing on one of the new lightweight walkways.

Figure 7: North West Balustrade Closest to Central Dome Fixing

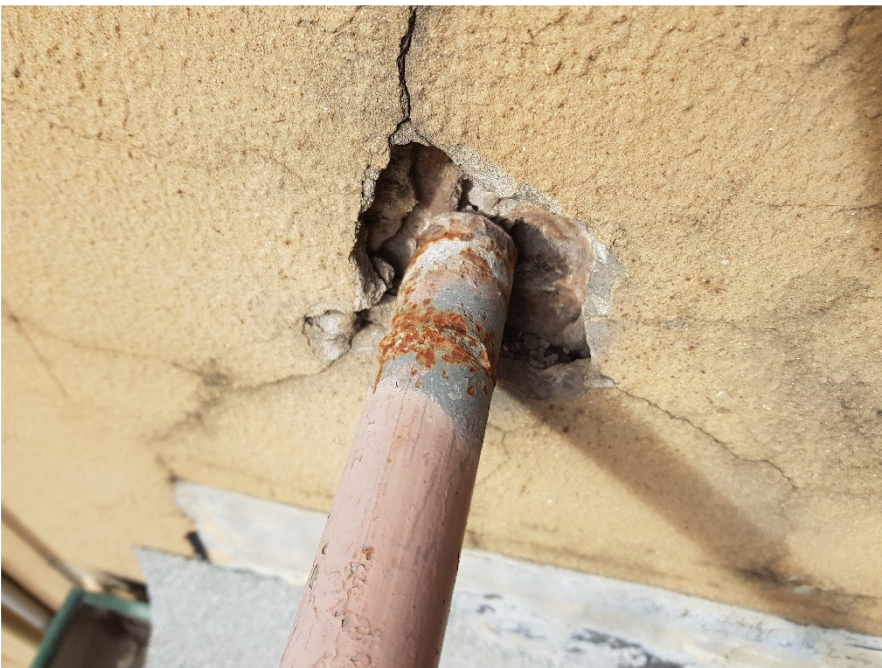
Figure 8: Original Railing Broken Off from Wall

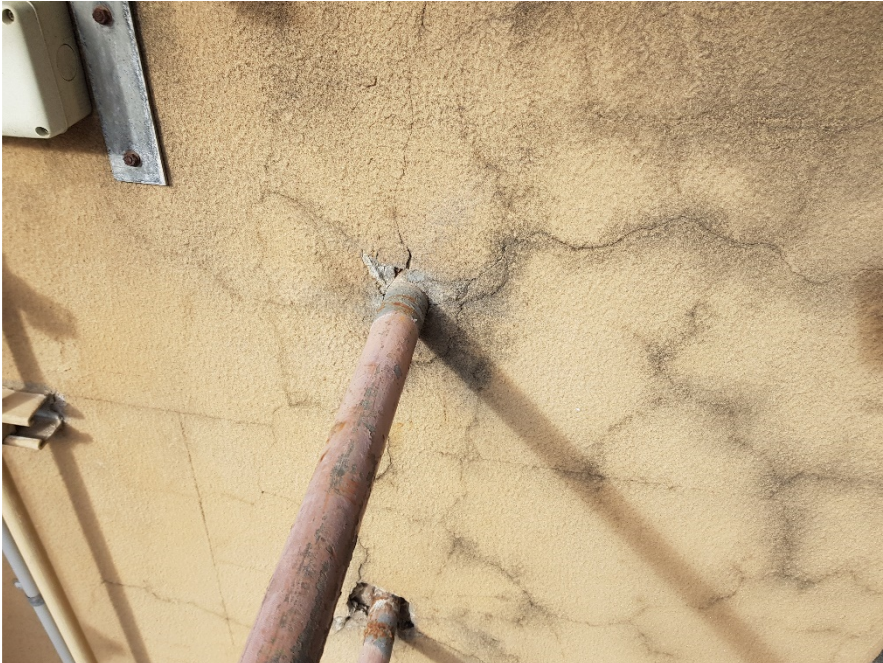
Figure 9: Cracking Around Embedded Railing

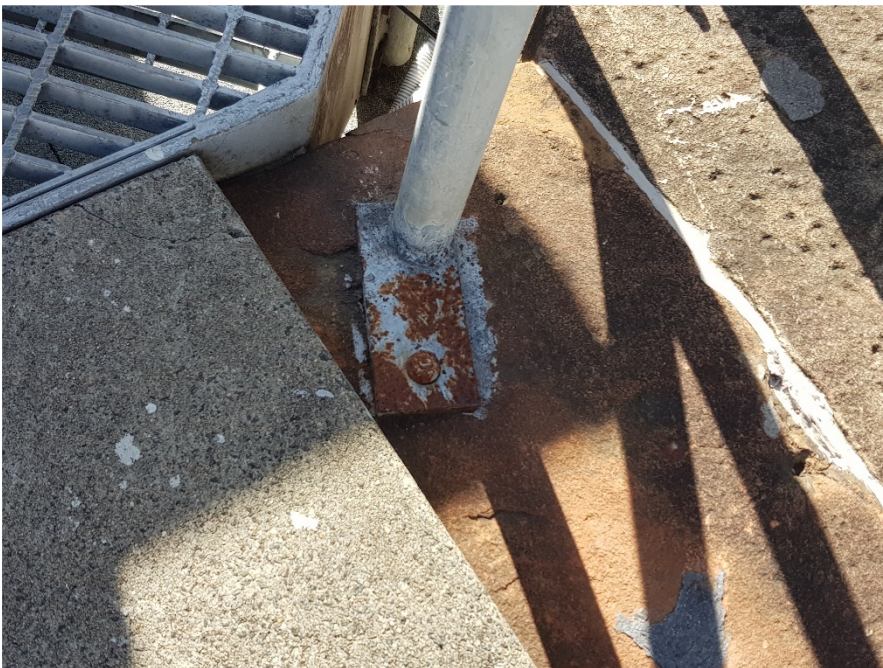
Figure 10: Corroded Connection of Access Structure South End
