# **Attachment G2**

**Condition Assessment  
Queen Victoria Building**

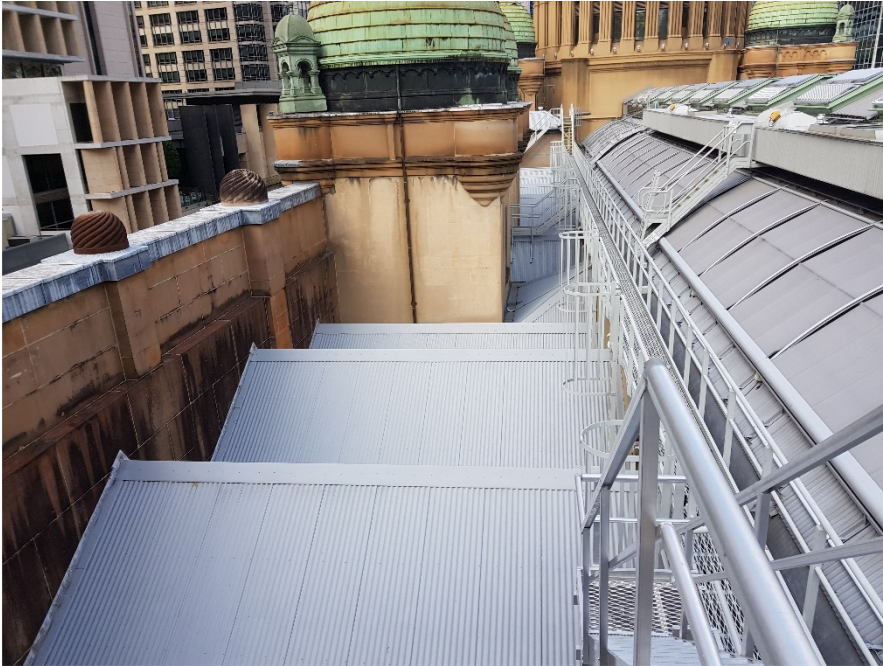
**Figure 11: Typical New Access Walkways**

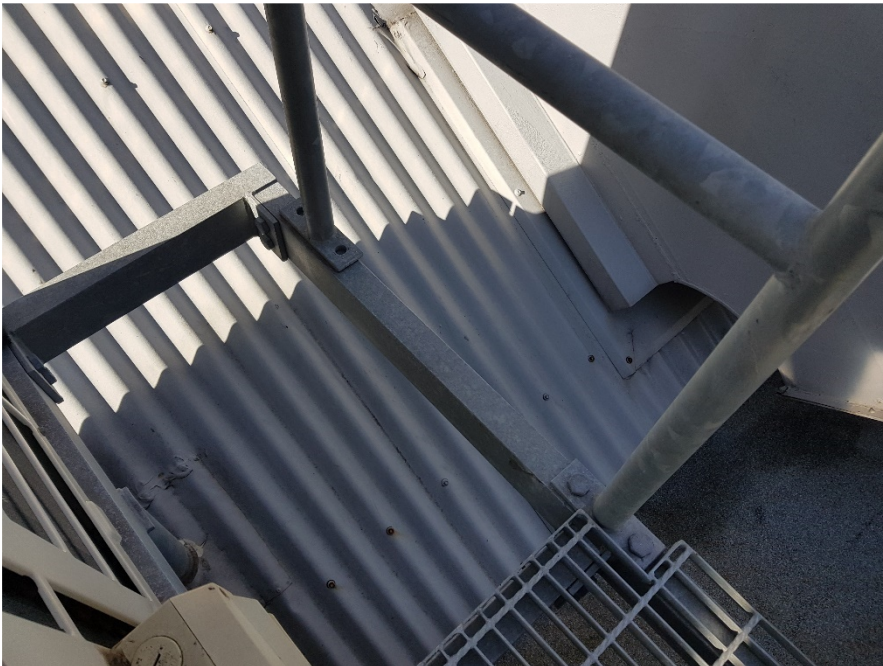
**Figure 12: Missing Bolts on Balustrade South End**

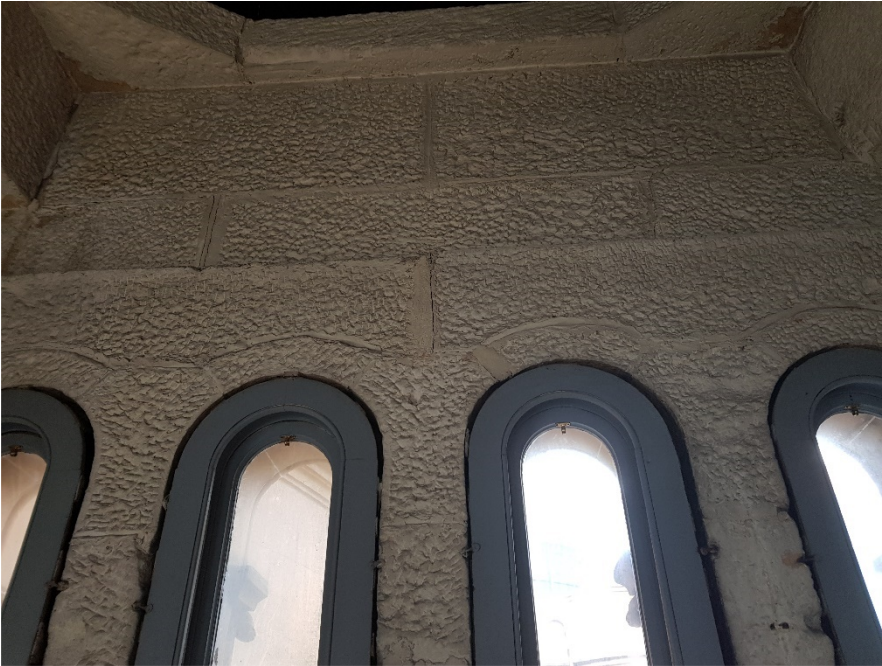
**Figure 13: Diagonal Cracking Through Bed Joints Above Windows**

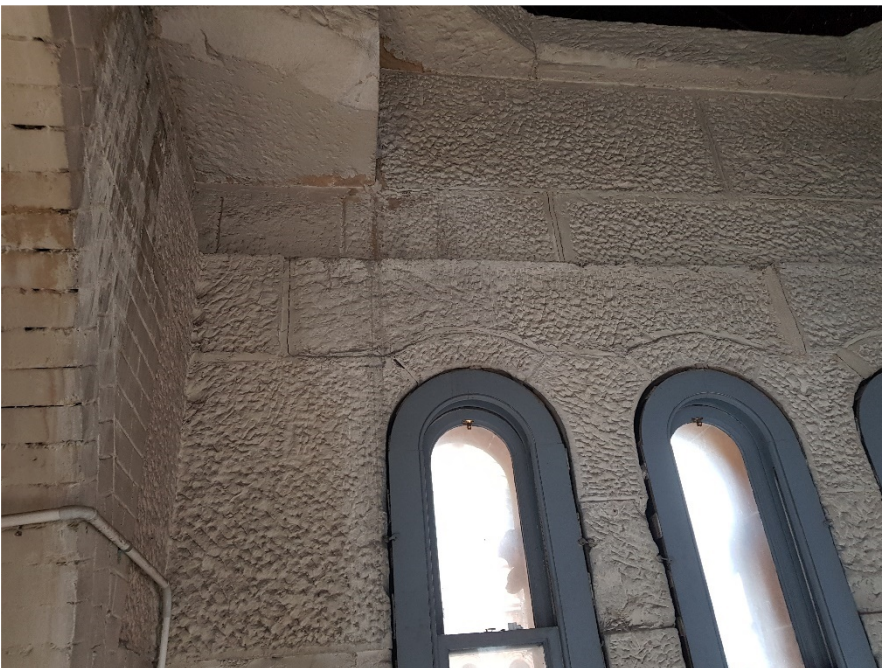
**Figure 14: Diagonal Cracking Through Bed Joints Above Windows**

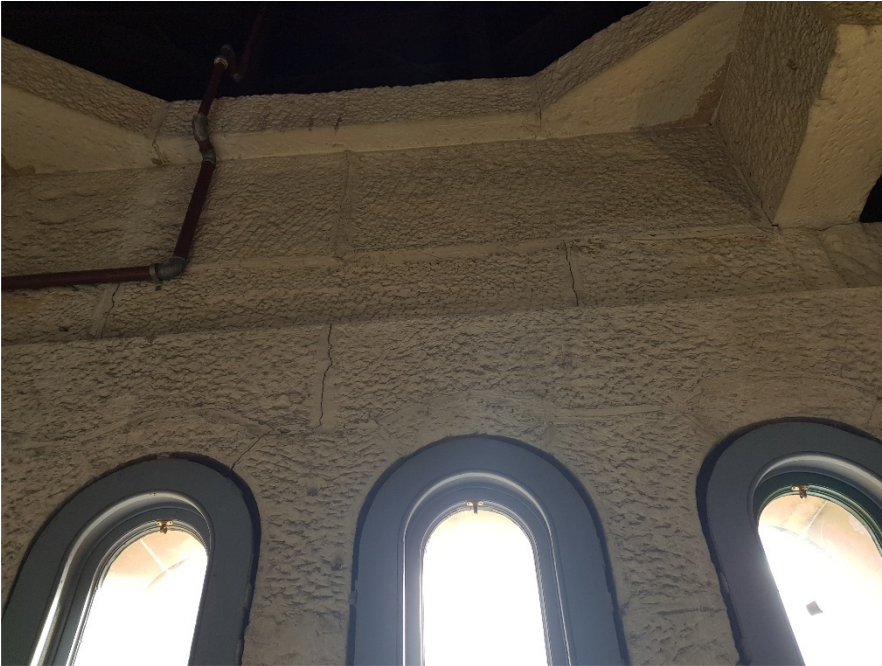
**Figure 15: Diagonal Cracking Through Bed Joints Above Windows**

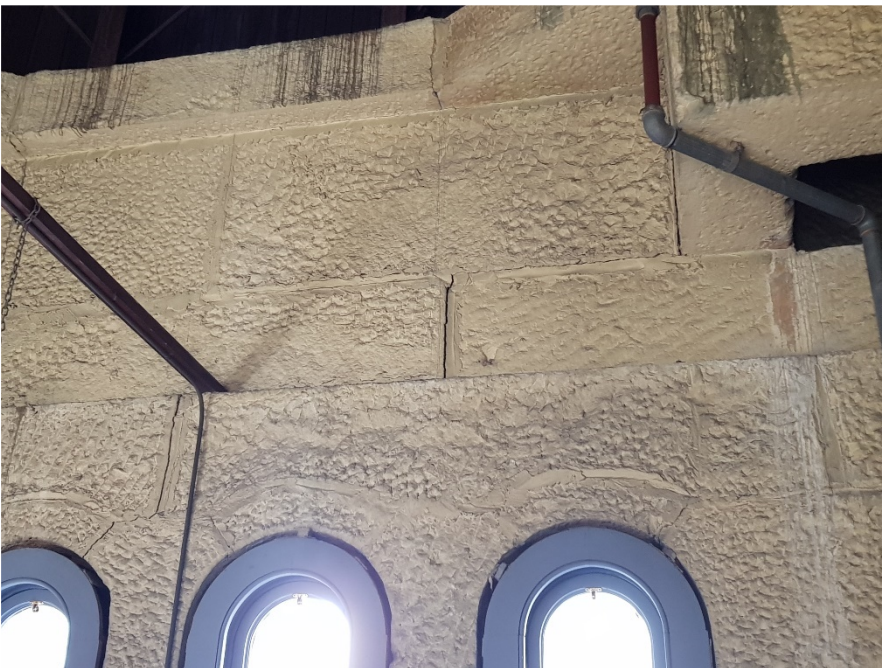
**Figure 16: Diagonal Cracking Through Bed Joints Above Windows**

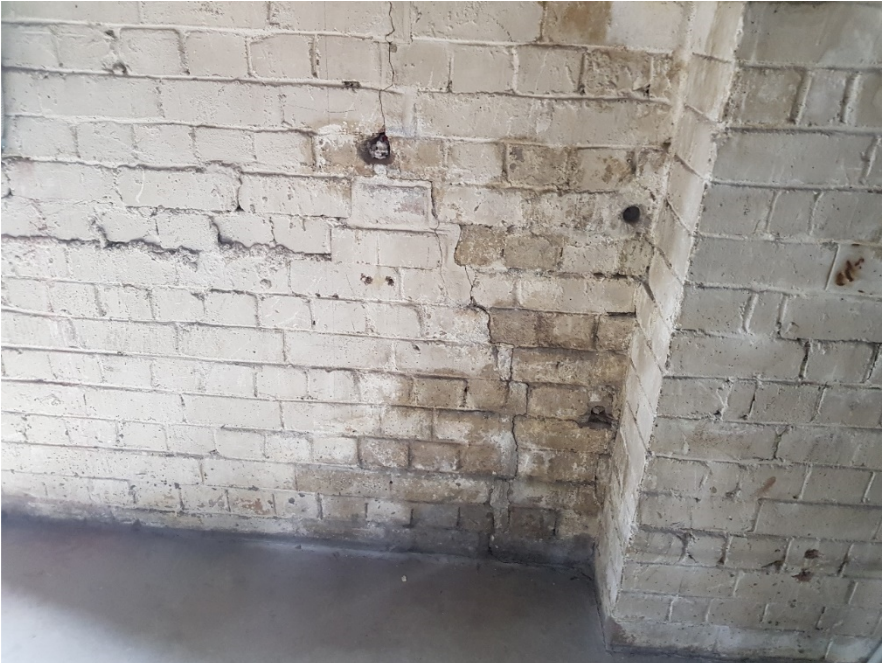
**Figure 17: Cracking Around Old Embedded Fixings**

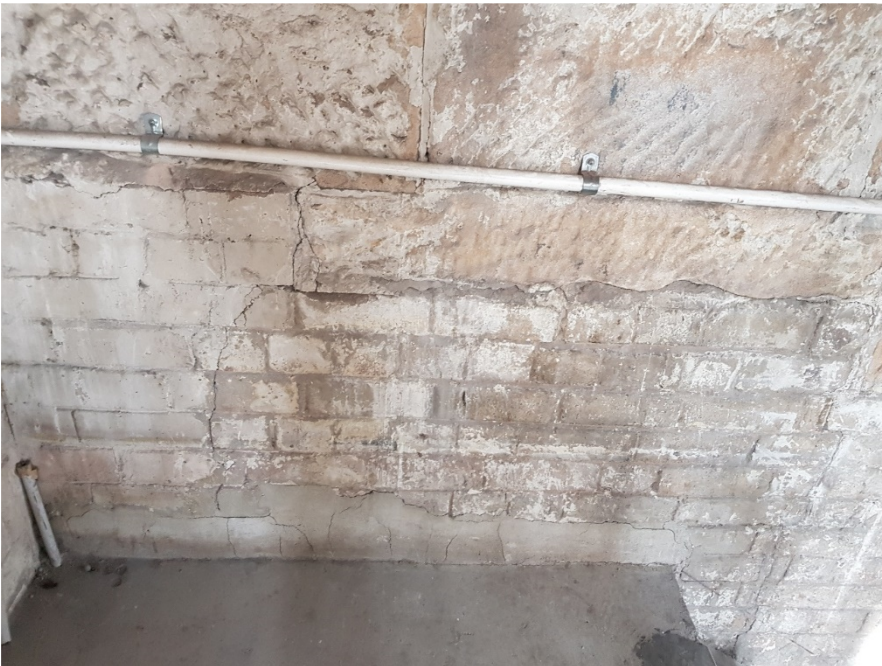
**Figure 18: Vertical Cracking at Sandstone Brick Interface**

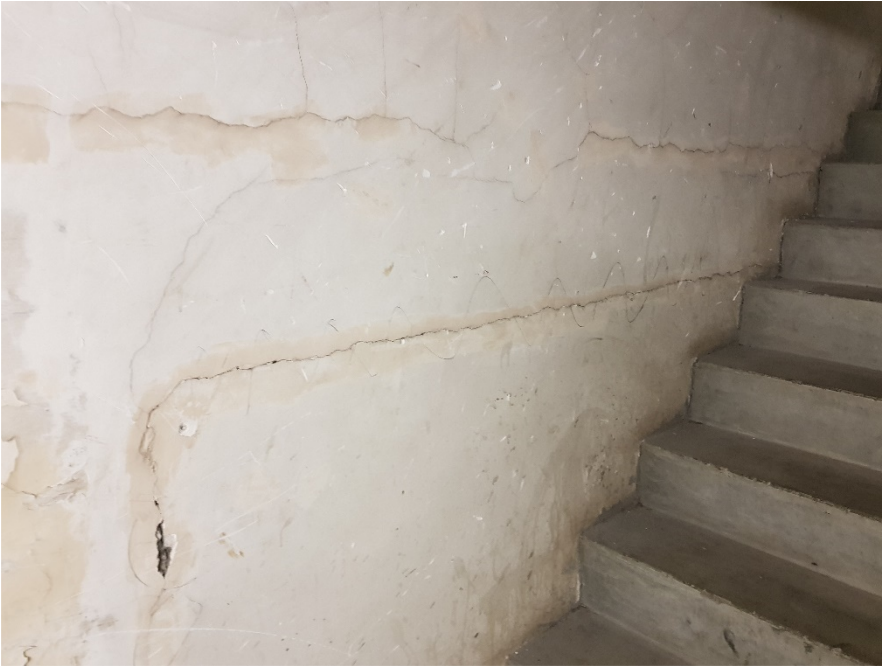
**Figure 19: Cracking in Northern Fire Escape Walls**

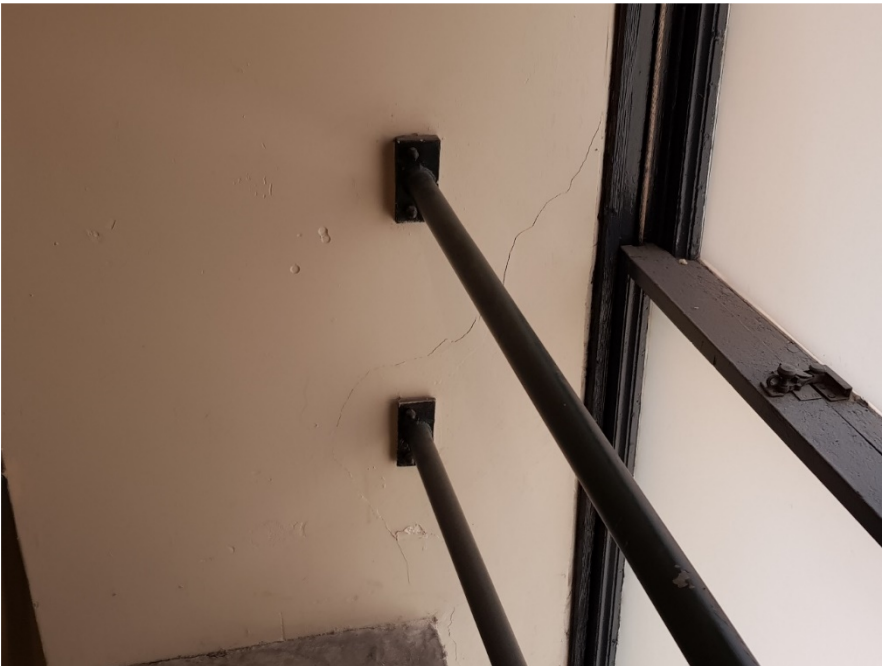
**Figure 20: Cracking Around Railing Fixings**

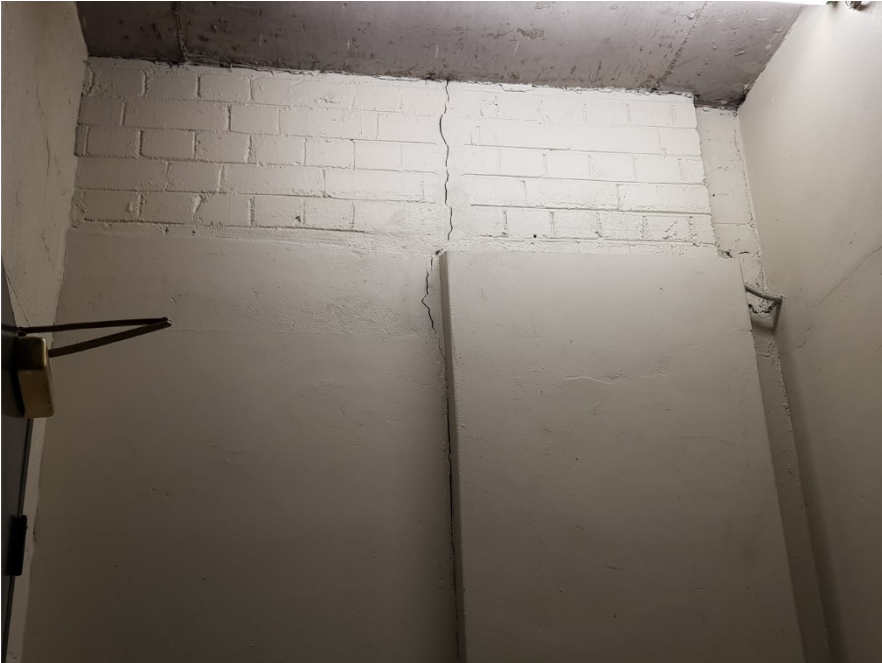
**Figure 21: Vertical Cracking in Masonry**

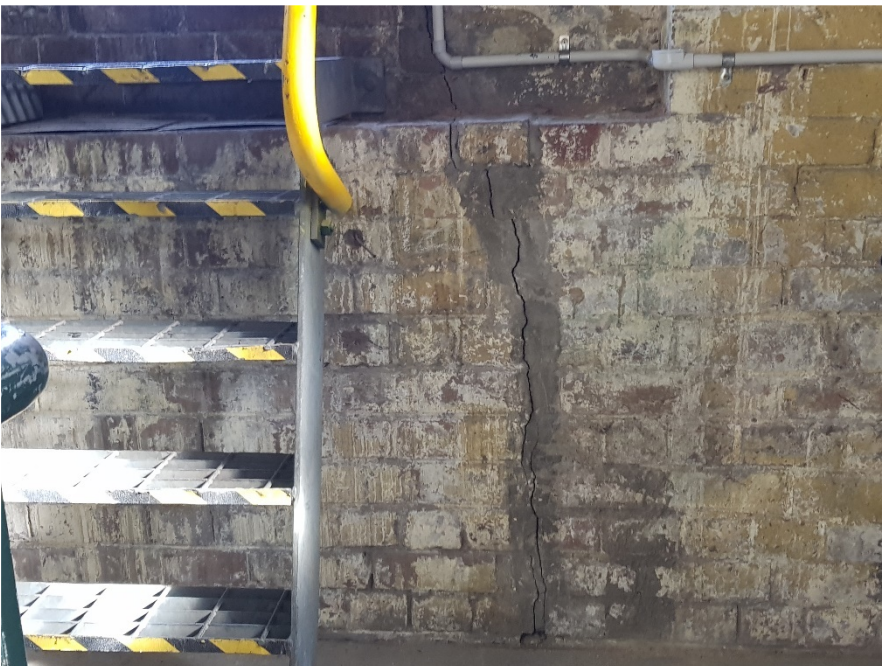
**Figure 22: Vertical Cracking in Masonry**

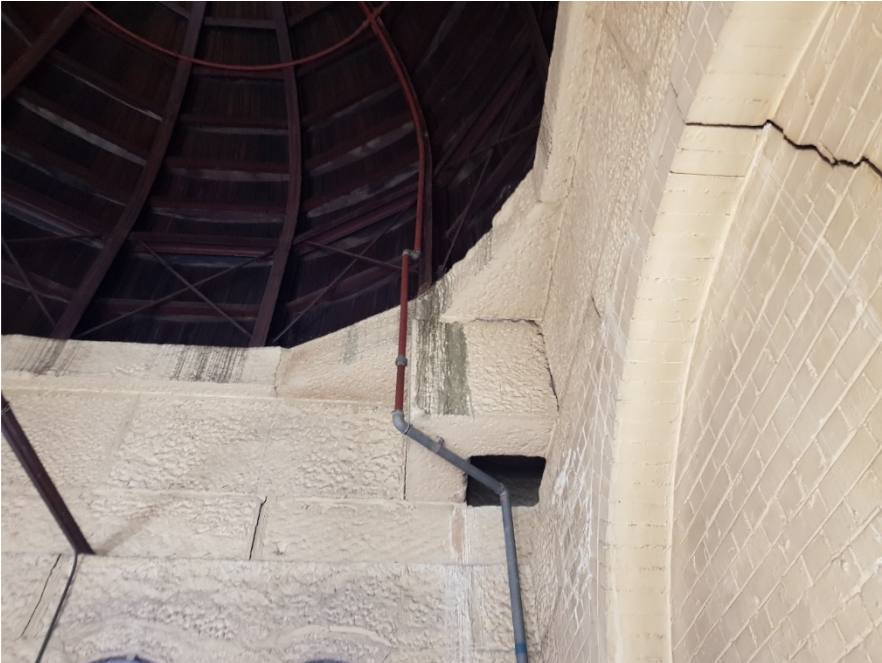
**Figure 23: Vertical Cracking in Dome Masonry**

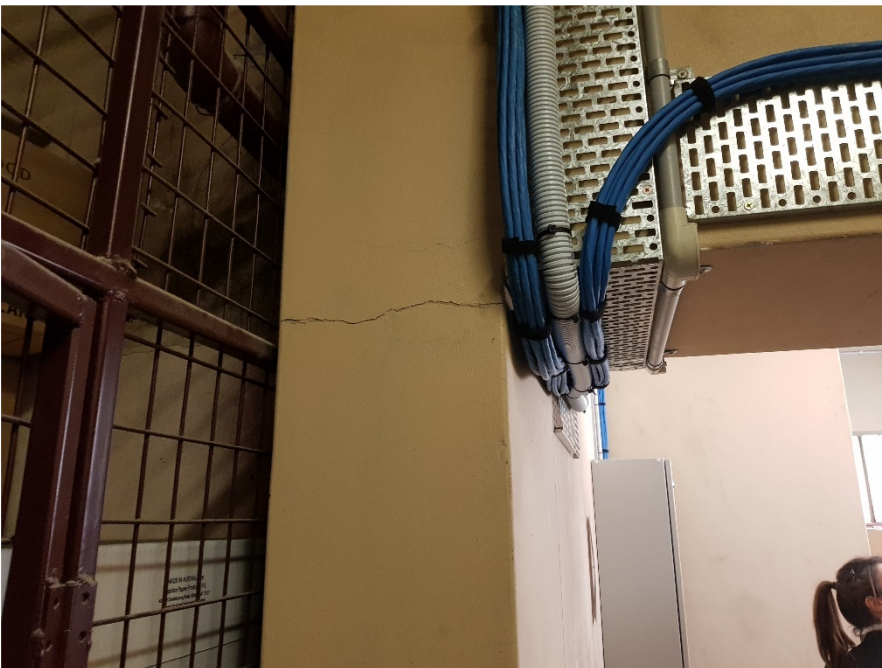
**Figure 24: Horizontal Crack in Column**

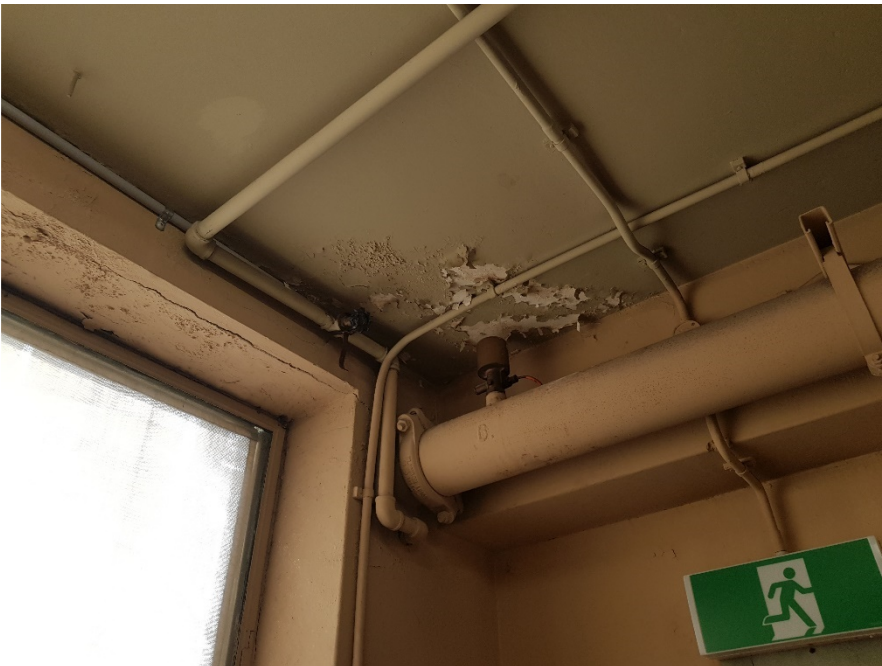
**Figure 25: Cracking in Lintel**

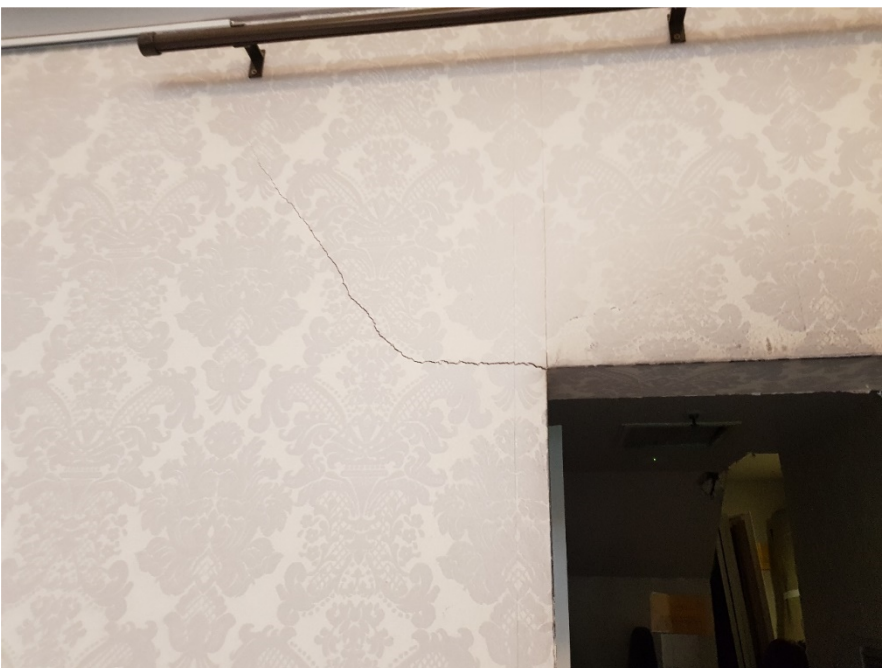
**Figure 26: Diagonal Cracking in Tea Room Lintel**

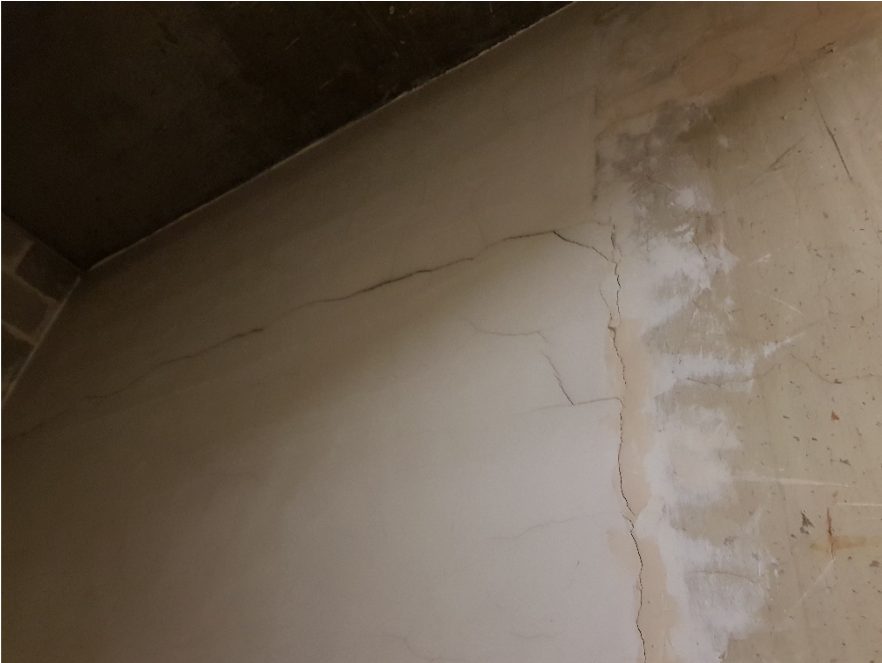
**Figure 27: Fire Escape Cracking**

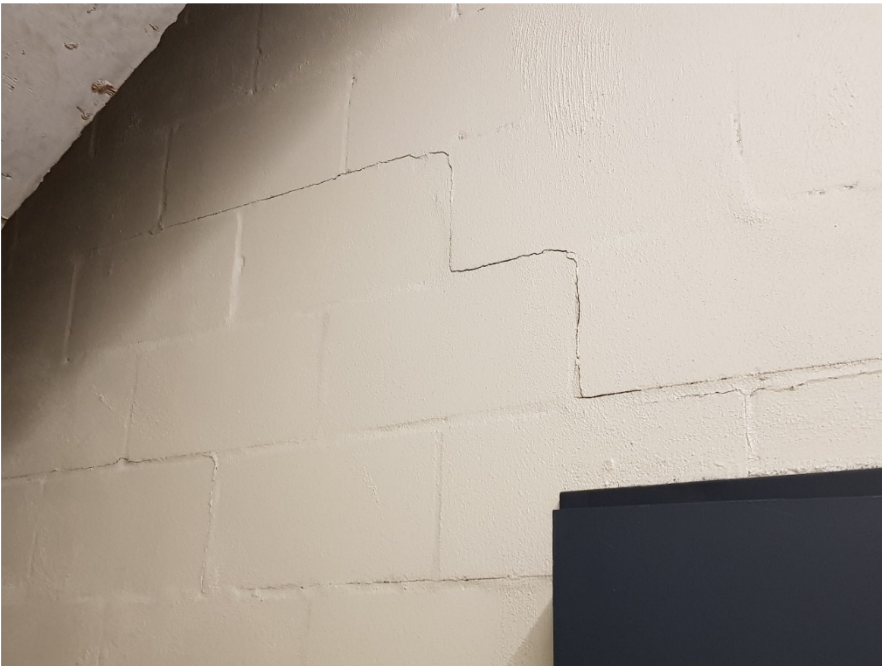
**Figure 28: Diagonal Cracking Above Fire Escape Door Opening**

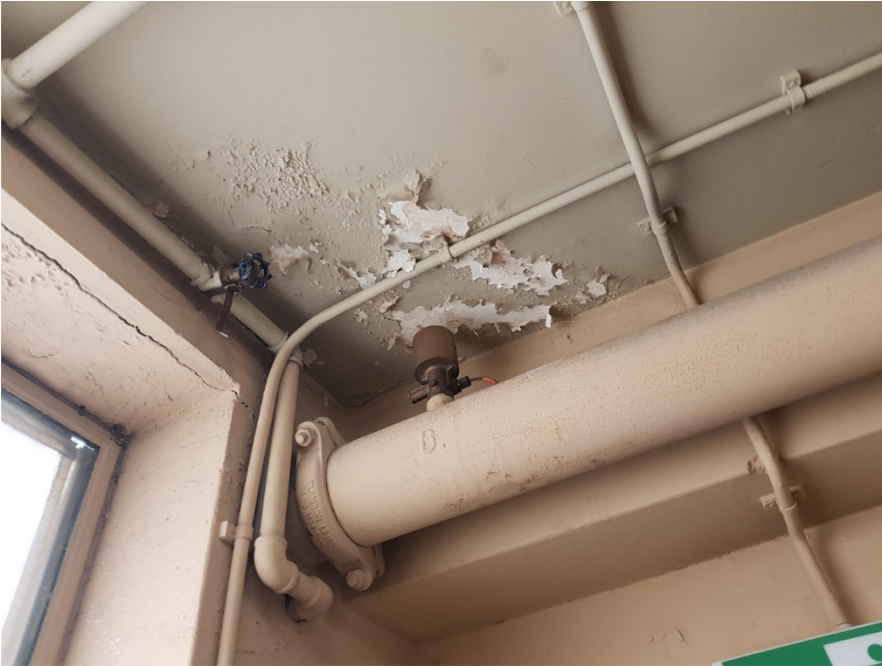
**Figure 29: Spalling Concrete**

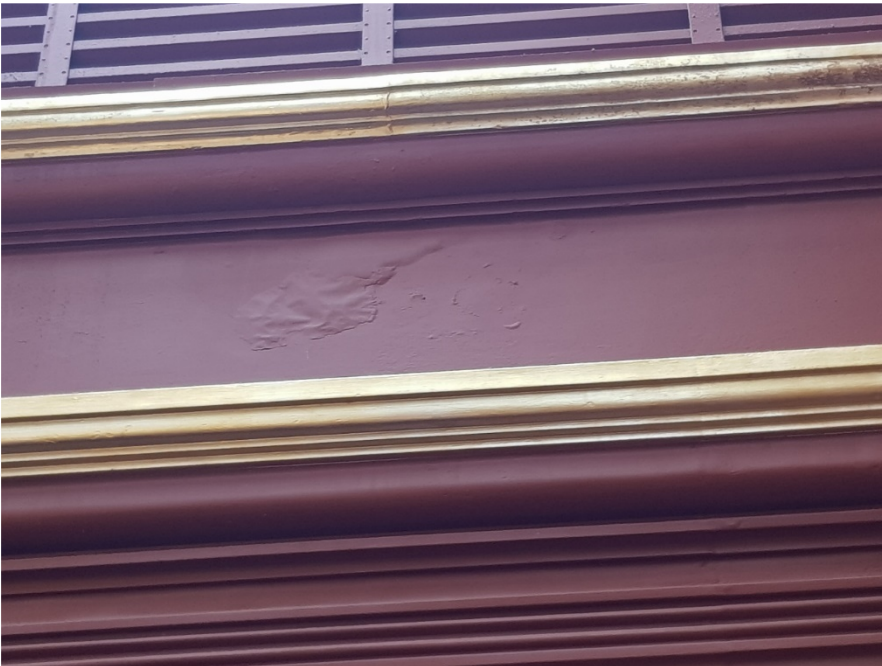
**Figure 30: Signs of Water Ingress On Tea Room Entrance Roof**

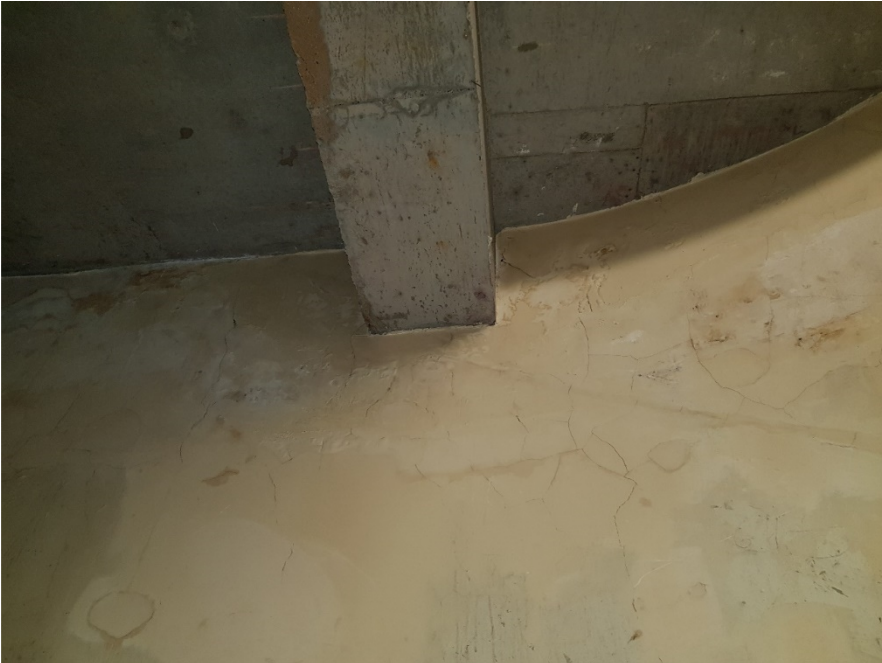
**Figure 31: Damp Walls in Fire Escape**

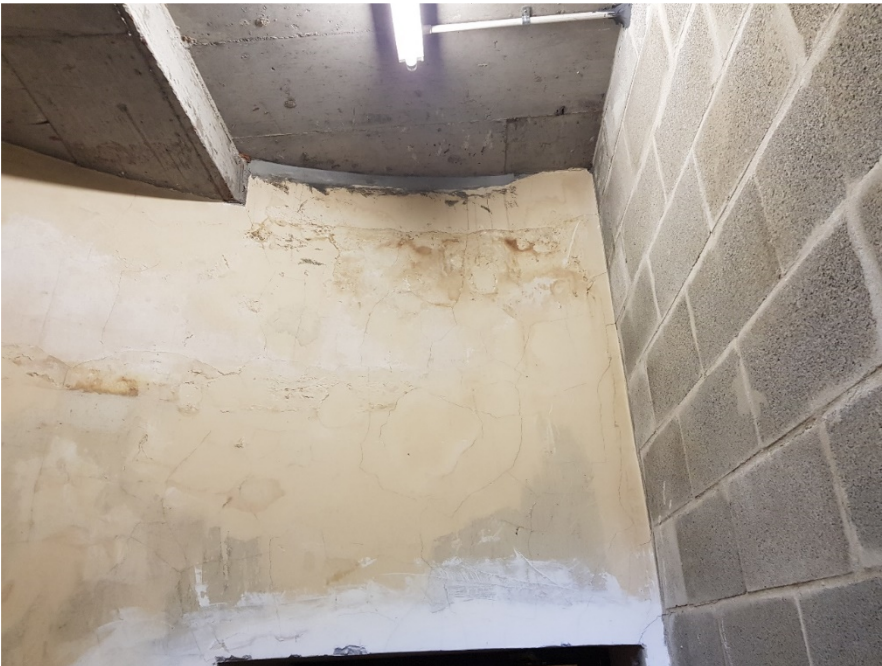
**Figure 32: Damp Fire Escape Walls Under North West Flat Roof**
