Demolition Methodology

Demolition Methodology – Dividing walls and shared chimneys
108-110-112 Victoria Street
Beaconsfield NSW 2015

03 February 2022

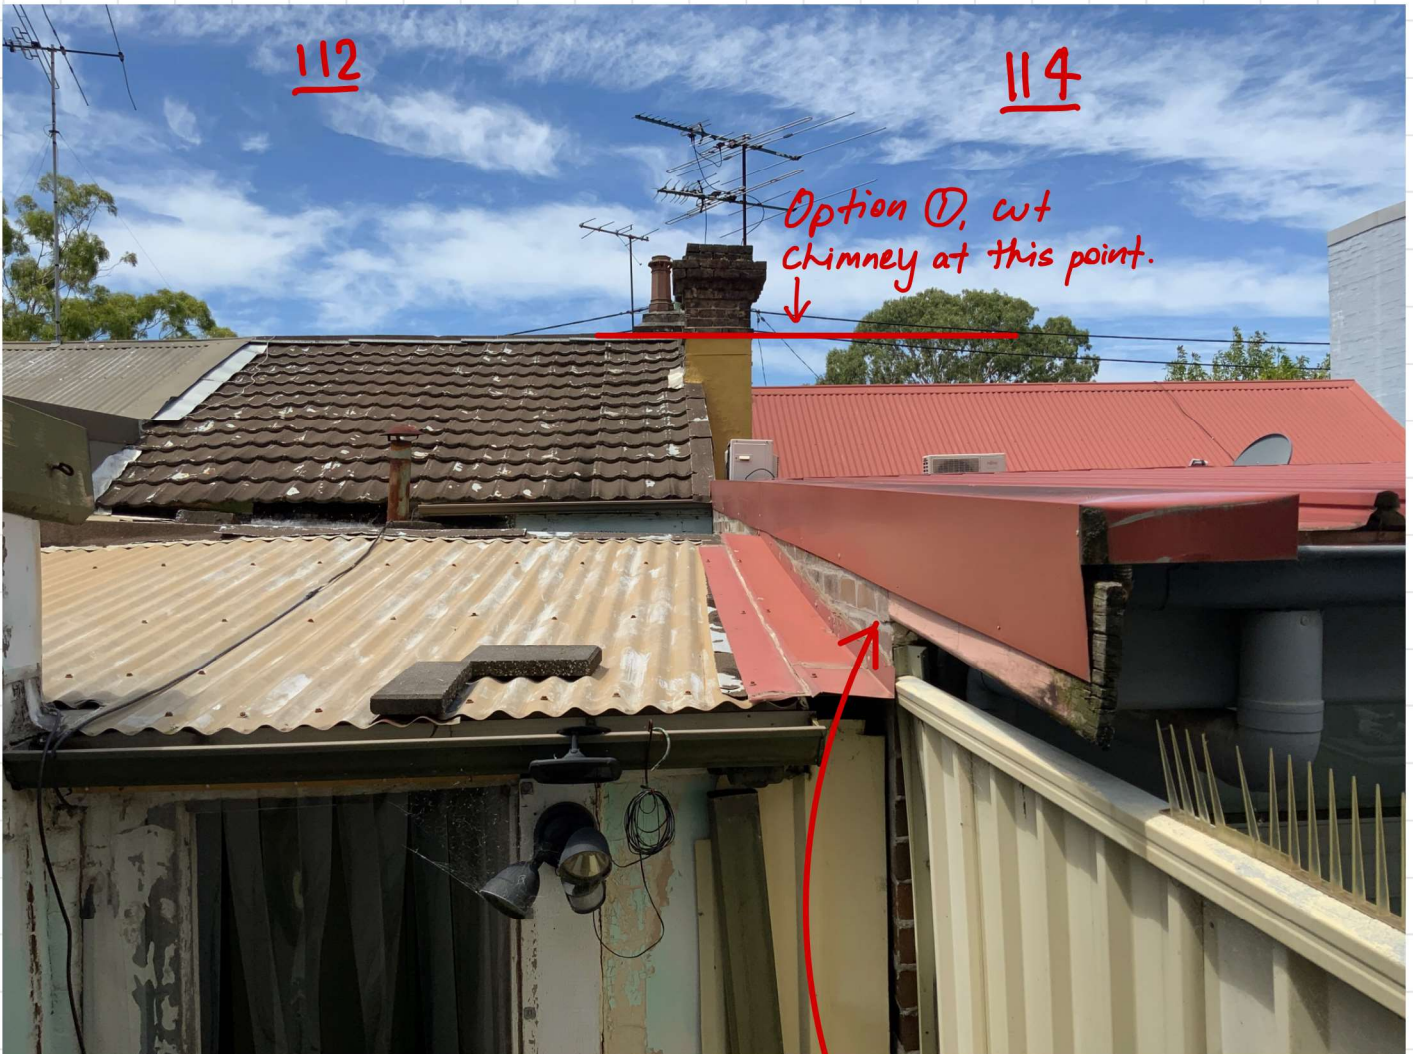
Photo ① - Rear Chimney at 112/114.

- The shared chimney towards the rear is mostly over the dwelling at no. 114 Victoria Street. There are two options which will ensure the stability of the chimney.

Party wall to
be retained and
is independent.

- The first and preferred option is to remove the top half of the chimney which appears to be unstable, brickwork is to be carefully removed by hand. Any overhanging brickwork over No. 112 is to be removed carefully and the side of the chimney is to be rebuilt over the existing party wall at no. 114. All brickwork is to be toothed into the original chimney brickwork, repair any loose brickwork or mortar. Refer to photo 1 over.

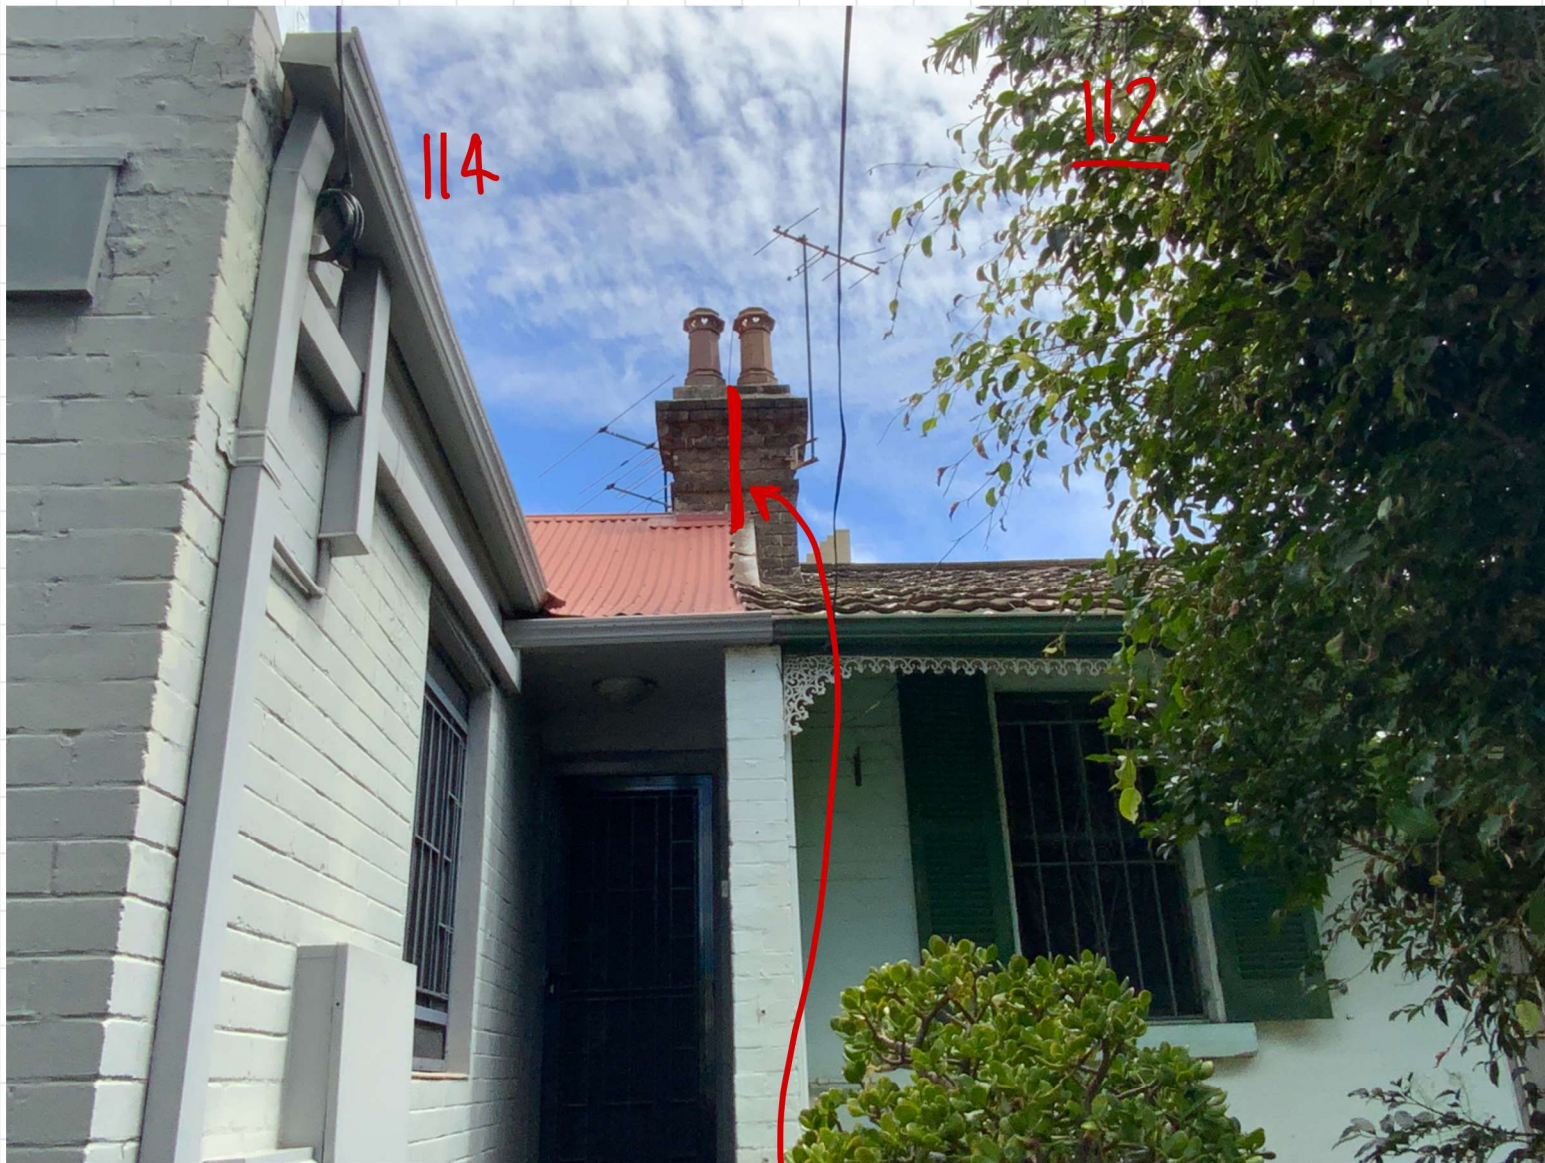
Photo ③ - Front Chimney at 112/114.

- The shared chimney towards the front is divided equally between both dwellings (112 and 114 Victoria Street).

Chimneys to be
Separated and
made good.

The brickwork to the chimney over 112 is to be carefully removed by hand. The side of the chimney is to be rebuilt over the existing party wall at no. 114. All brickwork is to be toothed into the original chimney brickwork. Repair any loose brickwork or mortar. Refer to photo 3 over.

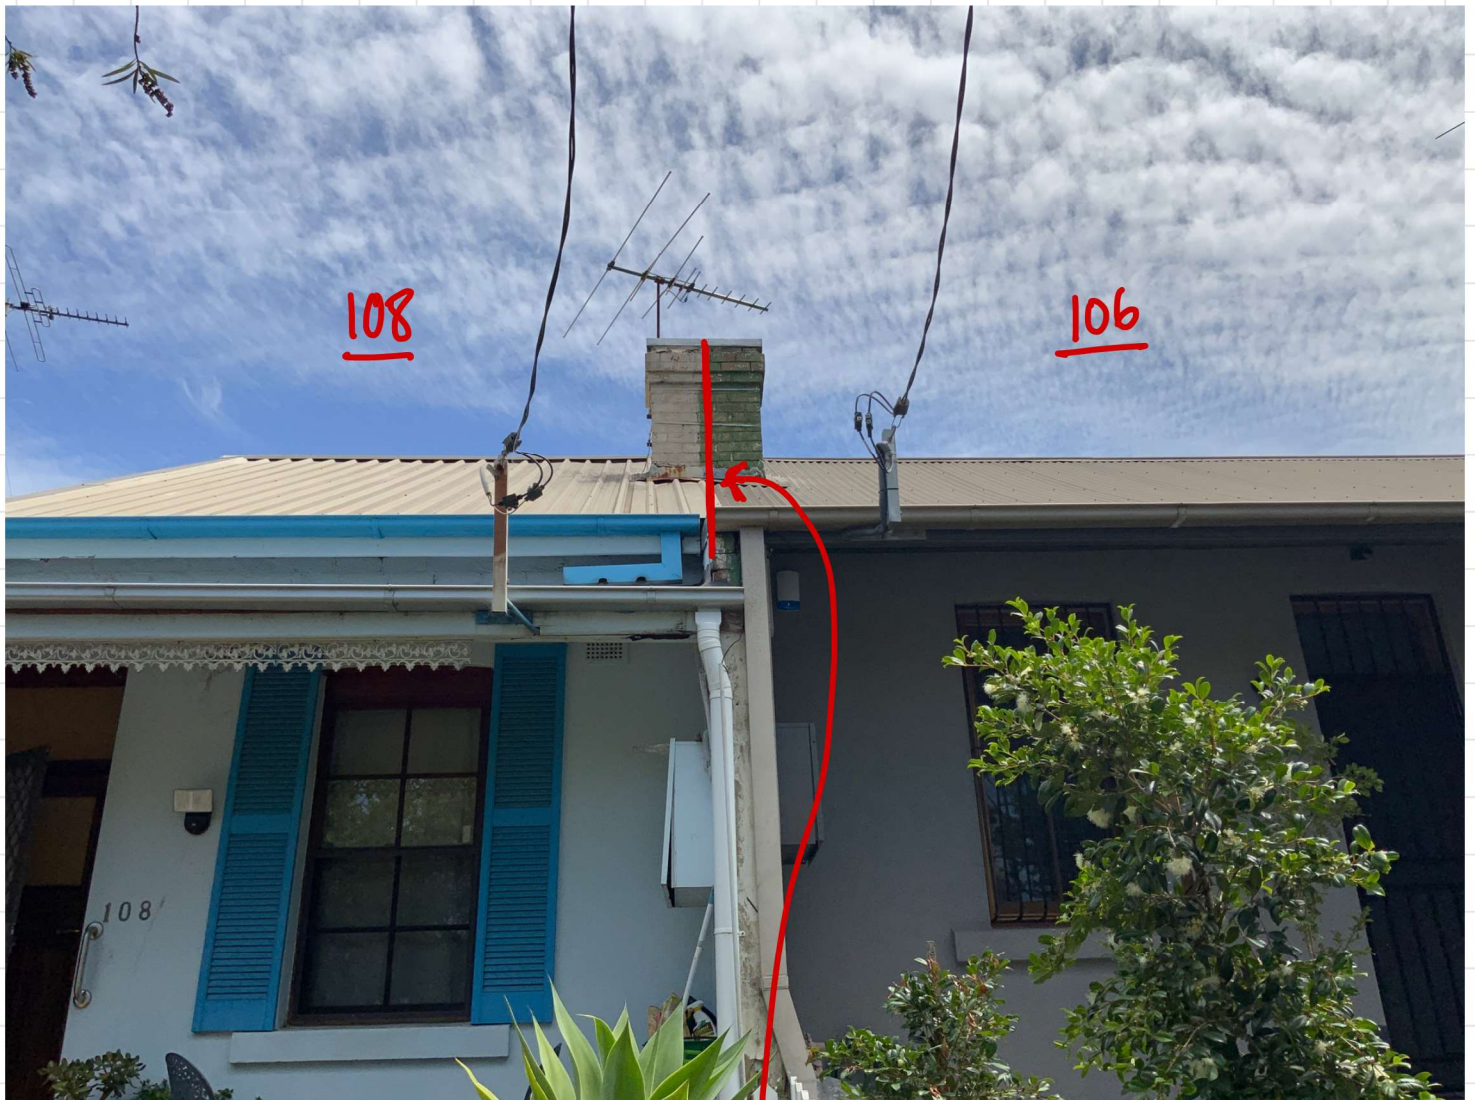
Photo ④ - Front Chimney at 108/106

- The shared chimney towards the front is divided equally between both dwellings (108 and 106 Victoria Street).

Chimneys to be
Separated and
made good.

The brickwork to the chimney over 108 is to be carefully removed by hand. The side of the chimney is to be rebuilt over the existing party wall at no. 106. All brickwork is to be toothed into the original chimney brickwork. Repair any loose brickwork or mortar. Refer to photo 4 over.
