# **Attachment H**

**Inspection Report  
420-426 Pitt Street, Haymarket**

**Council investigation officer Inspection and Recommendation Report**  
**Clause 17(2), Part 8 of Schedule 5, of the Environmental Planning and Assessment**  
**Act 1979 (the Act)**

**Re: INSPECTION REPORT  
MOSAIC  
420 PITT STREET HAYMARKET ("the premises")**

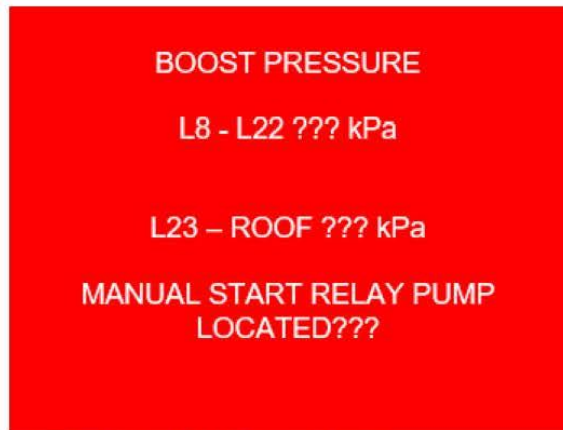
Boost and test pressure signage is not installed at the hydrant booster cabinet to advise the fire brigade of boost pressure to provide 700 kPa at the most hydraulically disadvantaged hydrant in each pressure zone or the required pressure for the relay pumpset.

Figure 1 - Example Boost Pressure signage.

- d. Multiple boost and test pressure signage should be installed at each boost inlet connection for each pressure zone as per Item 1A.B. above. The Zone 2 and 3 boost inlets connection should contain two pressures (see Figures 1 and 2).

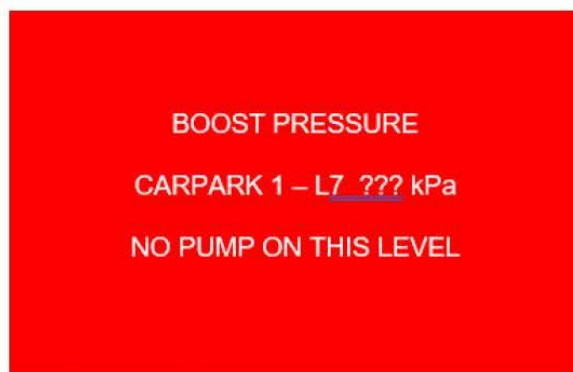
Figure 2 - Example Boost Pressure Signage
