Photos of Sydney Town Hall Roof Elements

Attachment A – Reference Photos of Sydney Town Hall Roof

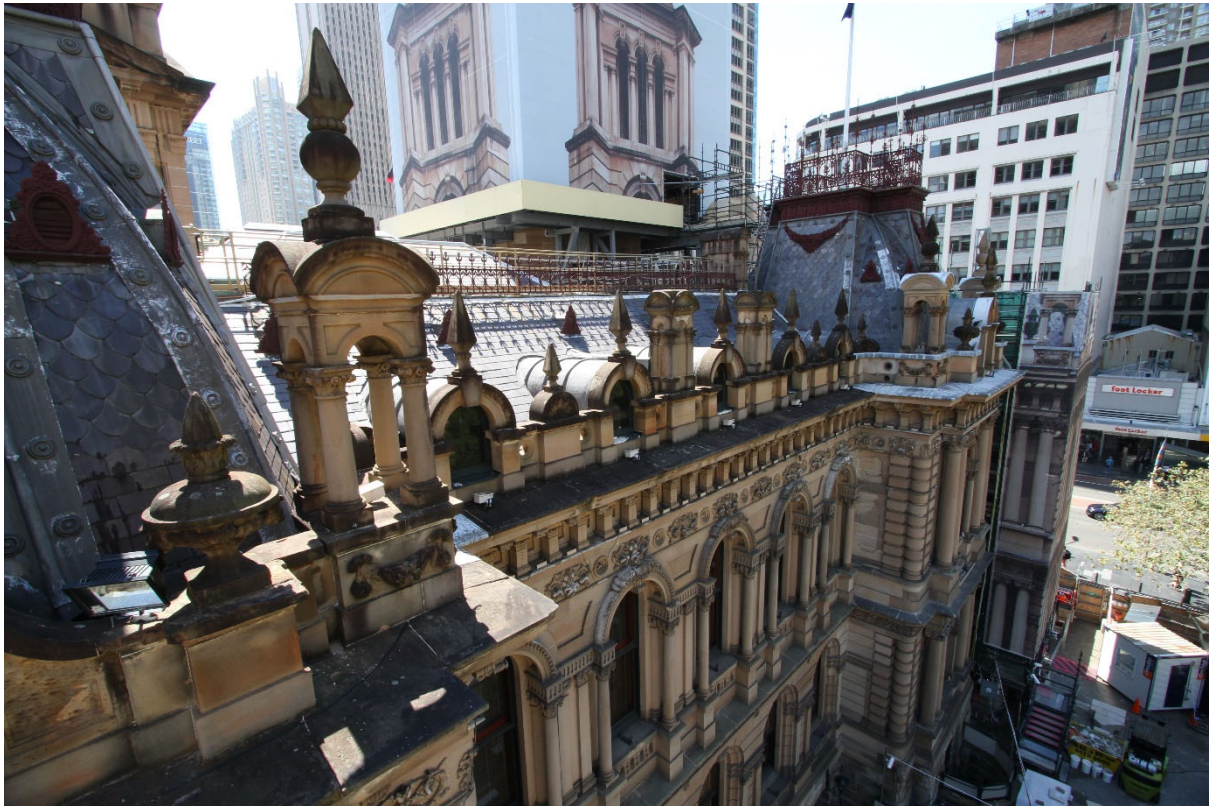
Figure 1. South-western turret (foreground) and South-eastern turret (background).

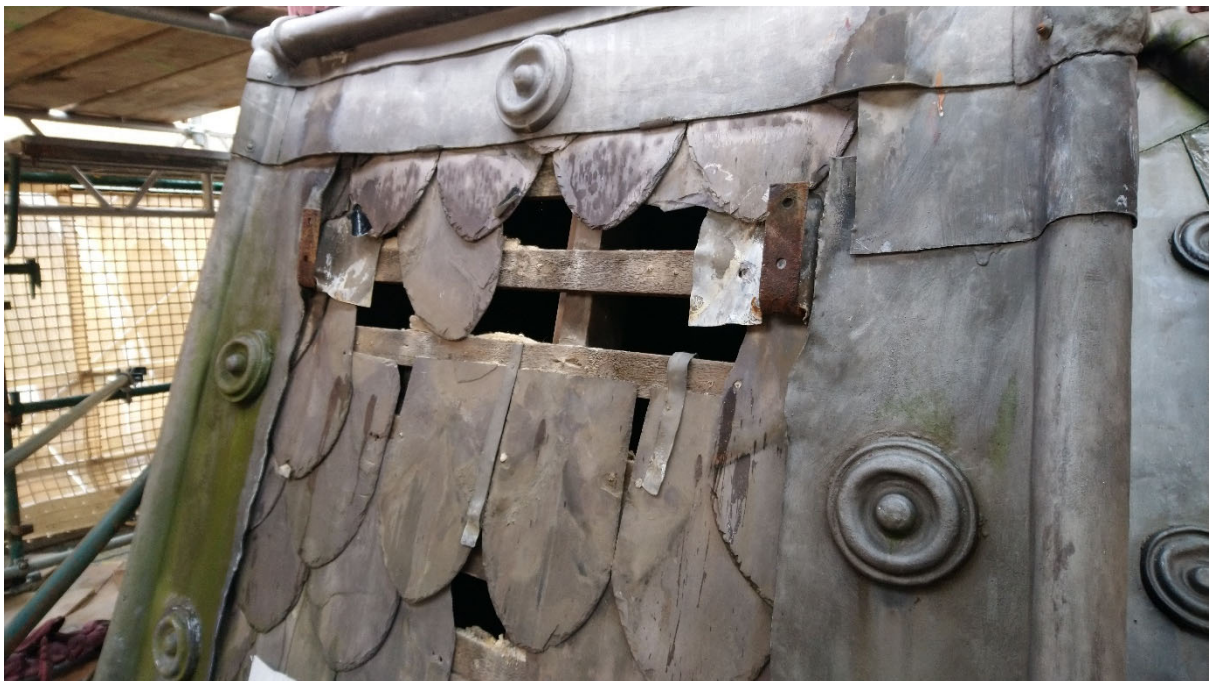
Figure 2. Deterioration to turret.

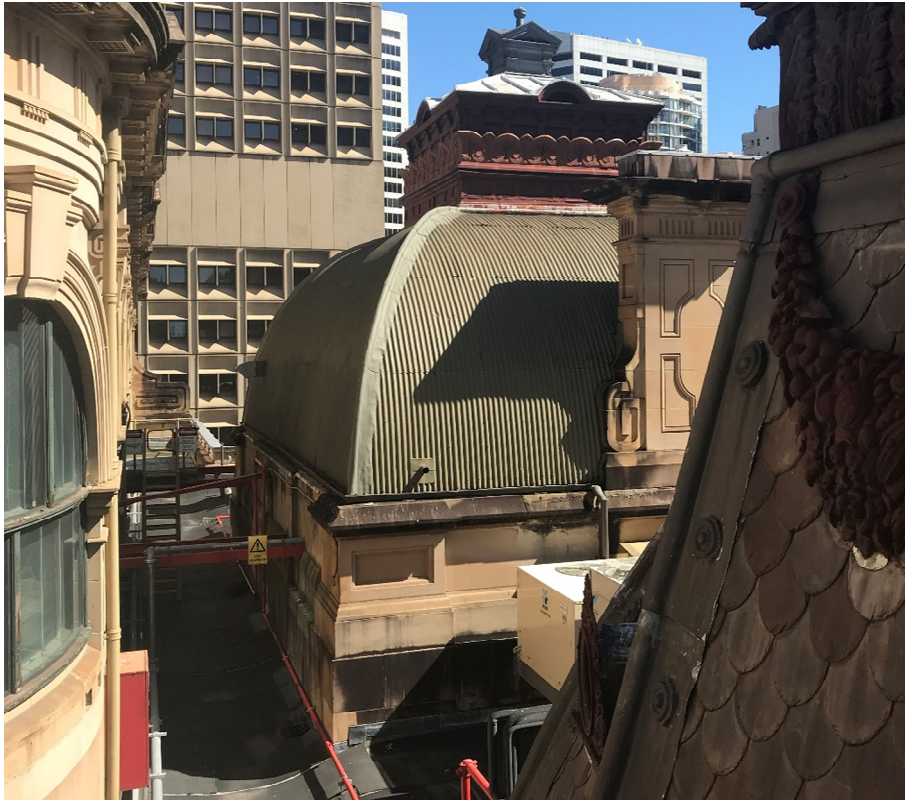
Figure 3. Northern Dome.

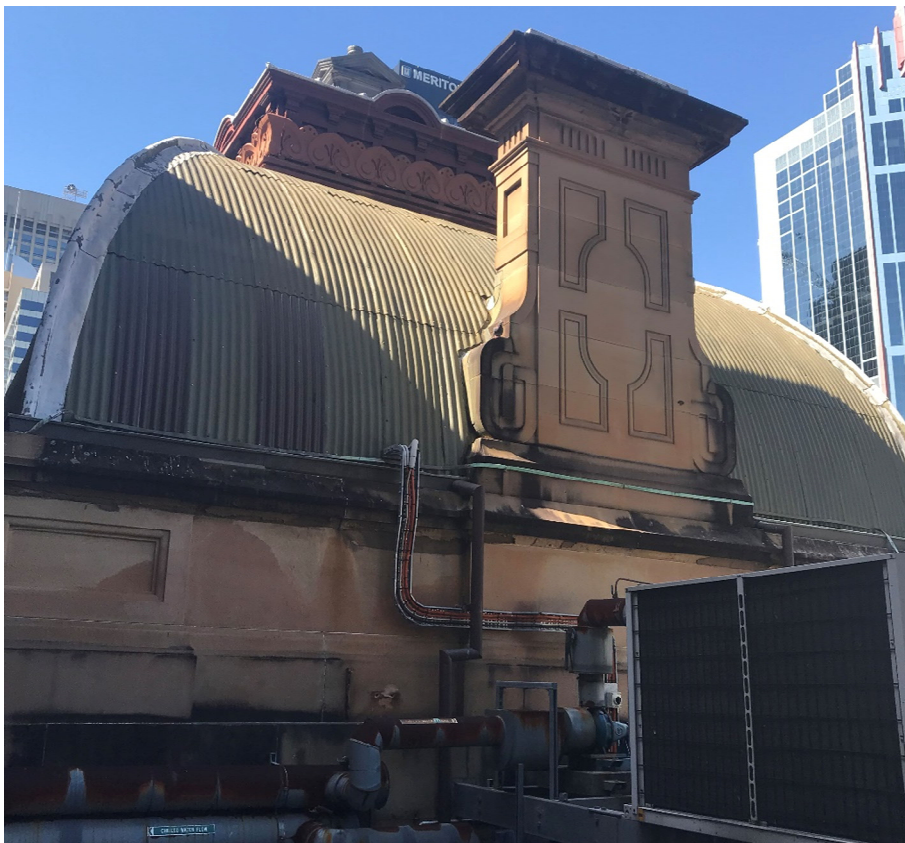
Figure 4. Southern Dome.

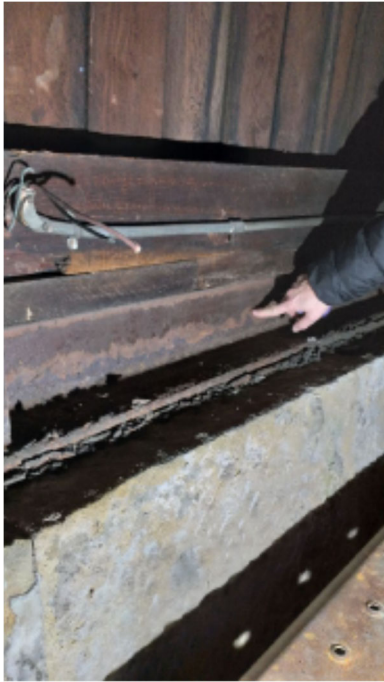
Figure 5. Interior of Dome showing line of rusted steel on L-angle base plate probably caused by water ingress.

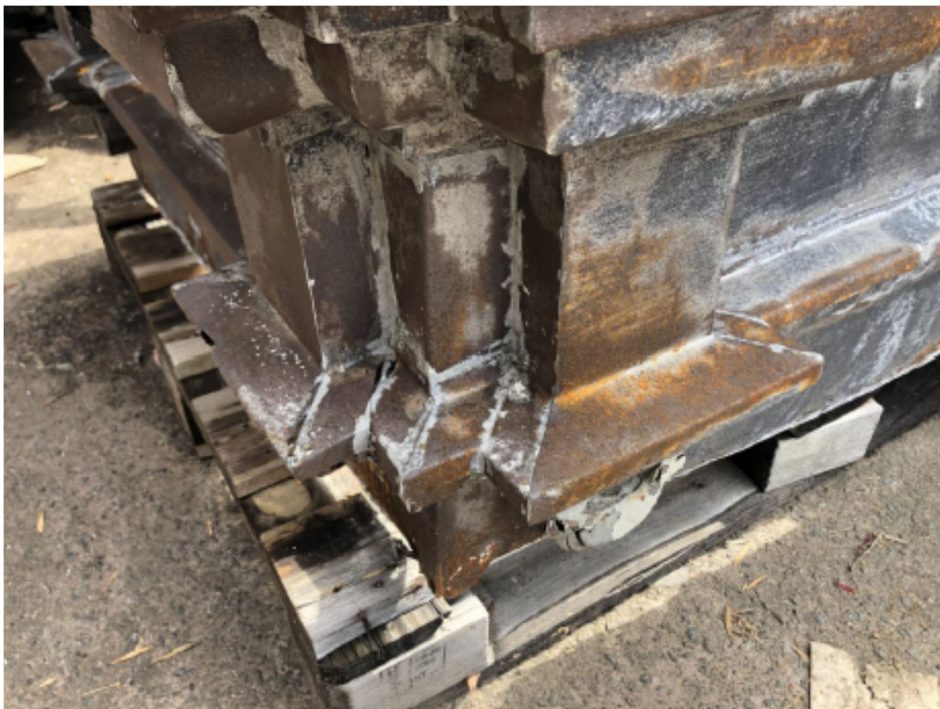
Figure 6. Dome cupola cladding showing the loss of galvanising and associated corrosion.

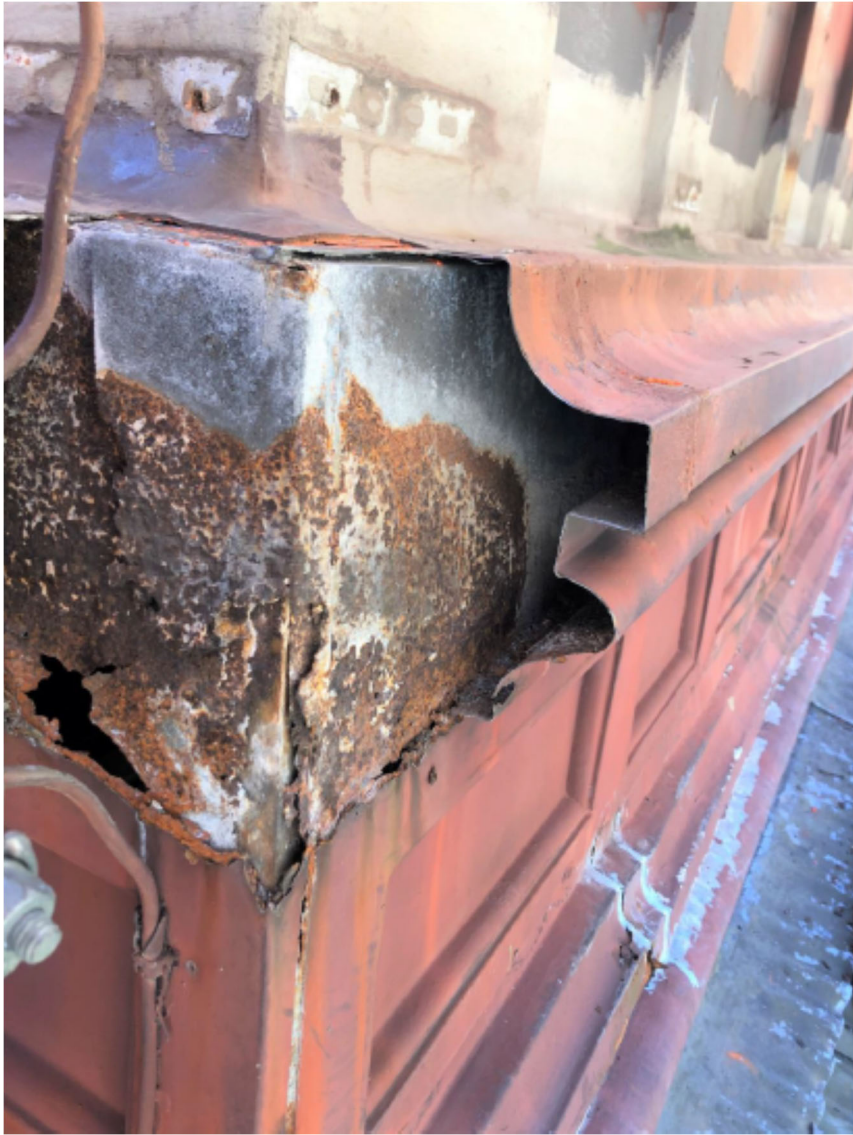
Figure 7. Dome Lantern, showing the deteriorated condition of the original galvanized steel sheet.

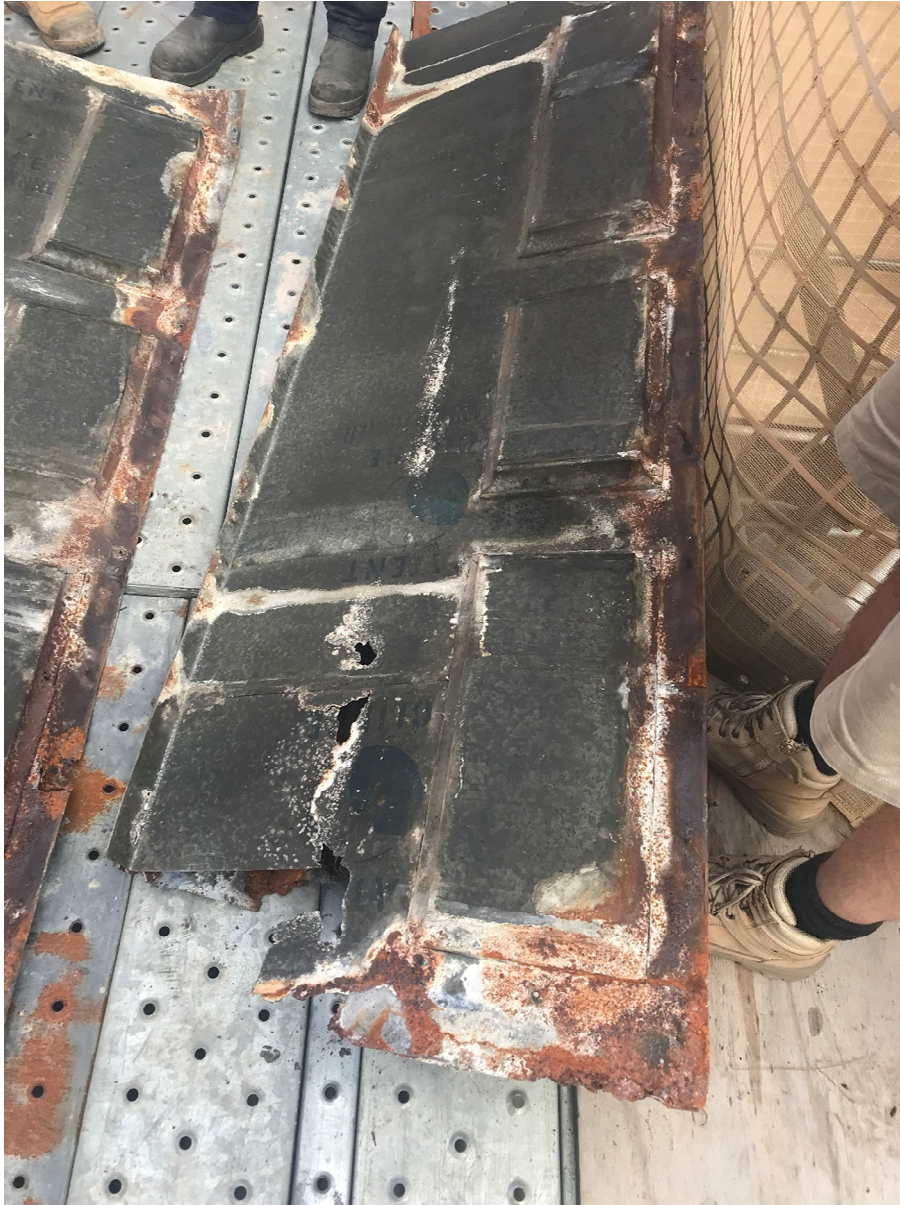
Figure 8. Dome Lantern, interior face of a portion of the removed original architrave panels with visible corrosion.
