**Inspection Report  
10-18 Gadigal Avenue, Waterloo**

**Council investigation officer Inspection and Recommendation Report  
Clause 17(2), Part 8 of Schedule 5, of the Environmental Planning and Assessment  
Act 1979 (the Act)**

**Premises:** 10-18 Gadigal Avenue Waterloo

**Re: INSPECTION REPORT  
EMBLEM APARTMENTS  
10-18 GADIGAL AVENUE WATERLOO ("the premises")**

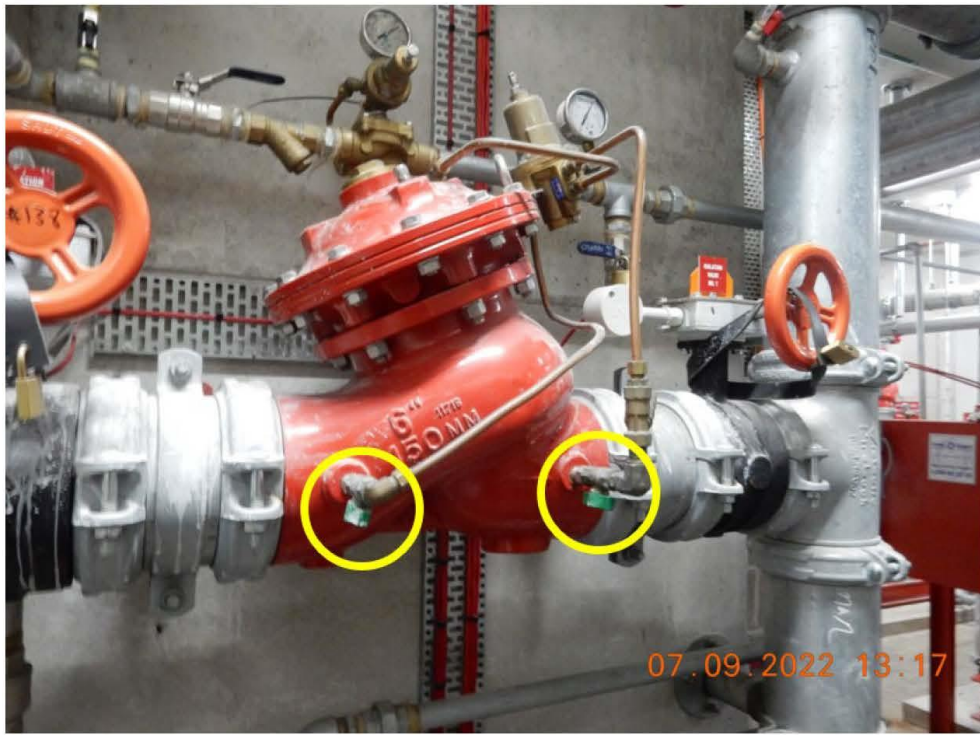
Figure 1

- A. The combined system incorporates Pilot Operated Pressure Reduction Valves (POPRV) downstream of the primary and secondary pumpsets. The *pilot valve*, supply and sensing tubes, incorporate a quarter-turn isolation valve (Figure 1) which are not monitored in accordance with Clause 2.13 and Clause 2.7 of Australian Standard (AS) 2118.6-2012.

Should the quarter-turn isolation valve be in the closed position, at the time of fire, the POPRV will not operate as designed and water will not flow to the broken sprinkler head or hydrant system. The sprinkler system flow switch may not detect water flow, therefore, the occupant warning, alarm signalling equipment, fire fan control panel and the combined system pumpsets will not activate as the Fire Detection and Control Indicating Equipment (FDCIE) has not received a signal to activate the fire safety systems.

- a. Inspect and address any other deficiencies identified on 'the premises', and require items 1A and 1B. B of this report to be addressed appropriately.
- b. Request the owners to remove or monitor the quarter-turn isolation valve on the Pilot Operated Pressure Reduction Valve in accordance with the requirements of AS 2118.6-2012.
