**Inspection Report
10-18 Gadigal Avenue, Waterloo**

**Council investigation officer Inspection and Recommendation Report
Clause 17(2), Part 8 of Schedule 5, of the Environmental Planning and Assessment
Act 1979 (the Act)**

Premises: 10-18 Gadigal Avenue Waterloo

**Re: INSPECTION REPORT
EMBLEM APARTMENTS
10-18 GADIGAL AVENUE WATERLOO (“the premises”)**

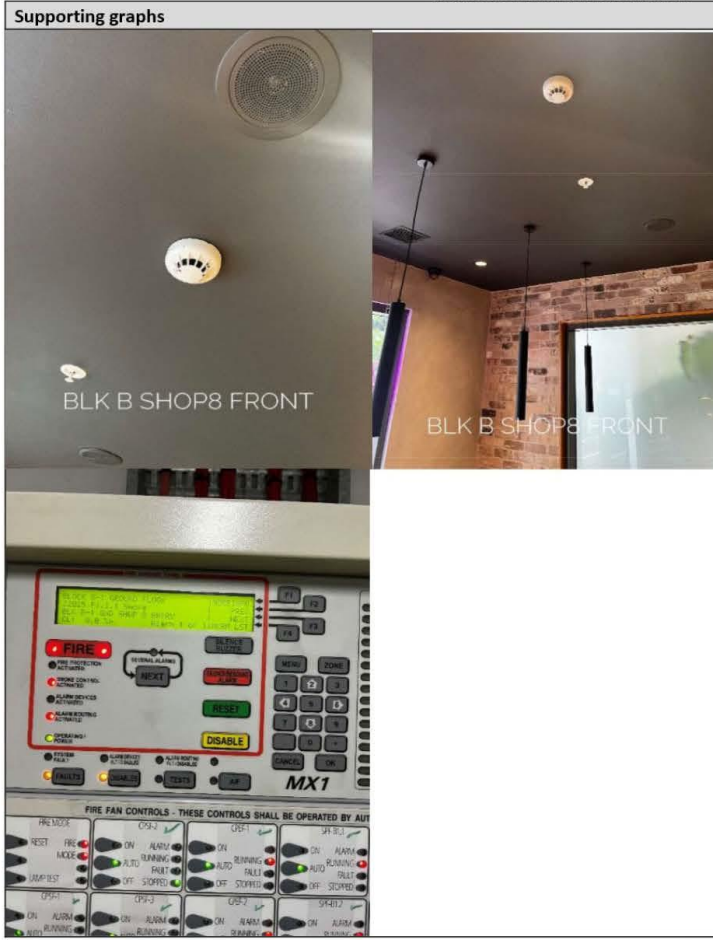
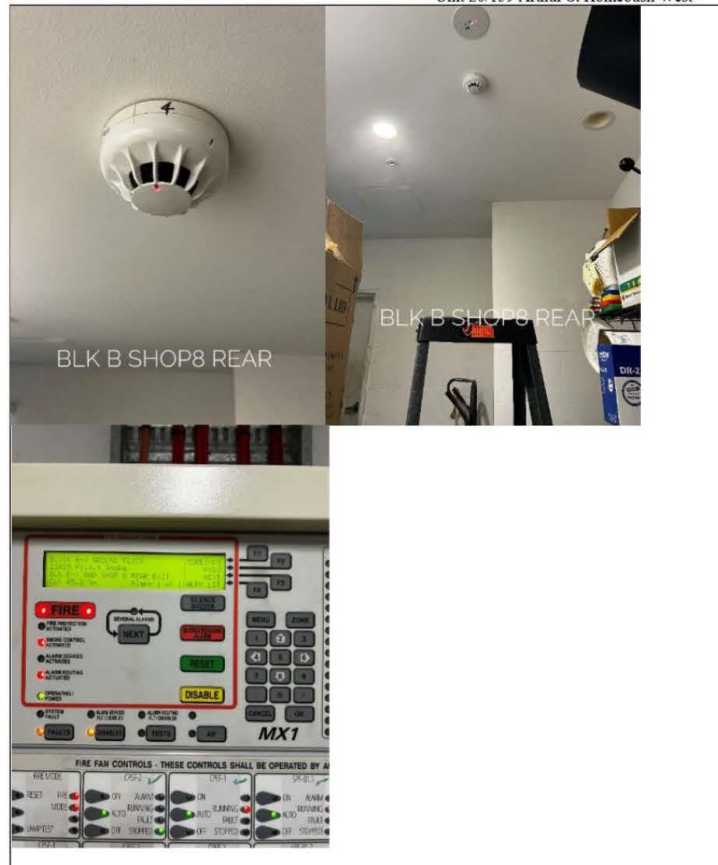
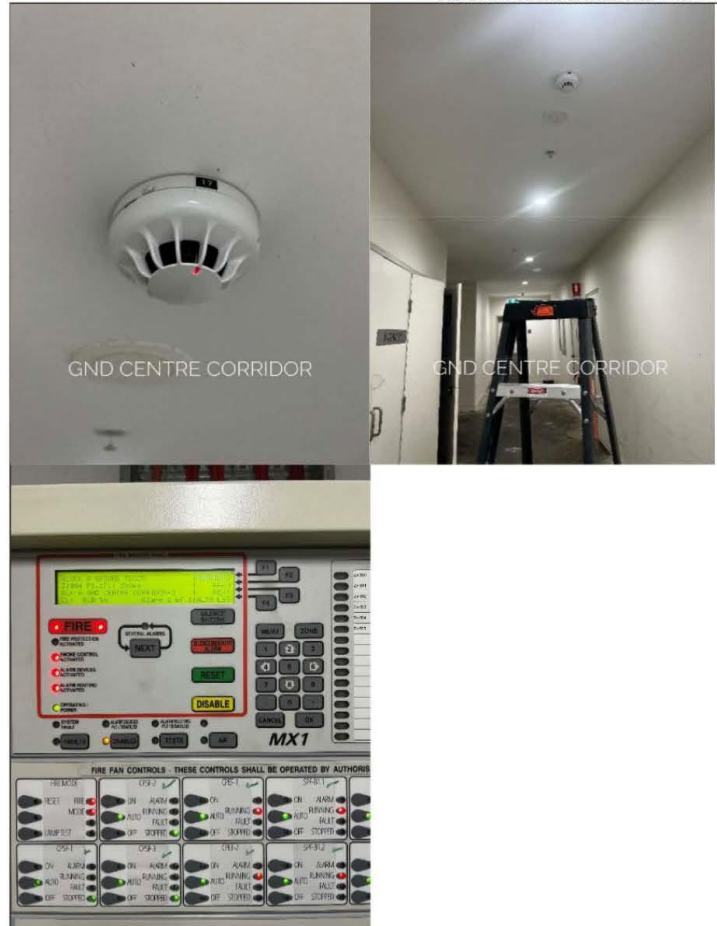
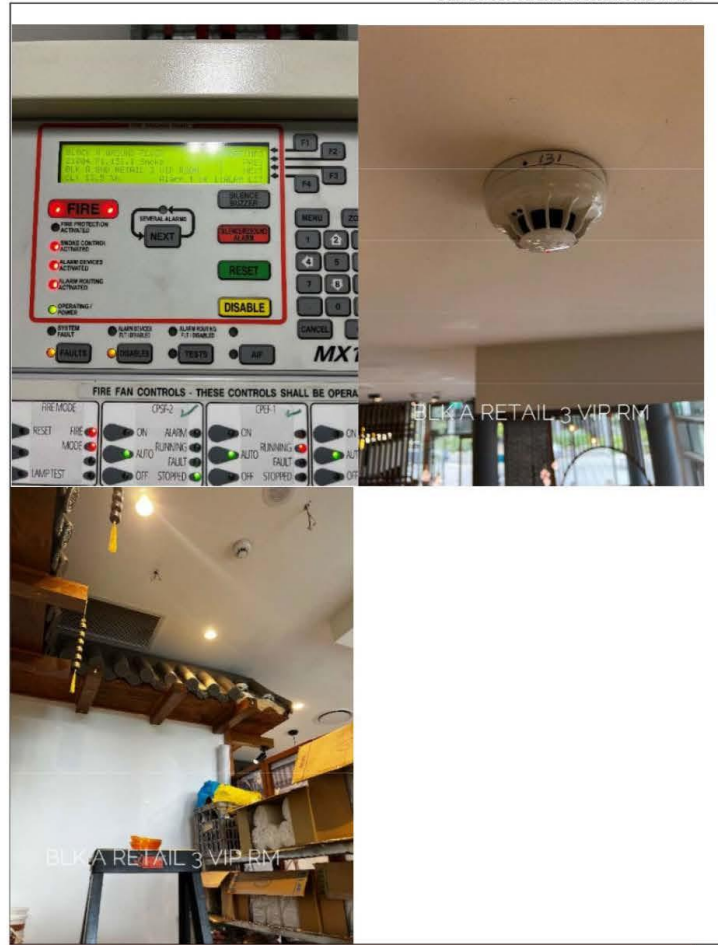
Work Order details:			
Please inspection and commission Points below: Smoke detector No.17 Block A GND Centre Corridor-2. Smoke detector No.131 Block A GND Retail 3 VIP ROOM Smoke detector No.1 Block B GND shop 8 Entry Smoke detector No.4 Block B GND shop 8 Rear Exit			
Service performance:			
Work Performance: We did commission for 4 smoke detectors mentioned above:			
Detector No.	Detector Location.	Smoke detector in Fire strip	FIP in Fire trip
17	Block A GND Centre Corridor-2	Yes	Yes
131	Block A GND Retail 3 VIP ROOM	Yes	Yes
1	Block B GND shop 8 Entry	Yes	Yes
4	Block B GND shop 8 Rear Exit	Yes	Yes
We still have a earth fault showing in the Panel. We did investigation and find out that a lot of detectors and devices in the loops are effected by rain. The base of detectors and the touch points of detectors are corroded by water. Please see our investigation report for more details.
