**Inspection Report
420-426 Pitt Street, Haymarket**

Council investigation officer Inspection and Recommendation Report
Clause 17(2), Part 8 of Schedule 5, of the Environmental Planning and Assessment
Act 1979 (the Act)

**Re: INSPECTION REPORT
'MOSIAC'
420-426 PITT STREET, HAYMARKET ("the premises")**

Re: **INSPECTION REPORT
MOSAIC
420 PITT STREET HAYMARKET ("the premises")**

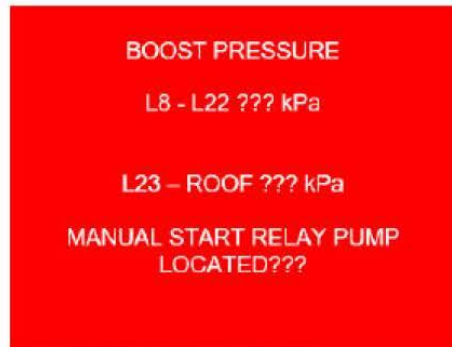
Boost and test pressure signage is not installed at the hydrant booster cabinet to advise the fire brigade of boost pressure to provide 700 kPa at the most hydraulically disadvantaged hydrant in each pressure zone or the required pressure for the relay pumpset.
 - C. The fire hydrant booster is in Campbell Street on the southern end of the building. The booster comprises an 'H' pattern booster for carpark 1 to Level 7 and a high-rise boost inlet connection.

Figure 1 - Example Boost Pressure signage.

- d. Multiple boost and test pressure signage should be installed at each boost inlet connection for each pressure zone as per Item 1A.B. above. The Zone 2 and 3 boost inlets connection should contain two pressures (see Figures 1 and 2).

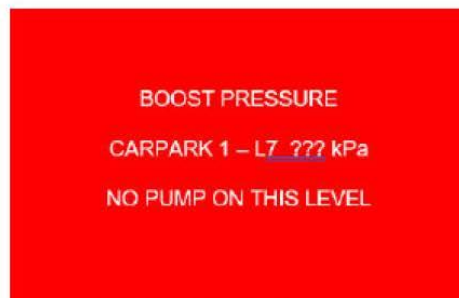
Figure 2 - Example Boost Pressure Signage
